## ON-SITE SIDE IMPACT INFLATABLE OCCUPANT PROTECTION INVESTIGATION

CASE NUMBER - IN-06-004

VEHICLE - 2006 MAZDA MX-5 MIATA

CRASH DATE - January 2006

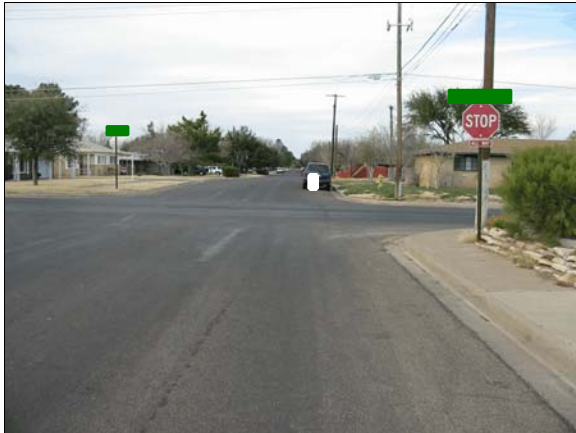
**Figure 1:** Approach of case vehicle northbound to intersection, case vehicle stopped at stop sign prior to entering intersection

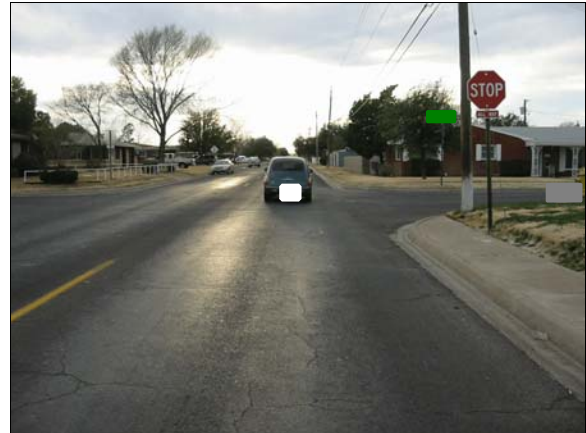
**Figure 2:** Approach of Toyota westbound to intersection

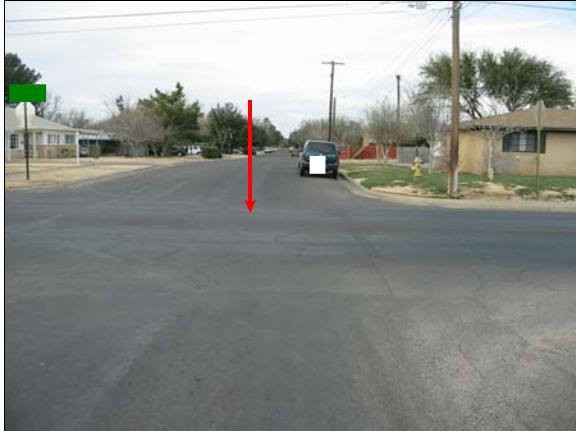
**Figure 3:** View north to area of impact (arrow)

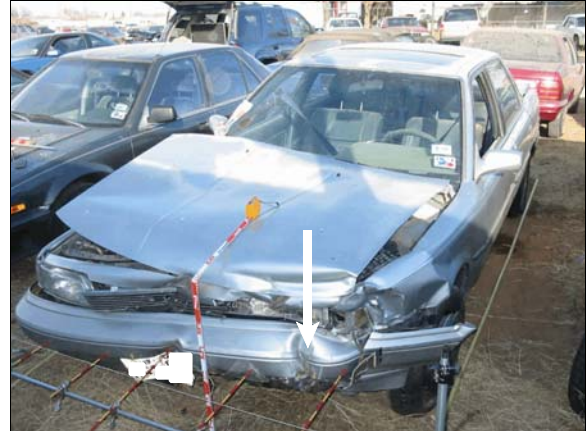
**Figure 4:** Overview of damage to front of Toyota from right fender impact with case vehicle, arrow shows location of stop sign impact

**Exterior Damage:** The Toyota's first impact with the case vehicle involved the front of the vehicle. The front bumper, front of the left fender, left headlamp/turn signal assembly, grille and the hood were directly contacted and crushed rearward and displaced to the right. Direct damage began at the left front bumper corner and extended 82 centimeters (32.3 inches) along the bumper. Crush measurements were taken at the bumper level and the maximum residual crush was measured as 20 centimeters (7.9 inches) occurring at C<sub>2</sub>. The table below shows the Toyota's crush profile for its front impact with the case vehicle's right fender.

The direct damage from the stop sign impact (event 3) began at the left corner of the front bumper and extended approximately 14 centimeters (5.5 inches) along the bumper. There was only minor crush due to this impact. A crush profile could not be taken for the stop sign impact due to the overlapping damage from the Toyota's front impact with the case vehicle's right fender.

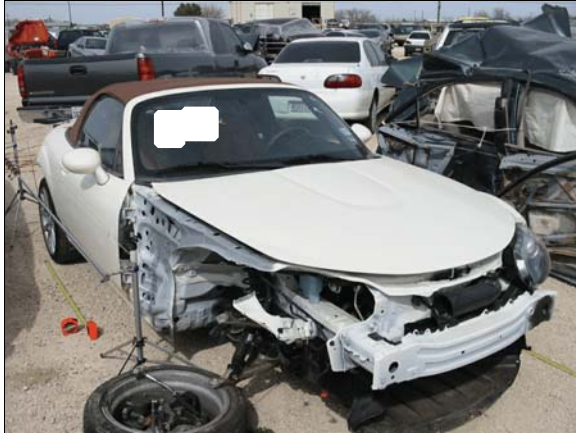
**Figure 5:** Right front overview of case vehicle, damaged right fender and front bumper had been removed and were not present at inspection facility

**Exterior Damage:** The case vehicle's first impact with the Toyota involved the right fender and right front wheel. The direct damage began 155 centimeters (61 inches) forward of the right rear axle. The direct damage most likely involved the full length of the fender; however, the length of the direct damage and the crush profile could not be determined because the fender had been removed from the vehicle and was not available for inspection. The second impact with the Toyota involved the case vehicle's right quarter panel, which was directly damaged and crushed inward. The direct damage began 9 centimeters (3.5 inches) rear of the right rear axle and extended 49 centimeters (19.3 inches) rearward along the quarter panel. The residual maximum crush was measured as 6 centimeters (2.4 inches) occurring at C<sub>3</sub> and C<sub>4</sub>. The table below shows the case vehicle's right quarter panel crush profile.

**Damage Classification:** The damaged right fender had been removed from the case vehicle and was not available for inspection. However, based on the components left on the case vehicle, the damage to the Toyota and the impact configuration, a CDC for the case vehicle’s right fender impact with the front of the Toyota was estimated to be: **02-RFEW-2 (70 degrees)**. Based on the vehicle inspection, the CDC for the case vehicle’s right quarter panel impact to the left side of the Toyota was determined to be: **03-RBEW-2 (90 degrees)**. The WinSMASH reconstruction program, missing vehicle algorithm, was used to reconstruct the case vehicle's Delta Vs for its right fender impact with the front of the Toyota. The Total, Longitudinal, and Lateral Delta Vs are, respectively: 27.0 km.p.h. (16.8 m.p.h.), -9.2 km.p.h. (-5.7 m.p.h.), and -25.4 km.p.h. (-

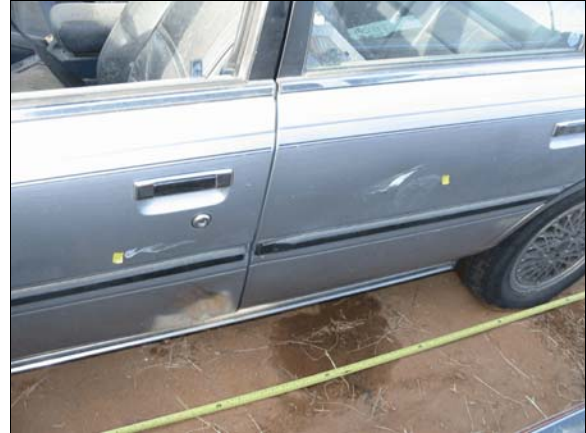
**Figure 6:** Damage to left front and left rear doors from impact with right quarter panel of case vehicle

The second impact with the case vehicle involved the left front and left rear doors. The back portion of the left front door and front middle portion of the left rear door were directly contacted. There was paint transfer from the case vehicle on both doors, and the case vehicle's right rear tire scuffed and dented the left front door. Otherwise, there was scant damage to the doors from this impact. The direct damage began 68 centimeters (27.8 inches) forward of the left rear axle and extended 63 centimeters forward along the left front and left rear doors. Maximum residual crush was approximately 1 centimeter (0.4 inch) occurring at C<sub>4</sub> and C<sub>5</sub>. The table below shows the Toyota's crush profile for the side-slap impact with the case vehicle.

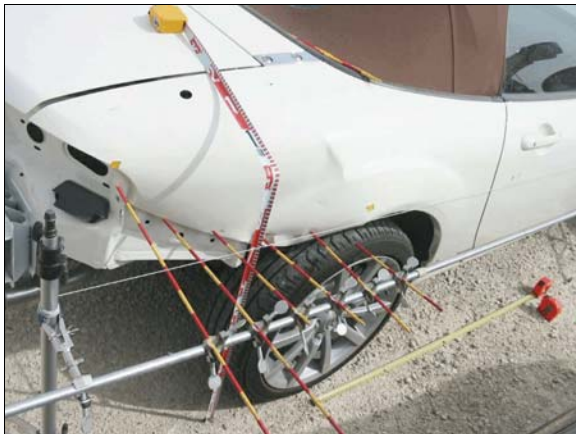
**Figure 7:** Damage to case vehicle's right quarter panel from side slap impact with the left side of the Toyota

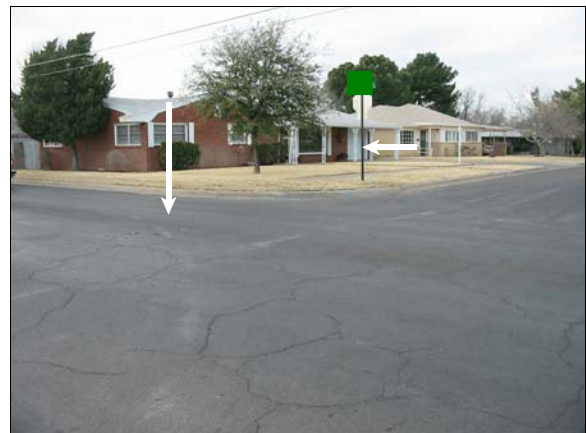
**Figure 8:** Left arrow shows area of final rest of case vehicle, stop sign (right arrow) impacted by Toyota has been replaced

**Post-Crash:** The case vehicle came to rest in the west leg of the intersection heading west (**Figure 8**). The Toyota continued northwest and came to rest in the front yard of a residence (**Figure 9**) heading northwest.

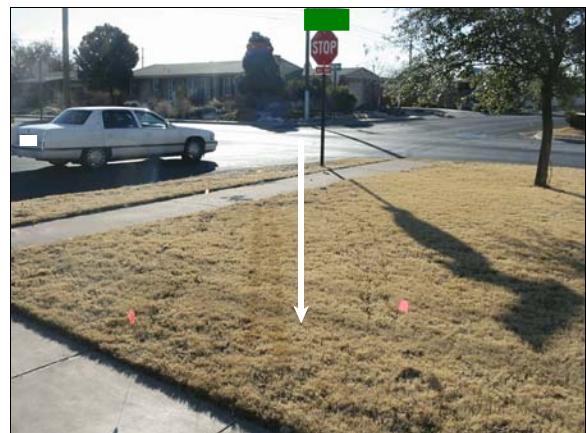
**Figure 9:** View southeast through the area of Toyota's final rest (arrow), flags show Toyota's left and right tire marks in grass

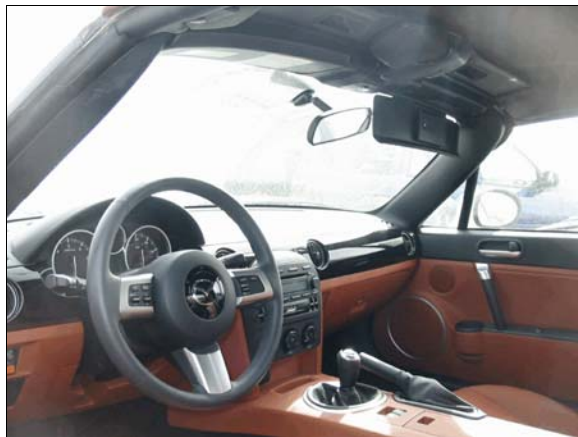
**Vehicle Interior:** Inspection of the case vehicle’s interior (**Figure 10** and **Figure 11**) revealed a small scuff on the right seat back-mounted side impact air bag. No other occupant contact evidence was found and no intrusion of the passenger compartment was observed. Finally, there was no compression of the energy absorbing steering column or deformation of the steering wheel (**Figure 12** below).

**Figure 10:** Overview of case vehicle’s steering wheel, windshield and instrument panel through driver’s door

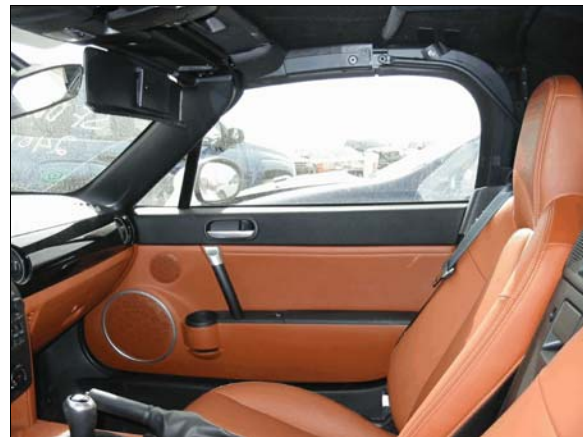
**Figure 11:** Overview of case vehicle’s right instrument panel, front right passenger’s seat and right front door

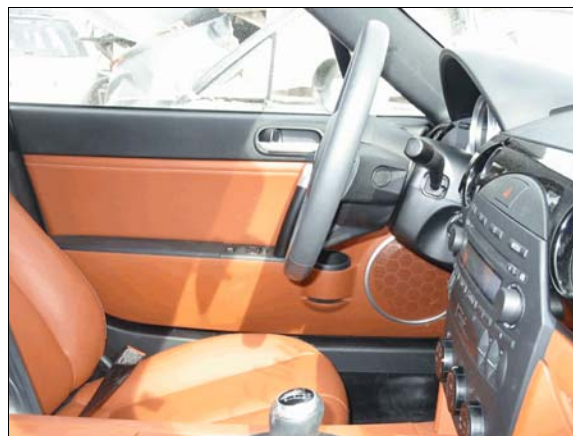
**Figure 12:** Right side view of case vehicle's steering wheel and steering column showing lack of deformation

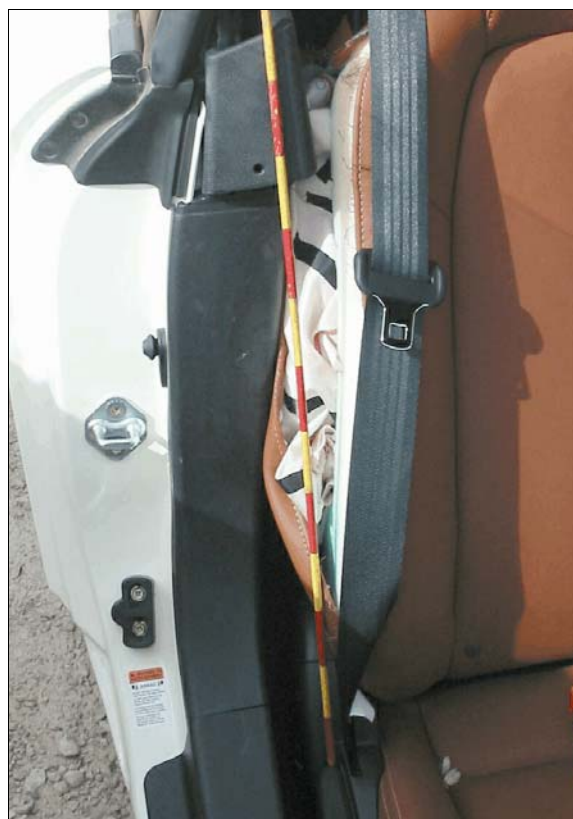
**Figure 13:** Case vehicle's front right passenger seat back-mounted side impact air bag located in right side of passenger seat back, each increment on rod is 5 cm (2 in)

The front right passenger's seat back-mounted side impact air bag deployed in this crash as a result of the initial impact to the case vehicle's right fender (event 1). The side impact air bag was located in the outboard side of the front right passenger's seat back (**Figure 13**). The air bag deployed properly through the tear seam in the side of the seat back. There was no evidence of damage to the air bag due to the deployment. The side impact air bag (**Figure 14** below) was an irregular oval-shape and was wider at the top than the bottom. The air bag measured 79 centimeters (31.1 inches) in height and 40 centimeters (15.7 inches) in width at it widest point near the top of the air bag. The air bag was designed without tethers or vent ports. An occupant contact scuff was observed on the central portion of the air bag

approximately 18 centimeters (7.1 inches) from the top of the air bag. It appeared to be a small scuff of eye makeup. No other evidence of occupant was observed on the air bag fabric

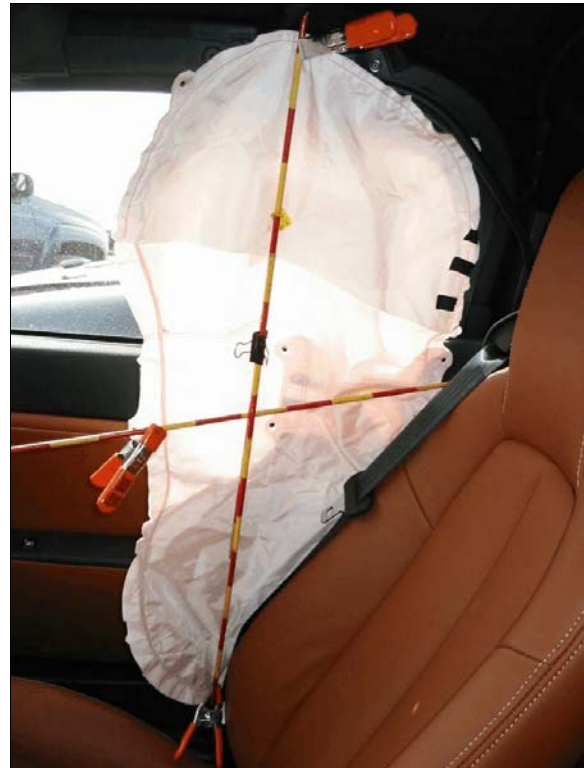
**Figure 14:** Case vehicle's front right passenger seat back-mounted side impact air bag
