**CALSPAN ON-SITE CHILD AIR BAG RELATED FATALITY  
INVESTIGATION**

**CALSPAN CASE NO: CA06-004**

**VEHICLE: 1996 PLYMOUTH VOYAGER**

**CRASH DATE: FEBRUARY 2006**

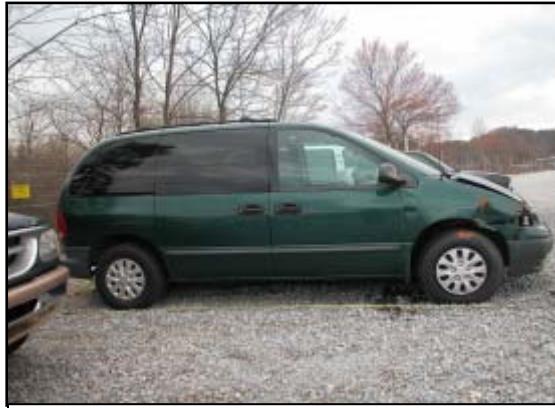
This on-site investigation focused on the severity of the crash and the source of injury that caused the death of a restrained 6-year-old male front right occupant of a 1996 Plymouth Voyager (**Figure 1**). The Plymouth was equipped with first generation frontal air bags for the driver and front right positions that deployed as a result of the crash. The Plymouth was occupied by a restrained 23-year old female driver, a restrained 6-year-old male front right occupant, a restrained 4-year-old male rear left occupant, and a 2-week-old male rear right occupant restrained in an infant child safety seat.

Figure 1. Subject vehicle 1996 Plymouth Voyager.

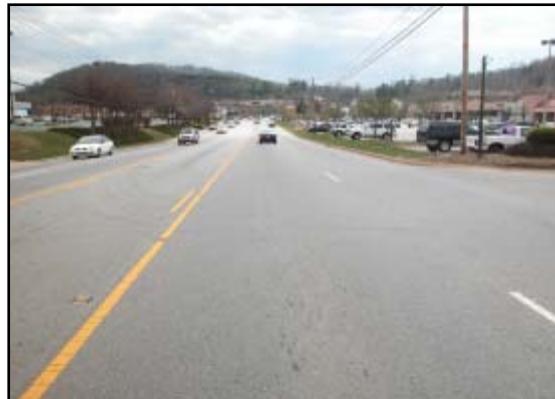
The front right area of the Plymouth impacted the left side of the Jeep within the left southbound travel lane (**Figure 4**). Based on the area of contact to the vehicles, it appears that the driver of the Plymouth probably steered left. Resultant directions of force were 1 o'clock for the Plymouth and 10 o'clock for the Jeep. The damage algorithm of the WinSMASH program computed total velocity changes of 15 km/h (9.3 mph) for the Plymouth and 13 km/h (8.1 mph) for the Jeep. The specific longitudinal and lateral components were -13 km/h (-8 mph) and -8 km/h (-4.7 mph) for the Plymouth and -7 km/h (-4.0 mph) and 11 km/h (7.0 mph) for the Jeep. As a result of the crash, the frontal air bag system in the Plymouth deployed.

**Figure 4. Area of impact from the southbound lane.**

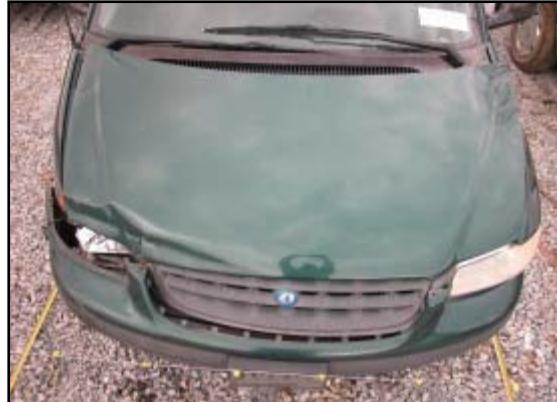
The 1996 Plymouth Voyager sustained minor severity damage as result of the crash with the Jeep (**Figure 6**). The damage was contained to the front right area of the vehicle, involving the hood, bumper fascia and support beam, headlight, upper radiator support, and the right front fender. Maximum crush was 5 cm (1.9”), and was located 7 cm (2.8”) right of the centerline. The direct contact damage began 3 cm (1.0) right of the vehicle’s centerline and extended 70 cm (27.5”) to the right. A crush profile was documented along the full width of the bumper beam, which measured 141 cm (55.5”). The crush profile consisted of six equidistant crush measurements that were as follows: C1 = 0 cm, C2 = 0 cm, C3 = 3 cm (1.2”), C4 = 5 cm (1.9”), C5 = 4 cm (1.6”), C6 = 3 cm (1.2). The Collision Deformation Classification (CDC) for this impact was 01-FZEW-1.

**Figure 6. Overhead view of the bumper crush to the Voyager.**

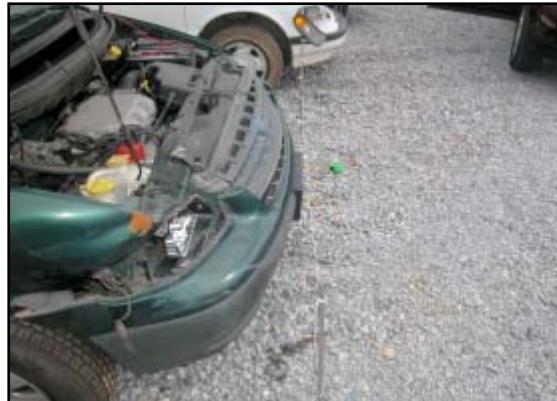
Additionally, the right side of the upper radiator support was displaced longitudinally as result of the crash (**Figure 7**). A crush profile was documented along the upper radiator support and was as follows: C1 = 0 cm, C2 = 0 cm, C3 = 0 cm, C4 = 0 cm, C5 = 3 cm (1.0”), C6 = 3 cm (1.3”).

**Figure 7. Lateral view of the upper radiator crush profile.**

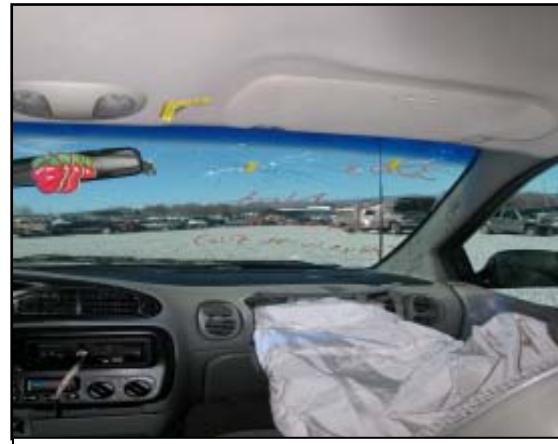
The doors remained closed and operational post-crash and there was no damage to the side and rear glazing. A fracture pattern was noted to the base of the windshield from contact with the hood edge. This fracture pattern radiated to the top of the windshield. Two spider-web fractures were also noted. These fractures occurred from the inside of the vehicle from contact by the deploying front right air bag.

Two tears were documented on the headliner forward of the right sun visor. All four occupants of the vehicle were restrained; therefore this damage was probably pre-existing. The 1 cm (0.3") laceration was located 9 cm (3.5") inboard of the right A-pillar and 1 cm (0.5") rear of the windshield header. The 5 cm (2.0") laceration was located 48 cm inboard of the right A-pillar and 9-14 cm (3.5-5.5") rear of the windshield header. **Figure 8** is an overall of the right side damage to the windshield and headliner.

**Figure 8.** Overall view of right side windshield and headliner damage.

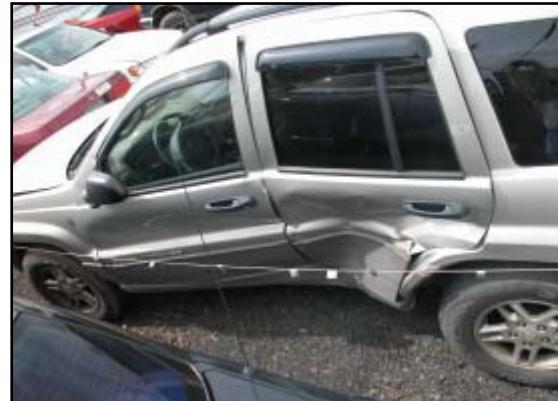
The Jeep sustained moderate severity left damage as result of the impact with the Plymouth (**Figure 9**). This impact resulted in lateral deformation the left side doors, fender, and quarter panel. The maximum crush measured 29 cm (11.3") and was located 75 cm (29.5") forward of the left rear axle on the left rear door. The direct contact damage began 39 cm (15.3") forward of the left axle and extended 149 cm (58.5") forward onto the left front door. The lateral deformation was documented at the mid-door level using a combined direct and induced damage width of 196 cm (77.3") and were as follows: C1 = 1 cm (0.4"), C2 = 22 cm (8.7"), C3 = 22 cm (8.7"), C4 = 15 cm (5.9"), C5 = 7 cm (2.8"), C6 = 0 cm. The CDC for this impact was 10-LPEW-2.

**Figure 9.** Impact damage to the left side 2004 Jeep Grand Cherokee.

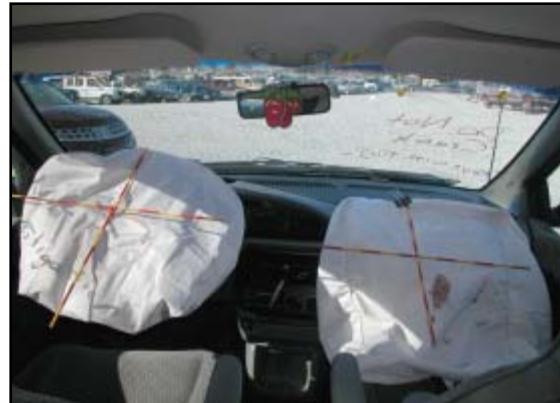
The Plymouth was equipped with first generation air bags for the driver and front right occupant positions. The history of the safety system was unknown; the driver purchased the vehicle used in September 2005. The system deployed as a result of the impact sequence with the Jeep (**Figure 10**).

**Figure 10.** Deployed frontal air bags.

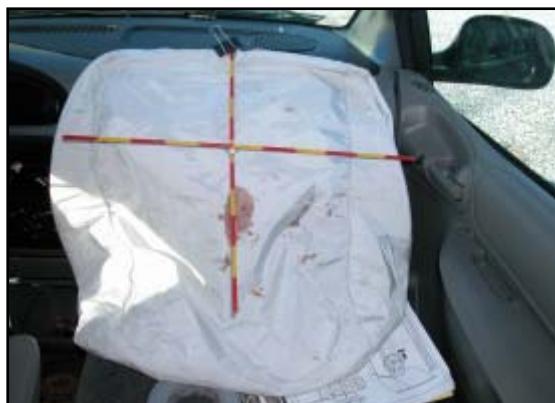
The right front air bag membrane measured 48 cm (18.8") in width and 83 cm (32.5") in height (**Figure 11**). The bag was not tethered and was internally vented. The maximum rearward excursion of this air bag was 71 cm (28.0") from the instrument panel and terminated 8 cm (3.0") from the right front seat back (**Figure 12**). The air bag membrane extended an additional 28 cm (11.0") into the instrument panel to the inflator.

**Figure 11.** Deployed front right air bag.

No damage was noted to the air bag; however, several areas of the membrane contained body fluid. The largest area of body fluid was located 38-52 cm (15.0-20.3") below the top peripheral seam and 23-29 cm (9.0-11.3") inboard of the left peripheral seam near the center aspect of the air bag membrane. Additionally, three smaller areas of body fluid were located at the 3, 5, and 7 o'clock regions on the air bag membrane. A 46 x 46 cm (18 x 18") area of body fluid spatter was noted on the top panel of the air bag membrane.

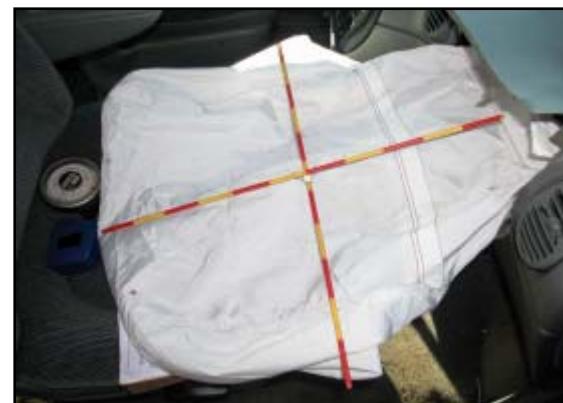
**Figure 12.** Lateral view of the maximum excursion of the front right air bag.

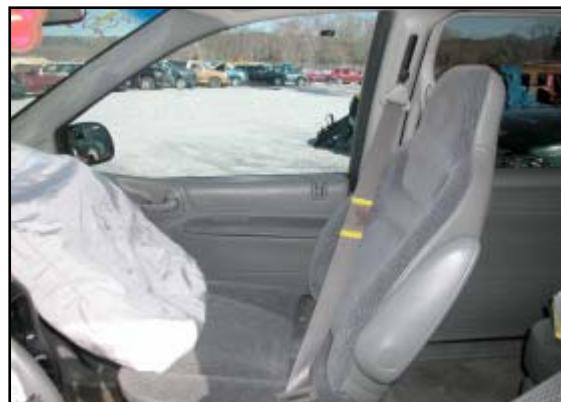
**Figure 13. Front right safety belt, body fluid highlighted by calibrated tape.**

The front right safety belt was used in the subject crash; however, no loading evidence was present on the belt system. Although the belt system was free of loading, body fluid was present on the webbing. The first area body fluid was located 80-86 cm (31.3-33.3") above the stop button. In the buckled position, the body fluid was located near the center of the seatback, which was consistent with the right occupant using the safety belt in the crash (**Figure 13**). The second area of body fluid was located 10-16 cm (4.0-6.3") above the floor anchor.

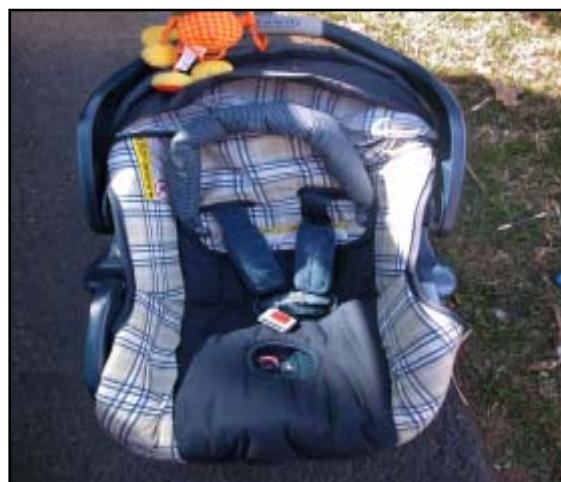
The RFCSS was installed in the second row right position of the Plymouth and was used without the detachable base (**Figure 14**). The driver stated during the SCI interview that the detachable base was located in the cargo area and she could not remove it due her recent caesarian section childbirth. Additionally, she stated that the lap and shoulder safety belt was routed across the top of the RFCSS through the belt path. The driver indicated that she set the retractor in the ALR mode. However, upon inspecting the RFCSS in the replacement vehicle, the retractor was not set in the ALR

**Figure 14. Graco infant seat.**

and the driver stated she was unaware that the safety belt could be locked. Furthermore, the Plymouth was not equipped with ALR's for the rear seating positions. A small stress mark was noted on the carry handle from contact with the front left seat back. The stress mark was approximately 3 cm (1.0") in diameter was located left of the centerline. The remainder of the RFCSS and detachable base exhibited no damage.
