**CALSPAN ON-SITE CERTIFIED ADVANCED-208 COMPLIANT VEHICLE  
CRASH INVESTIGATION**

**SCI CASE NO. – CA06-005**

**SUBJECT VEHICLE – 2006 PONTIAC G6**

**CRASH DATE – FEBRUARY 2006**

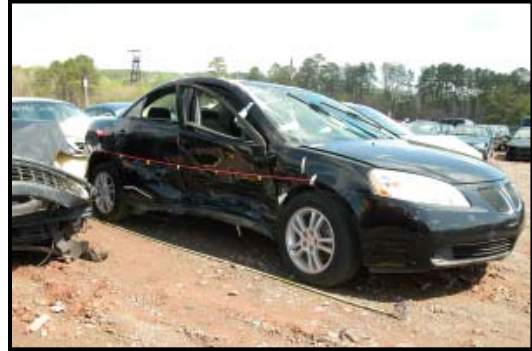
**Figure 1: Right front view of the Pontiac G6.**

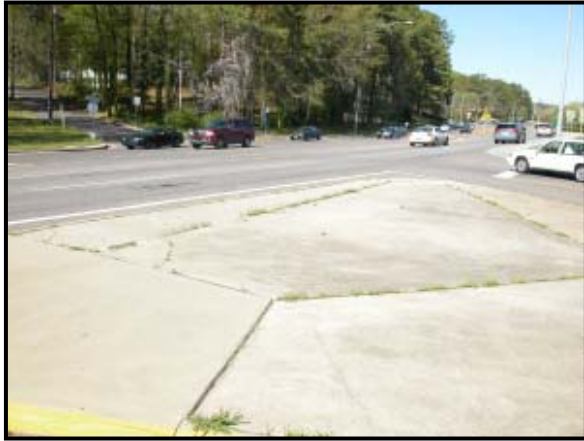
Figure 2: Northeast view into the intersection.

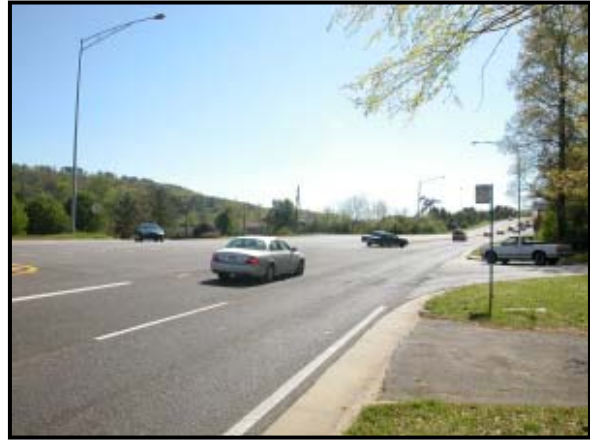
Figure 3: Southwest view of the intersection.

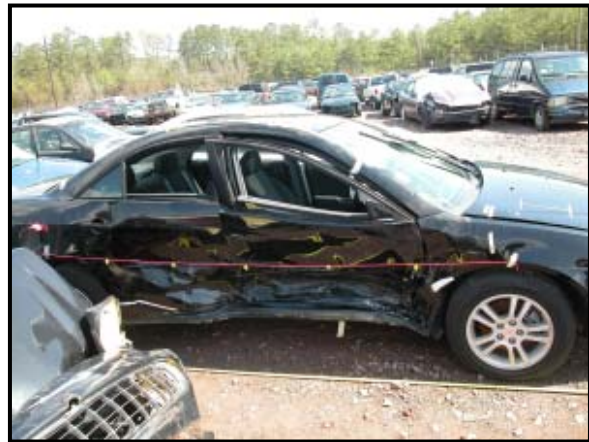
The right side of the Pontiac sustained 237 cm (93.5 in) of direct and induced damage which began 3 cm (1.2 in) aft the right front axle, **Figure 4**. The direct damage began immediately rearward of the right front wheel opening and measured 162 cm (63.6 in) in length. The residual crush was measured at the mid-door elevation. The crush profile was as follows: C1 = 0 cm (0 in), C2 = 10 cm (3.9 in), C3 = 26 cm (10.2 in), C4 = 31 cm (12.2 in), C5 = 17 cm (6.7 in), C6 = 0 cm (0 in). The maximum crush was located at the C4 mid door elevation, 93 cm (36.5 in) aft of the right front axle. The maximum crush was 31 cm (12.2 in). The right doors were jammed shut. The left doors remained closed during the crash and were operational at the time of the inspection. The right wheelbase was reduced 5 cm (1.9 in). The left wheelbase lengthened 1 cm (0.5 in) due to distortion in the vehicle's unibody construction. The right aspect of the windshield fractured and the glazing of the right windows disintegrated during the impact. The Collision Deformation Classification (CDC) of the Pontiac was 02-RYEW3. The Pontiac's Event Data Recorder measured and recorded bi-directional acceleration. The maximum longitudinal and lateral delta V components were -13.0 km/h (-8.1 mph) and -30.6 km/h (-19.0 mph).

**Figure 4: View of the right side damage.**

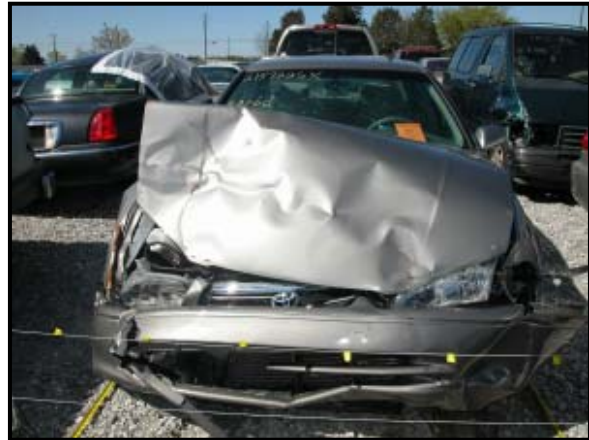
**Figure 5** is a front view of the subject Toyota Camry. The exterior damage to vehicle consisted of direct contact damage to the frontal plane that extended across its full 155 cm (61.0 in) end width. The residual crush profile was documented across the front bumper and was as follows: C1 = 19 cm (7.5 in), C2 = 17 cm (6.7 in), C3 = 18 cm (7.1 in), C4 = 20 cm (7.9 in), C5 = 23 cm (9.1 in), C6 = 26 cm (10.2 in). The maximum crush was located at C6, the front right bumper corner. The residual damage profile was biased to the left consistent with the angular orientation of the vehicles during engagement. The deformation energy was absorbed primarily by the vehicle's structures forward of the front axle location. The right wheelbase was reduced 3 cm (1.0 in). The left wheelbase was unchanged. The windshield and all side glazings remained intact. All four doors remained closed during the impact and were operational post-crash. The Collision Deformation Classification (CDC) of the vehicle was 11-FDEW2.

**Figure 5: Front view of the Toyota.**

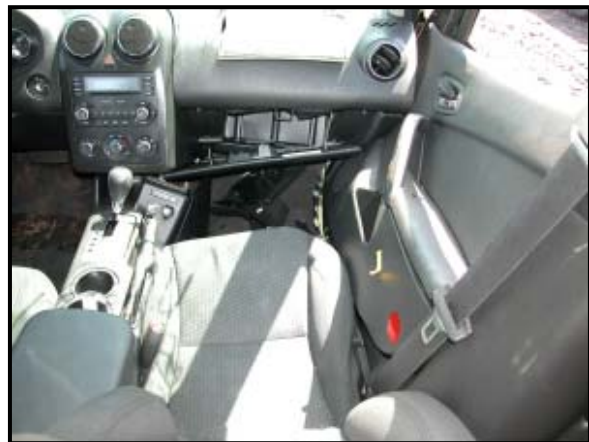
The interior damage of the Pontiac G6 consisted of right interior intrusion as a result of the exterior impact force and the deployment of the vehicle's frontal air bag system. **Figure 6** is a view depicting the intrusion in the front right interior. The right front door and right B-pillar were in contact with the front passenger seat and the seat cushion was compressed into the center console. The residual lateral intrusion at the right front seat bight measured 22 cm (8.5 in). The lateral intrusion in the right foot well measured 21 cm (8.2 in). The right upper B-pillar intrusion measured at belt line was 6 cm (2.5 in).

**Figure 6: View of the front right interior.**

The front right passenger seat jammed in its at-crash position due to the deformation of the floor pan and its compression into the center console. Its seat track position measured with reference to the driver's seat. It was located in a mid-track position that measured 10 cm (4.0 in) forward of full rear. The total seat track travel measured 22 cm (8.5 in). The seat back was reclined 30 degrees. The horizontal distance from the seat back to the instrument panel at the lower flap of the front right passenger air bag module measured 102 cm (40 in).

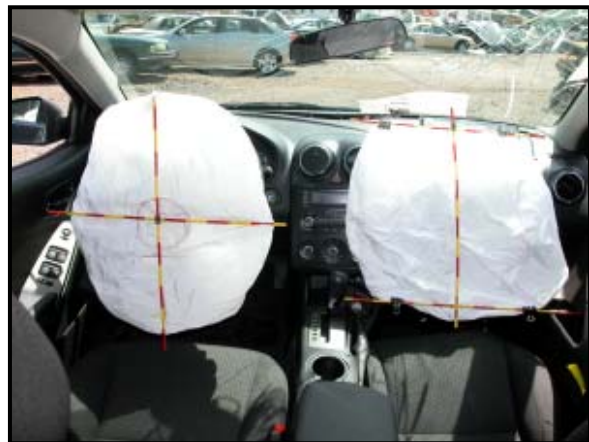
The driver and front right passenger air bag deployed as a result of the angular crash event, **Figure 7**. The driver air bag was housed within an I-configuration module designed into the center hub of the steering wheel. The diameter of the deployed air bag measured 58 cm (23 in). It was tethered by two straps and vented by a single 3 cm (1.2 in) diameter port on the back side of the bag's 12 o'clock sector. No evidence of occupant contact was identified on the driver air bag or its associated components.

**Figure 7: View of the deployed air bags.**

The front right passenger air bag was a top-mount design located in the right aspect of the instrument panel. The air bag deployed as designed from the H-configuration module. The membrane measured 46 cm x 51 cm (18 in x 20 in), width by height. The excursion measured 58 cm (23 in) from the module. It was tethered by a single full-width tether and vented by two ports located on the side panels. There was no evidence of occupant contact on the air bag.

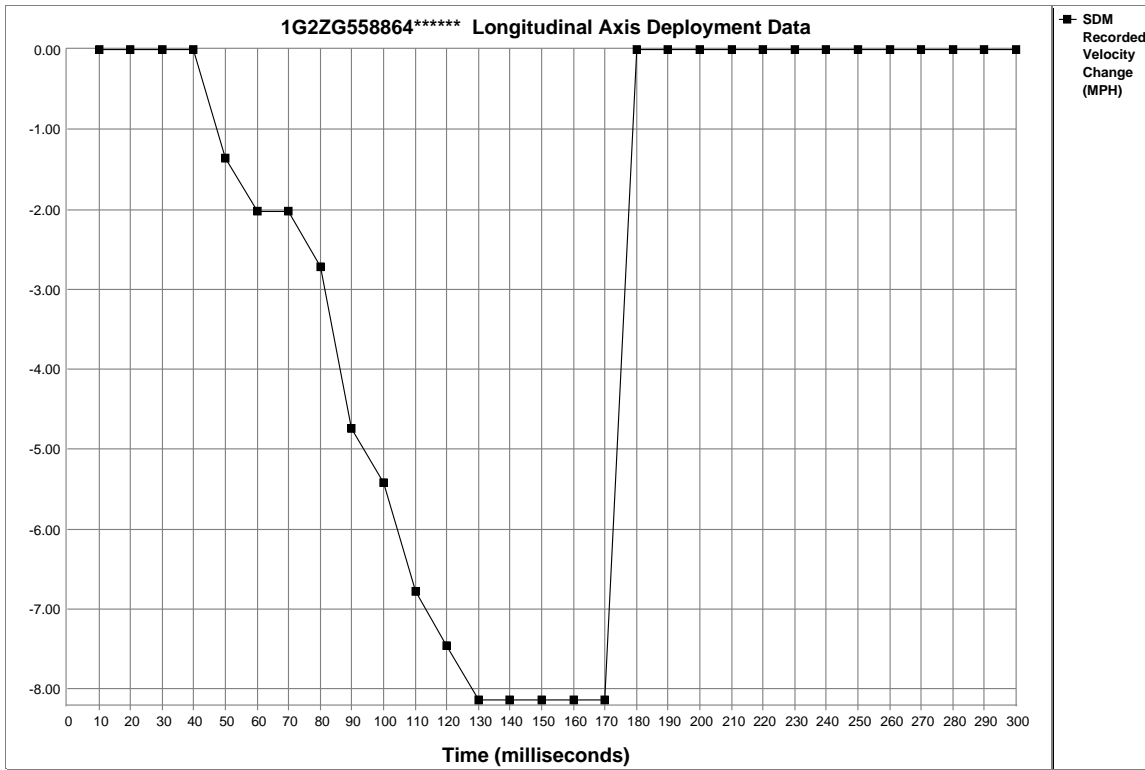
Time (milliseconds)	10	20	30	40	50	60	70	80	90	100	110	120	130	140	150
Longitudinal Axis Recorded Velocity	0.00	0.00	0.00	0.00	-1.36	-2.03	-2.03	-2.71	-4.74	-5.42	-6.78	-7.46	-8.13	-8.13	-8.13
Time (milliseconds)	160	170	180	190	200	210	220	230	240	250	260	270	280	290	300
Longitudinal Axis Recorded Velocity	-8.13	-8.13	0.00	0.00	0.00	0.00	0.00	0.00	0.00	0.00	0.00	0.00	0.00	0.00	0.00

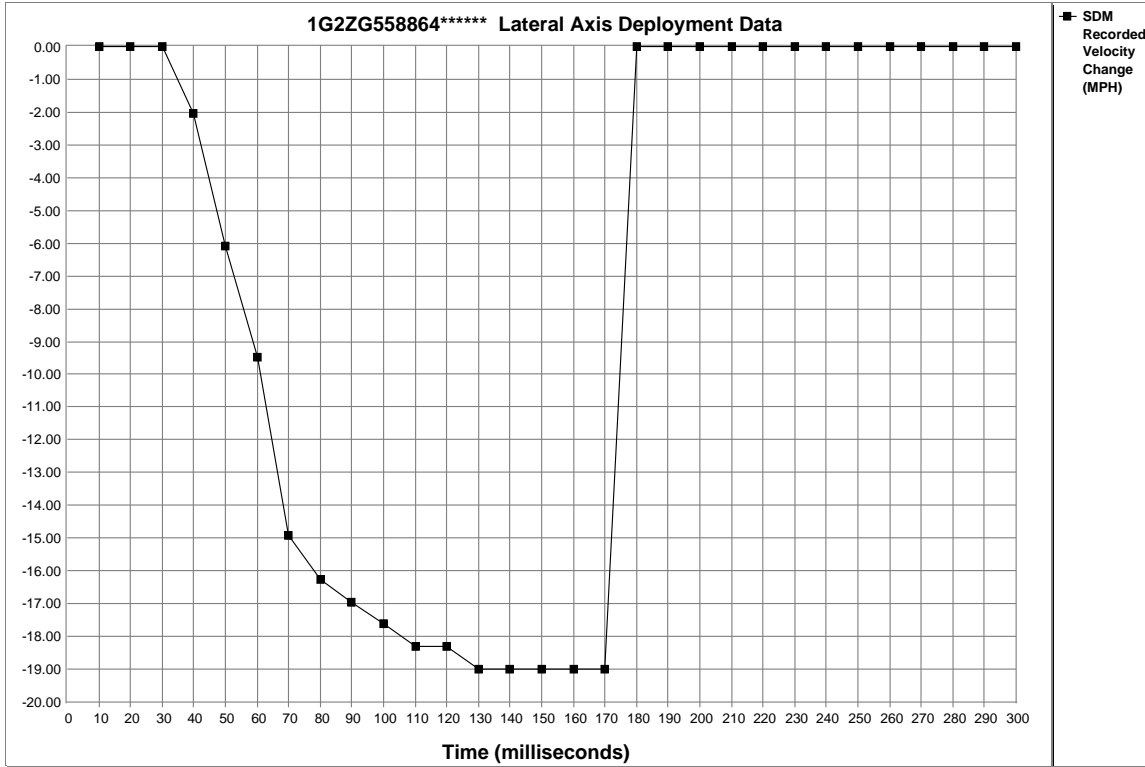
Time (milliseconds)	10	20	30	40	50	60	70	80	90	100	110	120	130	140	150
Lateral Axis Recorded Velocity Change (MPH)	0.00	0.00	0.00	-2.03	-6.10	-9.49	-14.91	-16.27	-16.95	-17.62	-18.30	-18.30	-18.98	-18.98	-18.98
Time (milliseconds)	160	170	180	190	200	210	220	230	240	250	260	270	280	290	300
Lateral Axis Recorded Velocity Change (MPH)	-18.98	-18.98	0.00	0.00	0.00	0.00	0.00	0.00	0.00	0.00	0.00	0.00	0.00	0.00	0.00
