Electronic Stability Control and Knee Air Bag Investigation/Vehicle to Vehicle  
Dynamic Science, Inc./Case Number: DS06005  
2005 Lexus RX330  
California  
December 2005

1. Report No. DS06005		2. Government Accession No.		3. Recipient Catalog No.	
4. Title and Subtitle  Electronic Stability Control and Knee Air Bag Investigation				5. Report Date August 17, 2006

**Dynamic Science, Inc.**  
**Crash Investigation**  
**Case Number: DS06005**

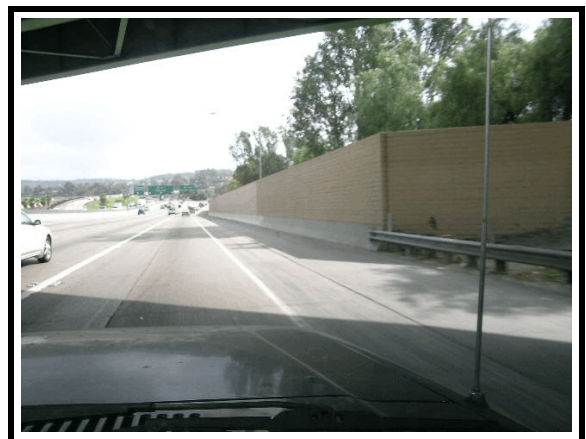
Based on the damage to the case vehicle, it is likely that the driver steered to her left in an attempt to avoid striking the pickup. The impact severity was moderate and resulted in the deployment of the driver’s front and knee air bags. The EDR reported longitudinal delta V was 34.7 km/h (21.6 mph), 150 milliseconds into the crash. During this impact, the case vehicle underrode the Dodge Ram and as the Lexus continued moving forward, the Dodge Ram rotated clockwise. The right front door hinge area of the Lexus snagged on the Dodge Ram’s left rear bumper corner. When the case vehicle snagged, it began to rotate counterclockwise, traveled off the freeway lanes and onto the south shoulder. The back left of the Lexus impacted the guardrail (05BLEE2), causing light damage. The barrier equivalent routine of the WinSmash program computed a total delta V of 8.0 km/h (5.0 mph).

**Figure 3.** Guardrail struck by case vehicle - 2<sup>nd</sup> event (east)

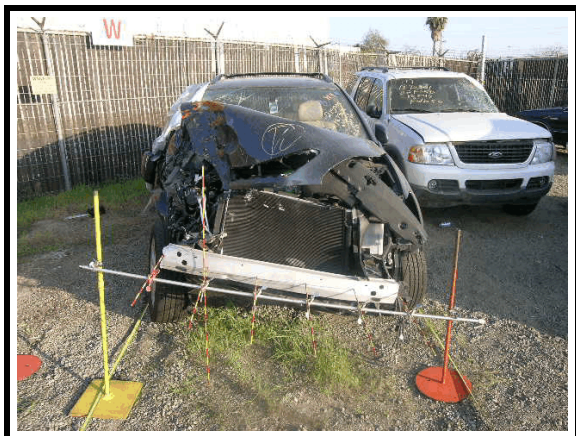
The 2005 Lexus RX330 sustained moderate front end damage as a result of the impact with the Dodge Ram. The case vehicle sustained 38.0 cm (15.0 in) of direct damage along the front bumper beginning 24.0 cm (9.4 in) right of the precrash center point of the vehicle, extending to the right. The direct damage extended down the right side of the vehicle to the right front door panel. The right front fender was peeled back and the right front door was damaged near the hinges. The hinges showed slight signs of stress but there was no hinge failure and the right front door remained closed and operational. There was direct damage to the right A pillar, above the belt line. There were additional direct damage scrapes on the right rear wheel lip that may be attributed to this crash event. The case vehicle underrode the Dodge Ram's rear bumper and it appeared that there was greater than 13.0 cm (5.1 in) of above bumper crush differential in the C4, C5 and C6 locations. Accurate above bumper measurements were not able to be obtained due to the damage. The plastic bumper cover was no longer with the vehicle. In order to calculate and report the correct amount of bumper crush, an exemplar vehicle was measured for freespace. Six crush measurements were documented along the front bumper as follows: C1=0.0 cm (0.0 in), C2=0.0 cm (0.0 in), C3= 0.0 cm (0.0 in), C4=1.0 cm (0.4 in), C5=1.0 cm (0.4 in), C6=5.0 cm (2.0 in). The location of maximum crush was C6, the right front bumper corner.

**Figure 4.** Front - 2005 Lexus RX330

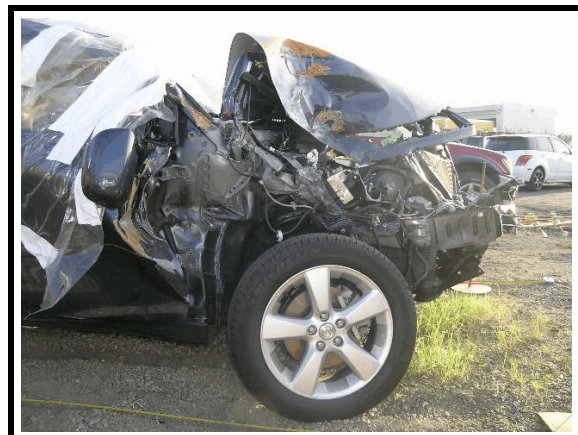
**Figure 5.** Damage to right front - 2005 Lexus RX330

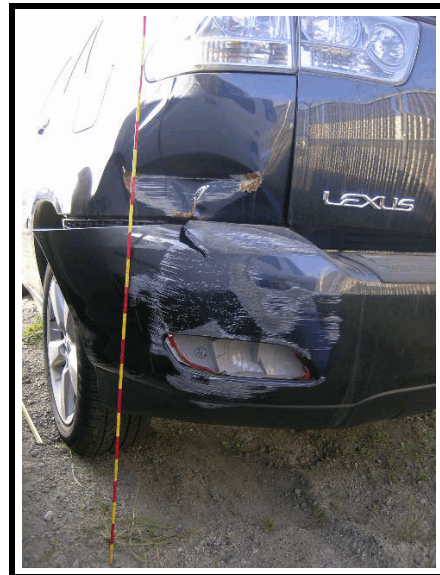
The Lexus sustained light back end damage as a result of the impact with the guardrail. The vehicle sustained 25.0 cm (9.8 in) of direct damage along the back bumper, beginning 60.0 cm (23.6 in) left of the precrash center point of the vehicle, extending to the left. There was minimal crush but the direct damage from this event extended 51.0 cm (20.1 in) forward of the rear stringline. Six crush measurements were documented along the back bumper as follows: C1=8.0 cm (3.1 in), C2=4.0 cm (1.6 in), C3=1.0 cm (0.4 in), C4=0.0 cm (0.0 in), C5=0.0 cm (0.0 in), C6=0.0 cm (0.0 in). The location of maximum crush was C1, the left rear bumper corner.

**Figure 6.** Back left damage -  
2005 Lexus RX330

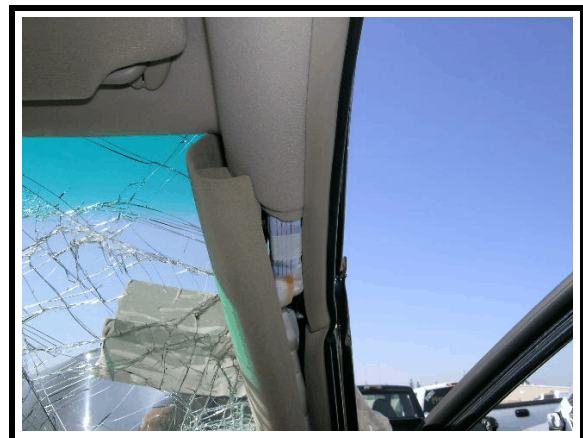
The only intrusion was in the front right seating area. There was lateral intrusion of the A pillar and A pillar cover, lateral intrusion of the side panel (forward of the A pillar) and longitudinal windshield intrusion. The specific passenger compartment intrusions were documented as follows:

Row/Position	Intruded Component	Magnitude of Intrusion	Direction
1R	Windshield	17.0 cm (6.7 in)	Longitudinal
1R	Side panel forward of the A pillar	6.0 cm (2.4 in)	Lateral
1R	A pillar cover	5.0 cm (2.0 in)	Lateral
1R	A Pillar	1.0 cm (0.4 in)	Lateral

**Figure 7.** Intrusion of A pillar and A pillar cover

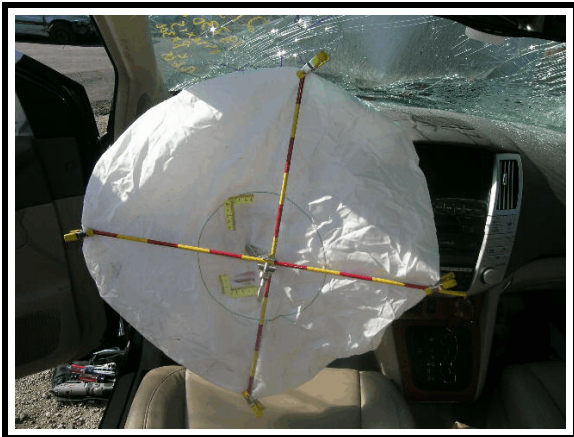
**Figure 8.** Driver’s front air bag

The driver's air bag was mounted in the center of the steering wheel hub. The air bag module had a Y configuration. The lower left and right cover flap measurements were as follows: the outer flap edge heights were 5.0 cm (2.0 in), the inner flap edge heights were 6.0 cm (2.4 in), the upper flap edges were 7.0 cm (2.8 in) and the lower flap edges were 5.0 (2.0 in). The top cover flap was fairly rectangular in shape and measured 9.0 cm (3.5 in) along the upper edge, 13.0 cm (5.1 in) along the lower edge and 7.0 cm (2.8 in) along both sides. The air bag was circular in shape and measured 60.0 cm (23.6 in) high/wide in its deflated state. The maximum excursion measured 33.0 cm (13.0 in) from the module face. The longitudinal distance between the module face and the front left seat back was 60.0 cm (23.6 in). The air bag had one internal tether and two vent ports on the back of the bag at the 10 and 2 o'clock positions. The vent ports consisted of narrow slits in the air bag material. Driver contact evidence was found on the front of the deployed air bag. Lipstick and tan makeup foundation transfers were found near the left center of the air bag. There were very small purplish dots scattered on the top left section; the source of these discolorations are unknown. Black cover flap streaks were located on the lower left side of the bag. The back of the deployed air bag had a few cover flap streaks, but was not damaged and showed no sign of occupant contact.

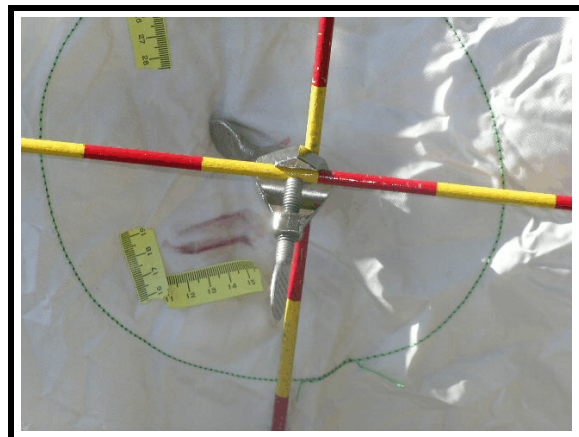
Although the driver was unrestrained, the driver's retractor pretensioner actuated during the crash and was locked in place post-impact. There were lipstick and foundation make-up transfers found on the front of the driver air bag. There were small tears in the instrument panel cover, on the lower left side. There was a scuff on the lower right A pillar and the upper left C pillar. There was a slight oil transfer to the back of the driver's headrest. There were deep scuffs to the upper right B pillar and a scuff to the right C pillar. A red mark and a blue transfer were found on the back of the right front seat back. All of the above were likely due to occupant contact.

**Figure 9.** Lipstick and foundation transfers to driver air bag

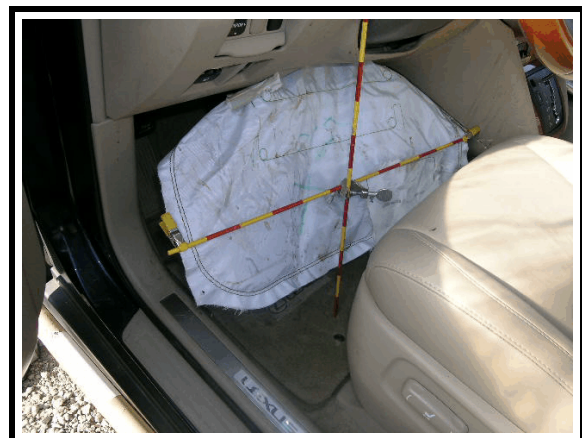
The driver's knee air bag was mounted below the steering column. The air bag module had an H configuration. The top and bottom flaps were 26.0 cm (10.2 in) wide. The height of the top flap was 4.0 cm (1.6 in) and the height of the bottom flap was 5.0 cm (2.0 in). The air bag was semicircular in shape and measured 63.0 cm (24.8 in) wide by 34.0 cm (13.4 in) high (in the center). There was a piece of fabric made of the same material as the air bag that was sewn onto the lower right section of the bag and measured 19.0 cm (7.5 in) wide by 31.0 cm (12.2 in) high. The knee air bag did not have tethers or vent ports. There was no damage and no visible occupant contact evidence found on the knee air bag and cover flaps, but there were coffee splatter stains all over the deployed bag.

**Figure 10.** Driver's knee air bag

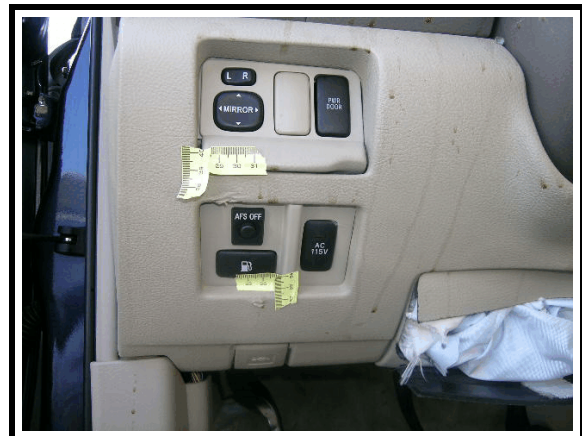
The 50-year-old female driver appears to have been seated in an upright posture in the leather covered bucket seat and was not restrained by the available 3-point manual lap and shoulder belt. The shoulder belt anchorage was in the full down position. The seat was adjusted to between the center and forward most track position. The seat back was reclined at a 100 degree angle and the seat bottom had a 9 degree angle. During the initial impact, the driver's front and knee air bags deployed and the left front seat belt pretensioner actuated, although the belt was not being worn during the crash. The female driver initiated a forward trajectory towards the 12 o'clock direction of force. She engaged the deployed front air bag with her face, leaving make-up transfers on the front of the bag. Her right hand may have been forced off the steering wheel due to the deploying air bag and may have contacted the rearview mirror, moving it out of position. Her knees and lower legs likely contacted the deployed knee air bag, but no evidence of occupant contact was found. It is possible that the driver's left knee may have also impacted the lower left instrument panel, damaging a small section of the material covering the panel.

**Figure 11.** Possible occupant contact points - lower left instrument panel

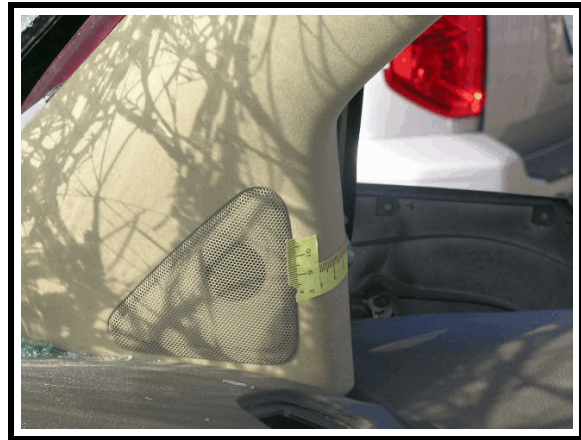
There was a slight scuff to the base of the A pillar that may have been due to contact from this occupant or possibly the occupant seated on his lap.

**Figure 12.** Scuff to right A pillar - possible occupant contact

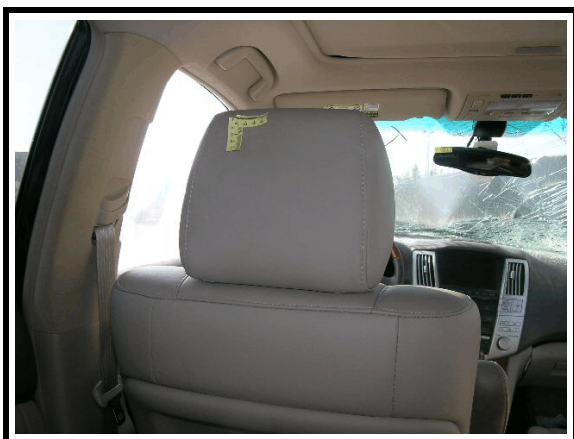
There were two possible occupant contact points found in this passenger's general seating area, but it is not known who caused one of the contacts. It is likely that the scuff found on the left C pillar was from this occupant. There may have been a passenger seated on the lap of the second row center occupant who may have caused the oil transfer to the back of the driver's head restraint by touching the head restraint with his hand. It is also possible that the second row left occupant contacted the seat back with his face or hand.

**Figure 13.** Oil transfer to back of driver head restraint - possible occupant contact

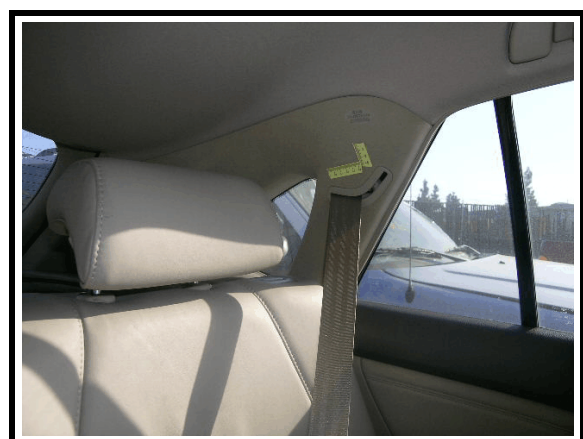
**Figure 14.** Scuff to left C pillar - possible occupant contact

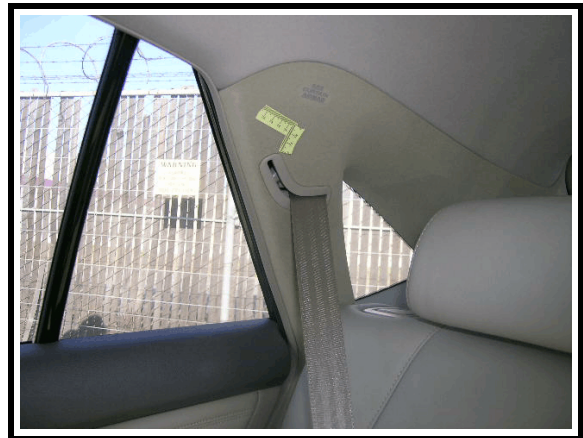
At impact, this passenger initiated a forward trajectory towards the 12 o'clock direction of force, likely contacting the back of the right front seatback with one or both knees, resulting in a blue and a red transfer. The case vehicle underrode the back bumper of the Dodge Ram and continued traveling forward. The right front door hinge area snagged on the left rear bumper of the Dodge Ram and the vehicle began a sharp counterclockwise rotation, causing this occupant to pitch left. The Lexus traveled off the freeway and onto the south shoulder. The back left bumper corner impacted a guardrail, likely causing this occupant to move rearward and slightly lateral towards the 5 o'clock direction of force. It is possible that this occupant contacted the right C pillar during this second impact, resulting in a scuff. Per the police report, this occupant was not injured in the collision.

**Figure 15.** Scuff to right C pillar - possible occupant contact

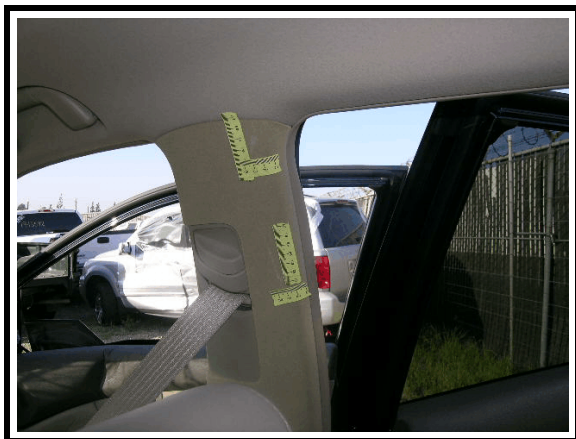
At impact, this passenger initiated a forward trajectory towards the 12 o'clock direction of force, likely contacting the left B pillar. There were deep scuffs found on the upper left B pillar, possibly a result of the 5-year-old holding onto the pillar for support during the crash. The case vehicle underrode the back bumper of the Dodge Ram and continued traveling forward. The right front door hinge area snagged on the left rear bumper of the Dodge Ram and the vehicle began a sharp counterclockwise rotation, causing this occupant to pitch left. The Lexus traveled off the free way and onto the south shoulder. The back left bumper corner impacted a guardrail, likely causing this occupant to move rearward and slightly lateral towards the 5 o'clock direction of force. Per the police report, this occupant was not injured in the collision.

**Figure 16.** Scuffs to right B pillar - possible occupant contact

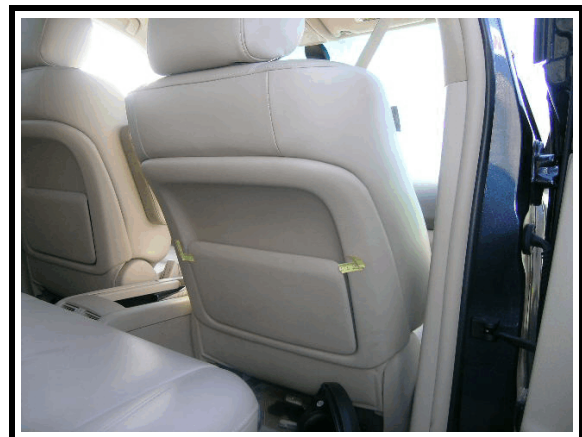
**Figure 17.** Transfers to right front seat back - probable occupant contacts
