ON-SITE CERTIFIED ADVANCED 208-COMPLIANT VEHICLE INVESTIGATION

CASE NUMBER - IN-06-005

VEHICLE - 2005 NISSAN ALTIMA

CRASH DATE - December 2005

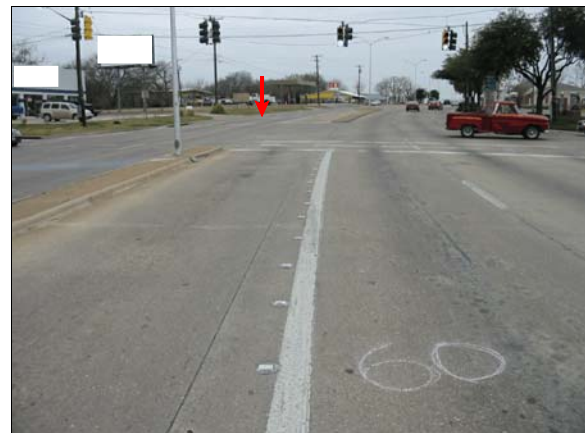
Pre-Crash: The case vehicle was traveling west in an undetermined lane of the westbound roadway (**Figure 1**). It is not known if the driver was intending to continue through the right curve and the intersection, or if he was going to turn at the intersection. The Honda was traveling east in the center through lane (**Figure 2** below). The Honda's driver was intending to continue through the left curve to the intersection. The police crash report indicated that as the case vehicle approached the intersection, the driver experienced a seizure and lost control of his vehicle. It drifted in a southwest direction, through the intersection and into the eastbound lanes of traffic. Due to the seizure, the driver most likely took no actions to avoid the cash. The crash occurred in the center eastbound through lane of the roadway (**Figure 3** below).

Figure 1: Approach of case vehicle westbound to impact (arrow), number shows meters to impact

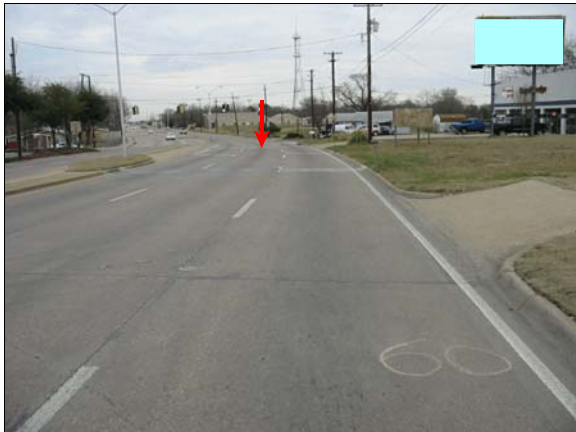
Figure 2: Approach of Honda eastbound to impact (arrow)

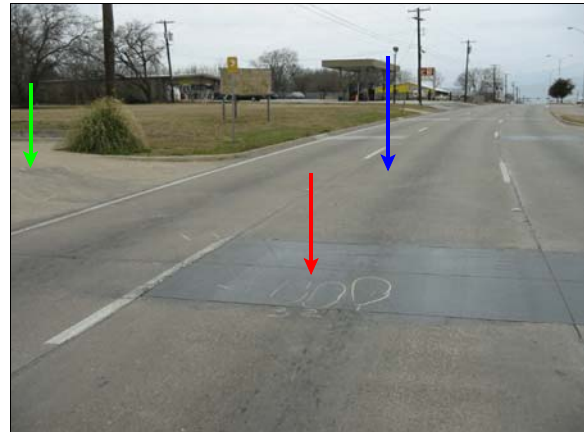
Figure 3: View southwest from case vehicle's approach to impact area (red arrow), green arrow shows area of final rest of case vehicle, blue arrow shows area of final rest of Honda

Post-Crash: As a result of the impact, the case vehicle rotated clockwise and continued southwest and came to rest in a driveway to a local business (**Figures 3 and 5**) heading northeast. The Honda, most likely braking at the time of the crash, was moved westward and rotated clockwise approximately 170 degrees and came to a final rest in the center lane heading west (**Figure 3**).

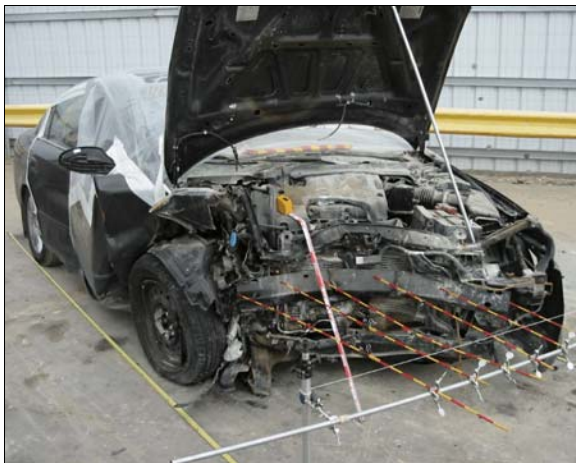
Crash: The front of the case vehicle (**Figure 4** below) impacted the front of the Honda, causing the case vehicle's driver air bag to deploy. The front right air bag did not deploy because there was no front right passenger in the vehicle.

Figure 4: Front right view of damage to front of case vehicle from impact with the Honda, each increment on vertical scale is tenth of meter, each increment on rods in 5cm (2 in)

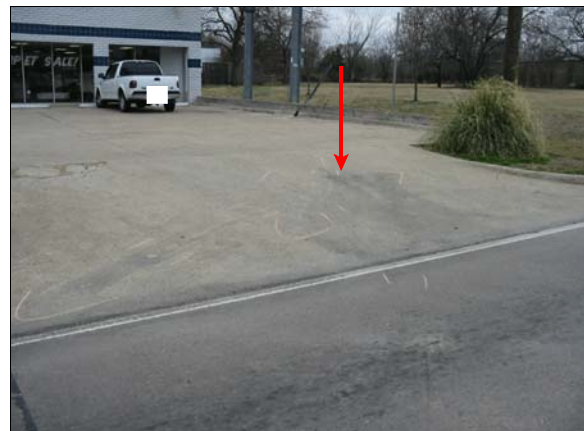
Figure 5: View southwest to area of case vehicle's final rest (arrow)

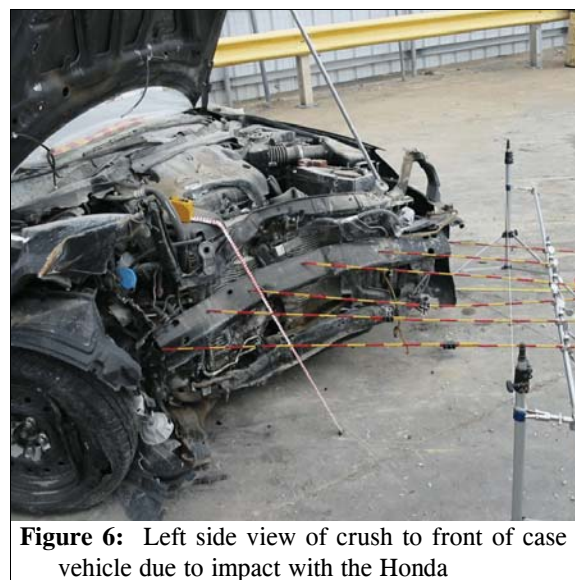
Exterior Damage: The case vehicle’s impact with the Honda involved the frontal plane. The front bumper, bumper fascia, grille, radiator, right fender, right headlamp/turn signal assembly and right front wheel were directly damaged and crushed rearward. Direct damage was difficult to determine because the bumper fascia was no longer attached to the vehicle. However, based on the damage to the bumper bar and the undeformed end width of the case vehicle, the direct damage was estimated to be approximately 113 centimeters (44.5 inches) in length. The front crush profile was taken at the bumper bar. The residual maximum crush was measured as 85 centimeters (33.5 inches) occurring at C₆ (Figure 6). The table below shows the case vehicle’s front crush profile.

Figure 6: Left side view of crush to front of case vehicle due to impact with the Honda

The case vehicle’s left side wheelbase was extended 8 centimeters (3.1 inches) while the right side wheelbase was shortened 48 centimeters (18.9 inches). There was induced damage to the windshield, right fender, right front wheel, right A-pillar, right front and rear doors, right sill, and the roof. No obvious induced damage or remote buckling was noted to the remainder of the case vehicle’s exterior.

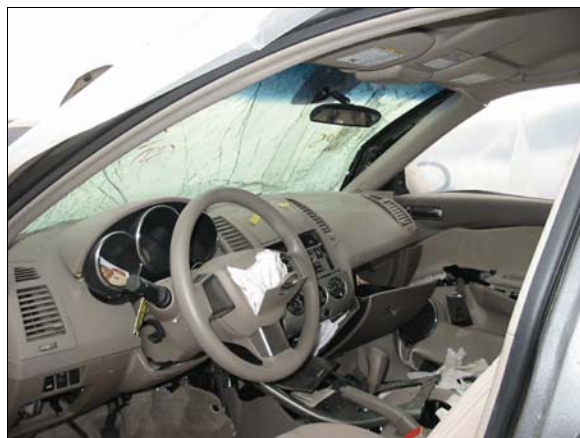
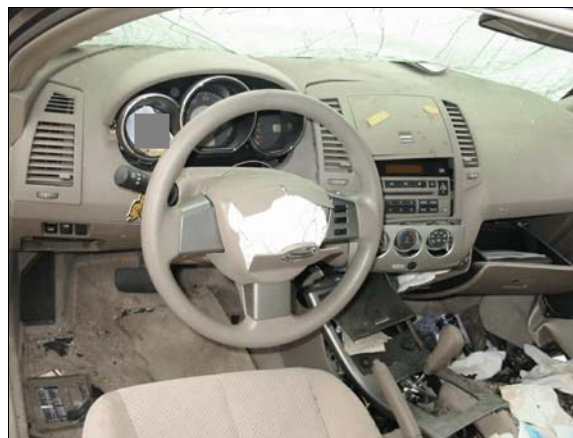
Vehicle Interior: Inspection of the case vehicle's interior (**Figures 7 and 8**) revealed evidence of occupant contact to the driver's air bag and safety belt. There was no deformation of the steering wheel but the steering column appeared to be slightly compressed. There were numerous intrusions to the passenger compartment. The most severe intrusions involved 31 centimeters (12.2 inches) of longitudinal intrusion to the side panel forward of the right "A"-pillar and 21 centimeters (8.3 inches) of longitudinal intrusion of the right toe pan.

Figure 7: Overview of case vehicle's steering wheel, instrument panel and windshield

Figure 8: Overview of case vehicle's steering wheel and instrument panel

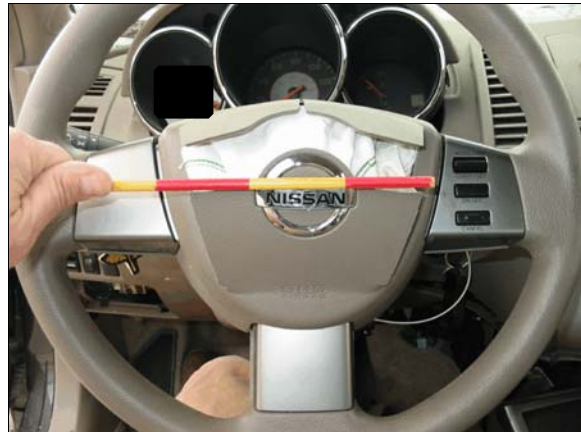
Figure 9: Case vehicle's driver air bag module cover flaps

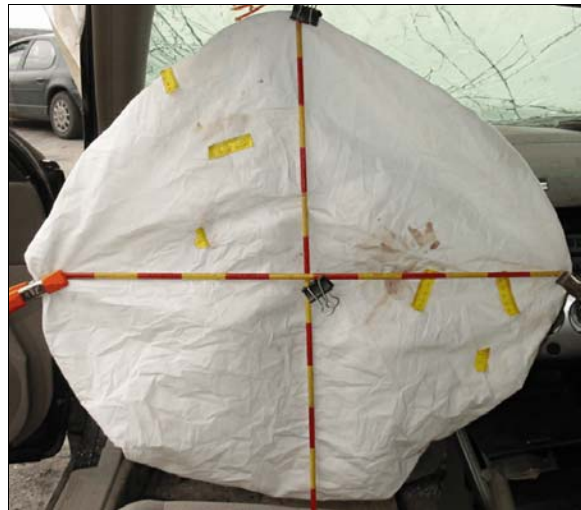
Figure 10: Case vehicle's driver air bag, yellow tape shows blood stains on air bag

excursion was 25 centimeters (9.8 inches). An inspection of the driver's air bag fabric revealed blood stains on the front of the air bag and a water stain or some other type of stain on the back of the air bag.

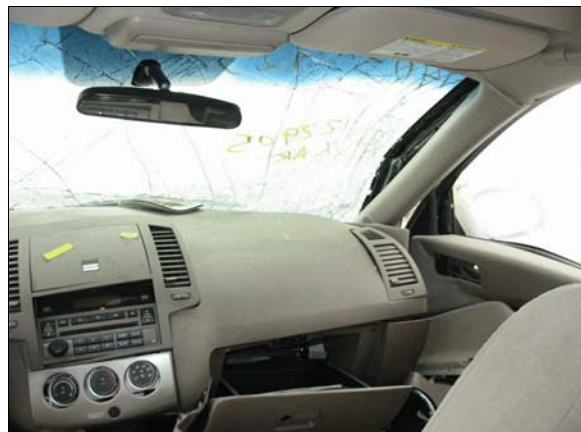
Figure 11: Overview of right instrument panel, front passenger air bag located in top of instrument panel

The front right passenger's air bag was located in the top of the instrument panel (**Figure 11** above). This air bag did not deploy as a result of the crash. With no occupant in the right front seat, the case vehicle's advanced occupant protection system suppressed the deployment of the air bag.

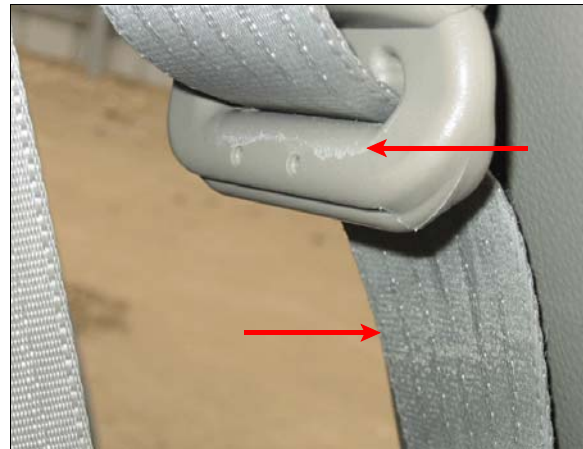
Based on the vehicle inspection, the case vehicle's driver was restrained by his manual, three-point, lap-and-shoulder safety belt system. Inspection of the driver's safety belt assembly revealed load abrasions on the D-ring and shoulder belt (**Figure 12**). In addition, the pretensioner had actuated and the retractor was jammed with a length of belt extended out of the retractor.

Figure 12: Arrows show load abrasions on case vehicle driver's D-ring and shoulder belt
