**CALSPAN ON-SITE CERTIFIED ADVANCED-208 COMPLIANT VEHICLE
CRASH INVESTIGATION**

SCI CASE NO. – CA06-006

SUBJECT VEHICLE – 2006 PONTIAC G6

CRASH DATE – FEBRUARY 2006

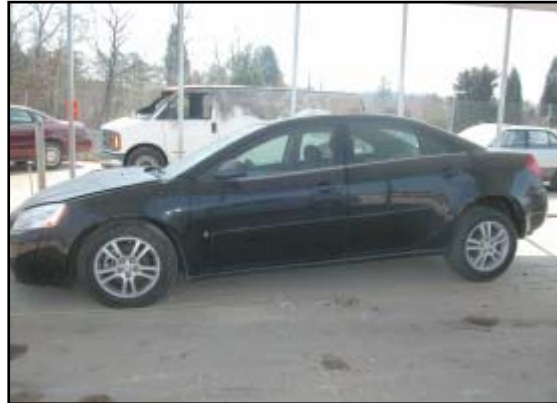
Figure 1. Subject vehicle 2006 Pontiac G6.

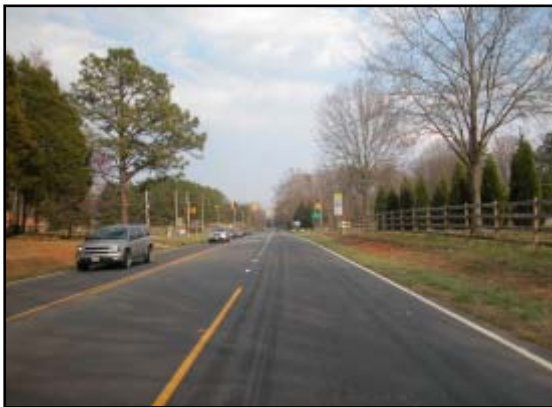
The restrained 16-year-old male driver of the 2006 Pontiac G6 was operating the vehicle eastbound (**Figure 2**) approaching the four-leg intersection where the driver intended to turn left. The 50-year-old female was operating the 1999 Lexus LS400 westbound approaching the intersection (**Figure 3**). Both vehicles were approaching and entering the intersection on a green signal phase. The driver of the Pontiac probably underestimated the speed and proximity of the Lexus and attempted to beat the Lexus across the intersection. The EDR data indicated that the driver of the Pontiac was traveling at 60 km/h (37 mph) five seconds prior to the Algorithm Enable (AE) and had slowed to 35 km/h (22 mph) one second prior to AE. The EDR data also indicated the driver applied braking through the five second recoded time frame prior to AE.

Figure 2. Pontiac’s eastbound approach to the intersection.

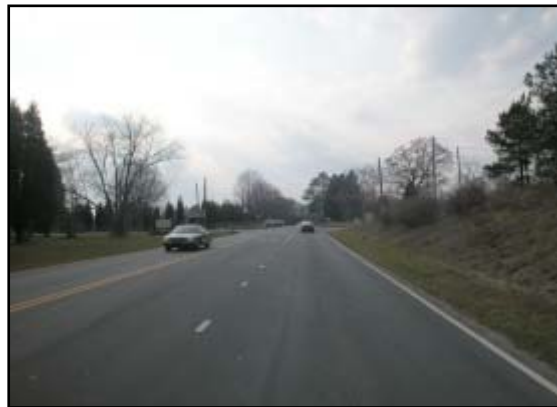
Figure 3. Lexus's westbound travel.

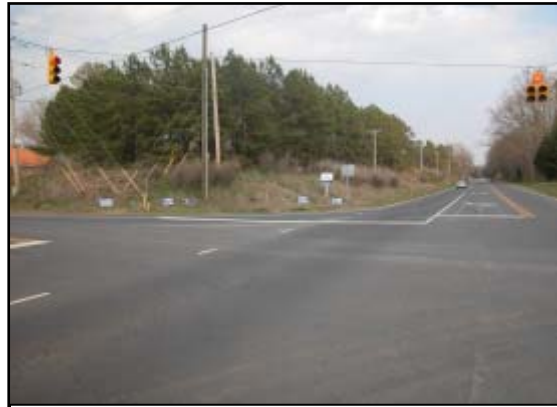
The initial contact involved the front right corner of the Pontiac and the front right corner of the Lexus (**Figure 4**). The vehicles impacted in the westbound lane within the boundaries of the intersection. Due to the narrow corner impact, the vehicles proceeded forward and the front right corner of the Lexus engaged the right side of the Pontiac. The direct contact damage from this impact extended from the front of the Pontiac onto the right side, terminating on the right rear wheel. The resultant directions of force were 12 o'clock for the Pontiac and 11 o'clock for the Lexus.

Figure 4. Area of impact from the Pontiac's approach.

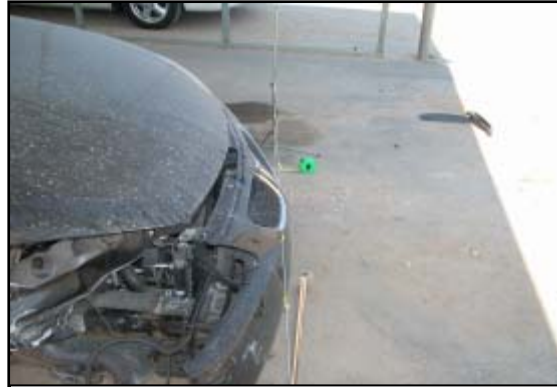
The direct contact damage on the front of the vehicle began 51 cm (20.0”) right of the vehicle centerline and extended 18 cm (7.0”) to the front right corner. The crush damage was outboard of the corner of the bumper beam. Therefore, no residual crush occurred at bumper level (**Figure 5**).

Figure 5. Lateral view of the front bumper of the Pontiac. No crush was noted at the bumper.

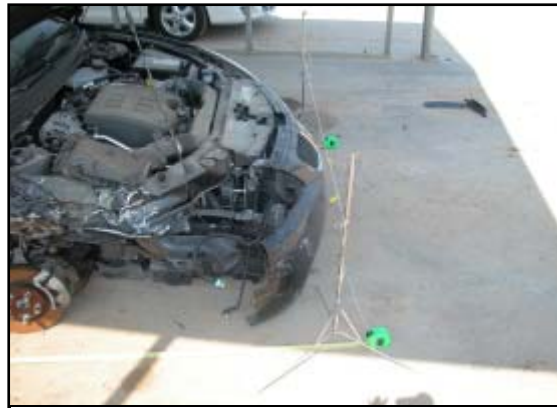
Frontal crush did occur to the upper radiator support. A crush profile was documented at the upper radiator support using a combined direct and induced damage width (Field L) of 111 cm (43.5”) and were as follows: C1 = 0 cm, C2 = 0 cm, C3 = 0 cm, C4 = 1 cm (0.3”), C5 = 2 cm (0.8”), C6 = 17 cm (6.7”). **Figure 6** is a lateral view of the crush at the upper radiator support. The Collision Deformation Classification (CDC) for this impact was 12-FREE-9.

Figure 6. Upper support radiator crush to the G6.

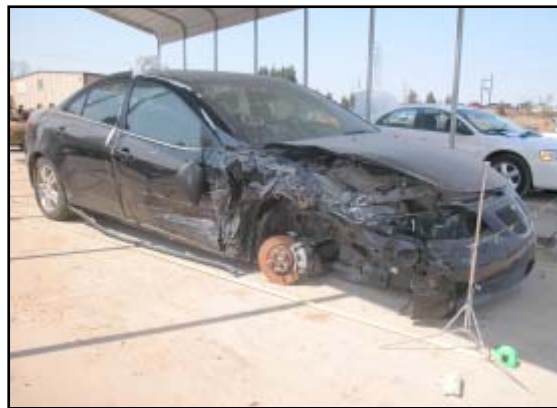
The 2006 Pontiac G6 sustained moderate severity front and right side damage as result of the corner impact with the Lexus. The damaged components involved the front bumper fascia, upper radiator support, right headlight assembly, right fender, right front wheel and suspension components, and right doors.

The damage to the right side plane resulted in 27 cm (10.7”) of longitudinal crush to the leading edge of the right fender. Additionally, the right side wheelbase was reduced 10 cm (3.9”) from contact to the right front wheel and suspension components. Abrasions and white paint transfers were noted on the right side, which measured 211 cm (83.0”), and began at the front right corner and extended to the right front door (**Figure 7**). As the Lexus continued down the right plane, the protruding right fender of the Lexus remained engaged with the Pontiac. This area of contact began rear of the right rear door and extended 91 cm (36”) rearward terminating on the right rear wheel.

Figure 7. View of the front and right side damage to the G6.

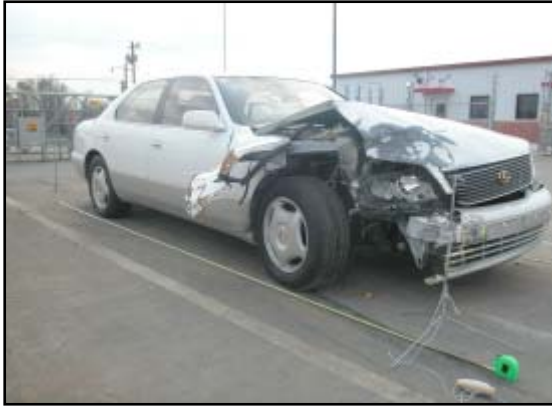
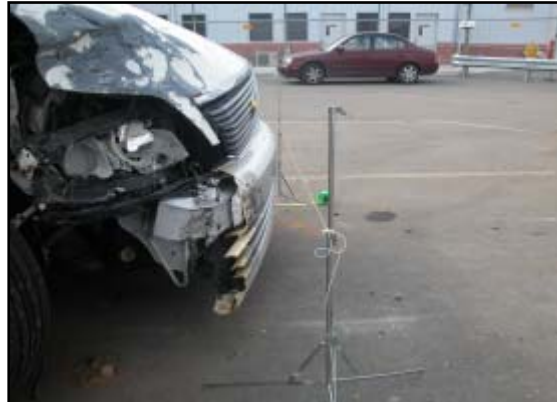
The 1999 Lexus LS400 sustained moderate severity frontal damage as result of the intersection crash (**Figures 8 and 9**). The direct contact damage began 15 cm (6.0) right of the vehicle centerline and extended to the front right corner. The total direct contact damage measured 39 cm (15.5”). Six equidistant measurements along the bumper beam were used to document the longitudinal crush using a combined direct and induced damage width (Field L) of 112 cm (44.0”). The residual crush was as follows: C1 = 0 cm, C2 = 0 cm, C3 = 7 cm (2.8”), C4 = 8 cm (3.1”), C5 = 12 cm (4.7”), C6 = 23 cm (9.1”). The CDC for this impact was 11-FREE-3.

Figure 8. Front right view of the damage to the Lexus.

Figure 9. Lateral view of the residual crush to the bumper beam.

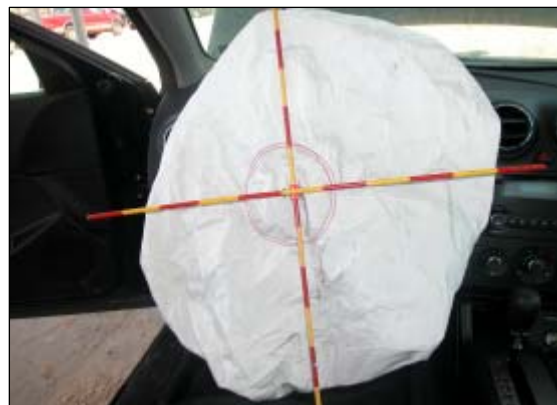
Figure 10. Deployed driver's frontal air bag.

In the subject crash, the first and second stages of the frontal air bags deployed (**Figure 10**). The driver's air bag was conventionally located in the center of the steering wheel hub and was concealed by two symmetrical I-configuration cover flaps. The cover flaps measured 13 cm (5.0") in height and 7 cm (2.8") in width. The driver's air bag measured 61 cm (24") in diameter in its deflated state. The air bag contained two tethers at the 3 and 9 o'clock positions and was vented by a single vent port at the 12 o'clock position. There were no damage or occupant contact points present on the air bag membrane.

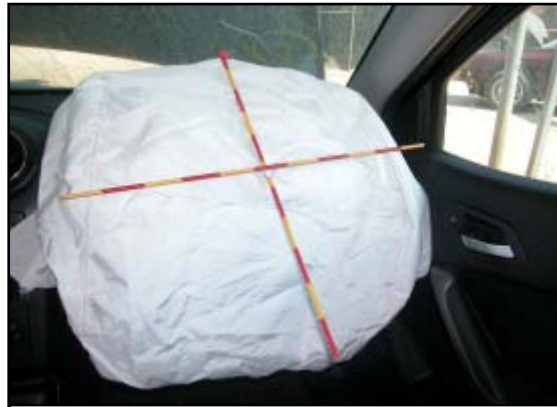
The front right passenger air bag was a top-mount design in the right instrument panel (**Figure 11**). Two non-symmetrical H-configuration cover flaps concealed the air bag within the instrument panel. The top cover flap measured 10 cm (3.8") in height and the lower cover flap measured 5 cm (2.0") in height. Both cover flaps measured 30 cm (11.8") cm in width. The air bag membrane measured 66 cm (26") in height and 53 cm (21") in width. The air bag was tethered by a single wide band tether across the face of the membrane. Two vent ports vented the air bag at the 11 and 1 o'clock positions on the side panels. The air bag membrane was not damaged and was free of occupant contact. The CAC system appeared to have performed as designed in the subject crash. The CAC system identified the presence of the front right occupant and deployed the appropriate safety system.

Figure 11. Deployed front right air bag.
