ON-SITE ROLLOVER INVESTIGATION

CASE NUMBER - IN-06-007

VEHICLE - 2006 HONDA CIVIC LX

CRASH DATE - March 2006

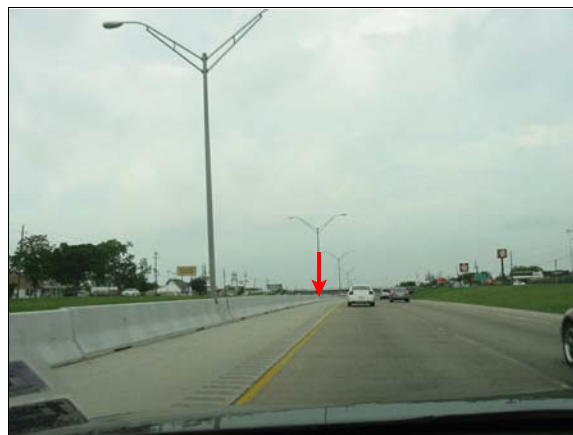
Pre-Crash: The case vehicle was traveling east in the inside through lane (**Figure 1**) at a driver reported speed of 113 km.p.h. (70 m.p.h.). The driver was intending to continue eastbound. The case vehicle's driver stated that a pedestrian was in the roadway. The driver stated he steered left to avoid hitting the pedestrian and lost control of the vehicle. There was no mention of a pedestrian in the roadway on the police crash report. The police crash report simply stated that the driver was speeding and lost control of his vehicle. The driver does not remember if he applied the brakes or made any other maneuver to avoid the impact with the median barrier. The crash occurred in the median at the median barrier.

Figure 1: Approach of case vehicle eastbound in inside through lane, arrow show possible location of impact

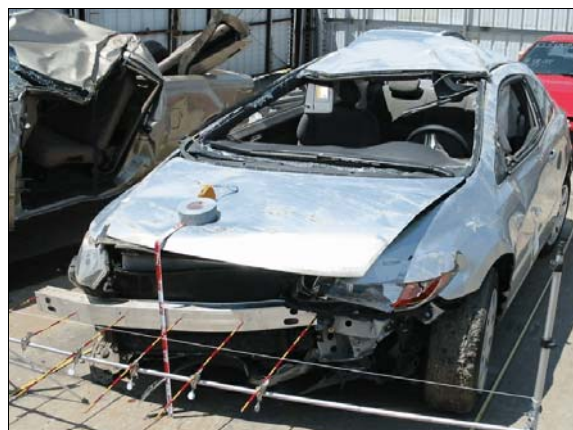
Figure 2: Overview of damage to front of case vehicle from impact with median barrier and damage from roll over, increments on tape measure on hood are in tenths of meter, each increment on rods is 5 cm (2 in)

Exterior Damage: The case vehicle’s initial contact with the concrete median barrier involved the frontal plane with damage distributed mostly to the left portion. The front bumper, bumper fascia, grille, left turn signal/headlamp assemblies, hood, and left fender were directly damaged and crushed rearward as well as displaced to the right. Direct damage began at the left bumper corner and extended 65 centimeters (40.3 inches), along the front bumper. Residual maximum crush (**Figure 7** below) was measured as 19 centimeters (7.5 inches) occurring at C₁. The left side wheelbase was shortened 13 centimeters (5.1 inches), while the right side wheelbase was shortened 1 centimeter (0.4 inches). There was induced damage to both the right headlamp/turn signal assemblies as well as the hood, and right fender. The table below shows the case vehicle’s front crush profile for the impact with the median barrier.

Units	Event	Direct Damage		Field L	C ₁	C ₂	C ₃	C ₄	C ₅	C ₆	Direct	Field L
		Width CDC	Max Crush								±D	±D
cm	1	65	19	119	19	14	13	11	7	5	-54	0
in		25.6	7.5	46.9	7.5	5.5	5.1	4.3	2.8	2.0	-21.3	0.0

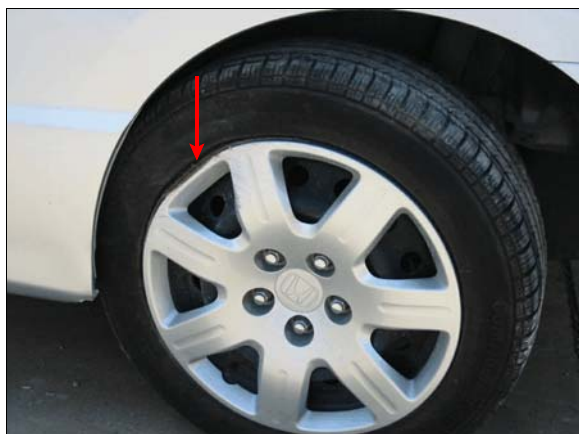
Figure 3: Damage to left rear wheel (arrow) from impact with median barrier, wheel angled in at bottom

The case vehicle sustained damage to the left rear wheel rim from contact with the median barrier. The trunk contact with the median barrier that occurred during the rollover involved the top left portion of the trunk. Direct damage began at the top left corner near the bottom of the “C”-pillar and extended diagonally to the back edge, damaging the spoiler. Direct rollover damage was observed on the case vehicle’s hood, right and left A-pillars, roof side rails, right quarter panel, “C”-Pillars, right fender, left rear wheel and the roof. In addition, all side glazing was broken out except for the left rear window. The windshield was out-of-place, but this did not appear to be related to the crash. Lastly, based on measurements from the case vehicle and an exemplar vehicle, the maximum vertical and maximum lateral crush to the case vehicle’s greenhouse was determined to be 6 centimeters (2.4 inches) and 4 centimeters (1.5 inches) respectively (Figures 8 and 9).

Tire	Measured Pressure		Recommend Pressure		Tread Depth		Damage	Restricted	Deflated
	kpa	psi	kpa	psi	milli-meters	32 nd of an inch			
LF	179	26	221	32	7	9	None	No	No
RF	179	26	221	32	6	7	None	No	No
LR	296	43	221	32	5	6	Sidewall scuffed, rim abraded, wheel bent inward	Yes	No
RR	179	26	221	32	7	9	None	No	No

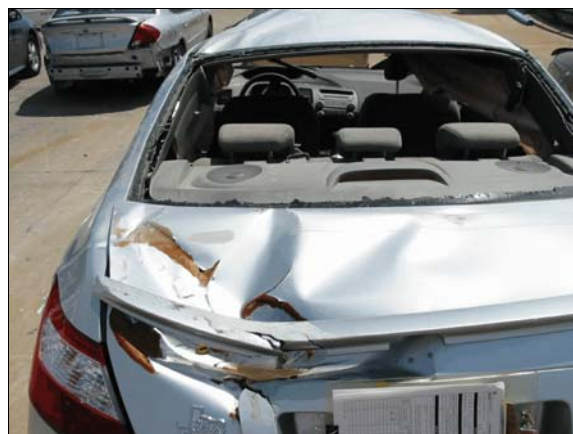
leading. The top left portion of the trunk lid impacted the top of the median barrier during the second quarter roll (**Figure 4**). The right roof side rail then impacted the pavement (**Figure 5**), most likely causing the case vehicle's right side curtain air bag to deploy. The case vehicle continued to roll over, landed on its wheels and then on its upper left side (**Figure 6**). The case vehicle then continued over onto its roof for a total of six quarter rolls (i.e., one-and-one-half rolls).

Figure 4: Damage to trunk lid from impact with top of median barrier during rollover

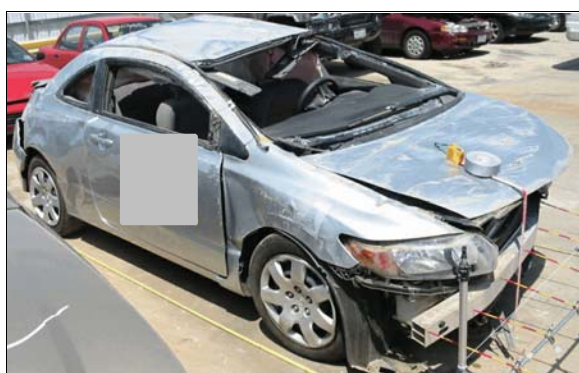
Figure 5: Overview of rollover damage to right side and top of case vehicle

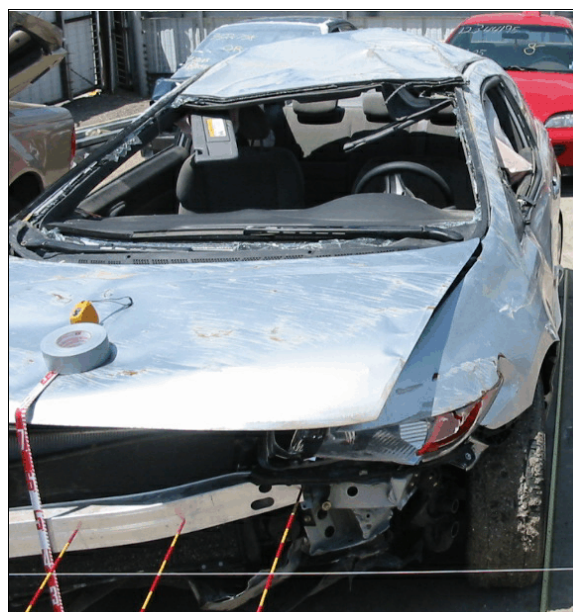
Figure 6: Rollover damage to hood, roof and upper left side

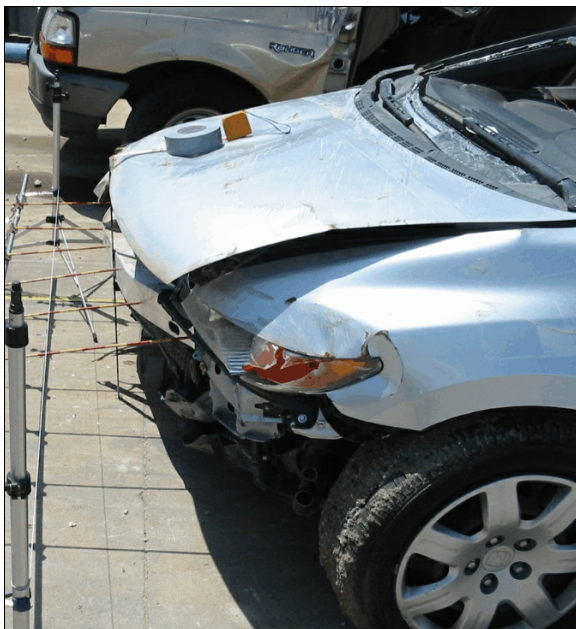
Figure 7: Left side view of crush to front of case vehicle

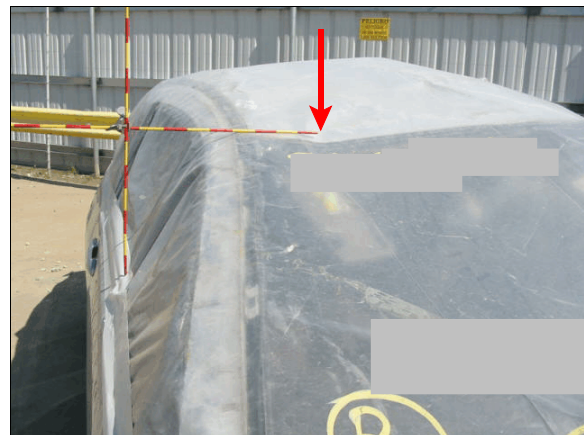
Figure 8: Arrow shows location of maximum vertical crush located at right windshield header

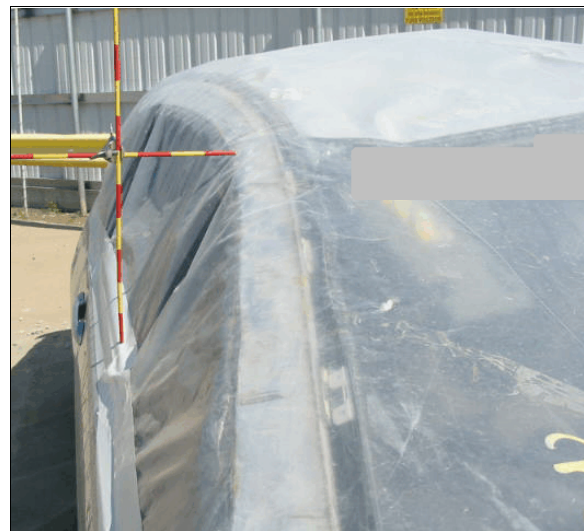
Figure 9: Case vehicle’s maximum lateral crush located at top of right “A”-pillar

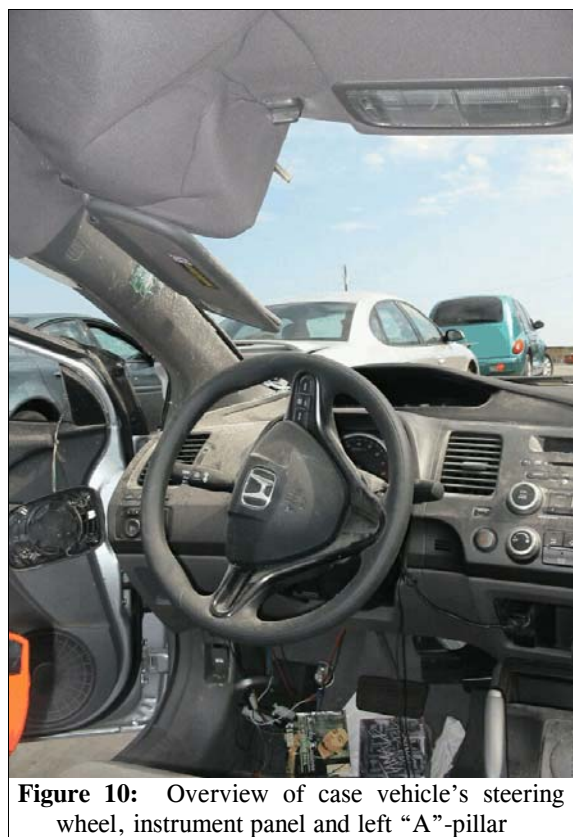
Vehicle Interior: Inspection of the case vehicle's interior (**Figure 10** and **Figure 11** below) revealed no evidence of occupant contact to any of the interior surfaces or components. A few small scuffs were observed on the roof over the back seat; however, these scuffs were not likely related to occupant contact. The driver most likely contacted the deployed side curtain air bags and his seat back-mounted side impact air bag; however, no obvious occupant contact evidence was observed on these air bags. The case vehicle sustained several intrusions to the passenger compartment. The left A-pillar was intruded 3 centimeters (1.2 inches) vertically and 1 centimeter (0.39 inches) laterally while the right A-pillar was intruded 3 centimeters (1.2 inches) vertically and 4 centimeters (1.6 inches) laterally. In addition, the roof was intruded 2 centimeters (0.8 inches) at the driver's position, 4 centimeters (1.6 inches) at the front middle position, and 9 centimeters (3.5 inches) at the front right position. Lastly, there was no evidence of compression of the energy absorbing steering column or deformation of the steering wheel (**Figure 12** below).

Figure 10: Overview of case vehicle's steering wheel, instrument panel and left "A"-pillar

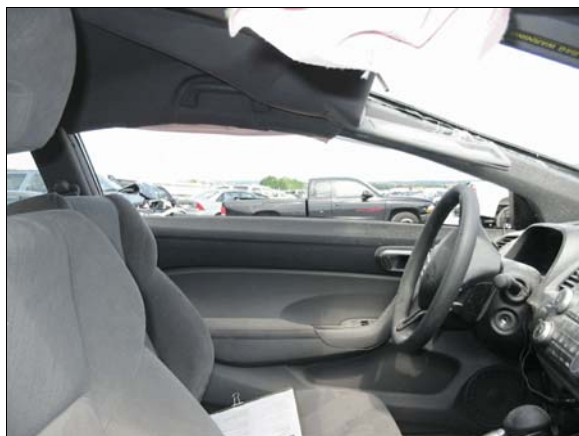
Figure 11: Right side view of case vehicle's left front door, steering assembly and left "A"-pillar

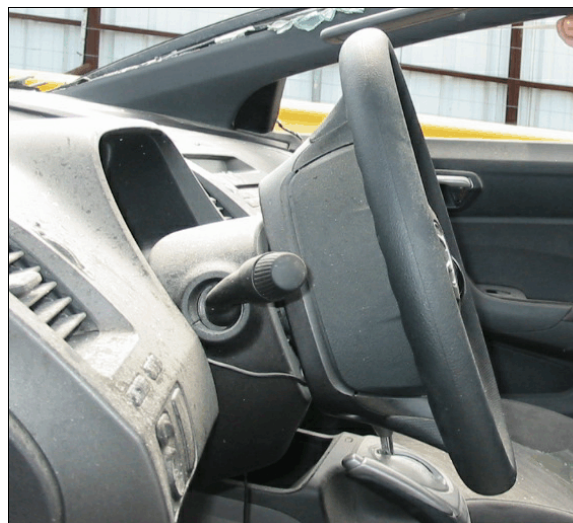
Figure 12: Left side view of case vehicle's steering wheel and steering assembly showing lack of deformation

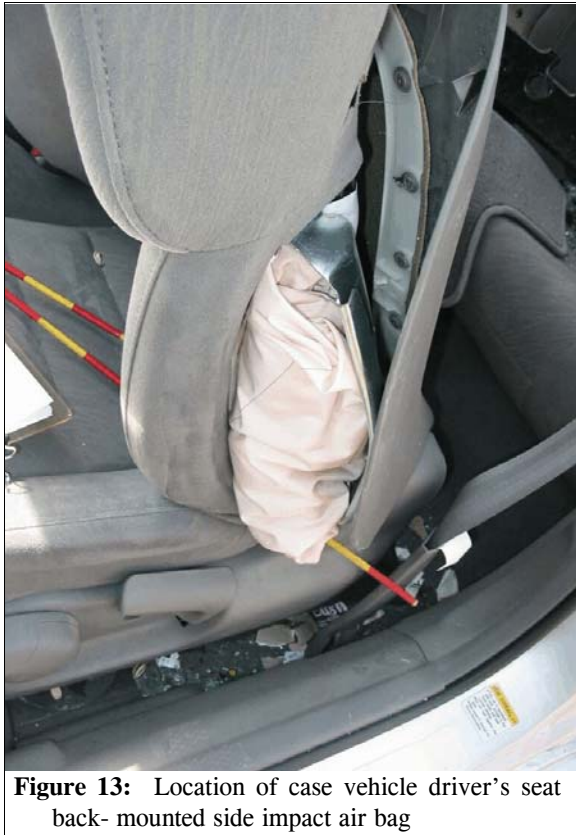
The driver's seat back-mounted side impact air bag was located in the outboard side of the driver's seat back (**Figure 13** below). The air bag (**Figure 14** below) was approximately oval in shape and measured approximately 52 centimeters in height (20.5 inches) and 38 centimeters (15 inches) in width. It was designed with one vent port 3.5 centimeters (1.4 inches) in diameter located at the front, central outboard side of the air bag. There was a double-stitched oval section of material, approximately 16 centimeters (6.3 inches) in length, in the central portion of the air bag where both sides of the air bag were sewn together. This appeared to shape the inflation

Figure 13: Location of case vehicle driver's seat back-mounted side impact air bag

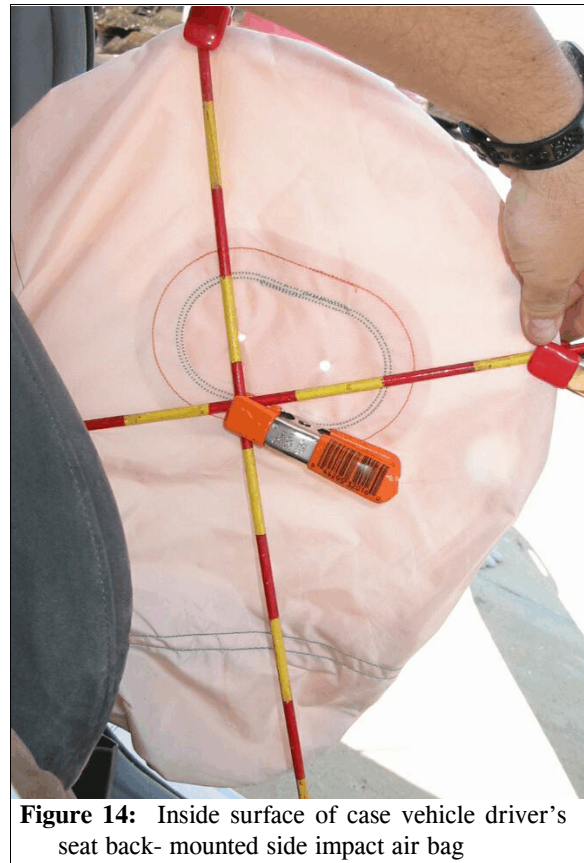
Figure 14: Inside surface of case vehicle driver's seat back-mounted side impact air bag

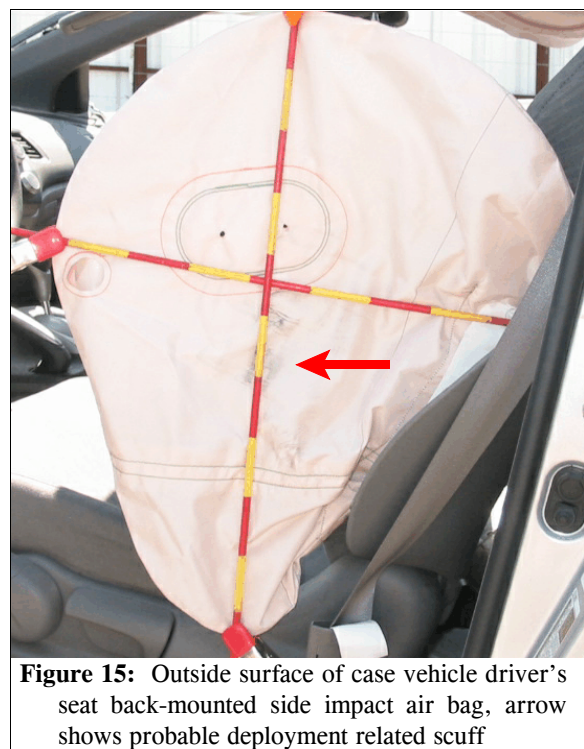
chamber during deployment. There was no evidence of occupant contact to this air bag. However, a large probable deployment scuff was noted on the central portion of the outboard surface of the air bag (Figure 15).

Figure 15: Outside surface of case vehicle driver's seat back-mounted side impact air bag, arrow shows probable deployment related scuff

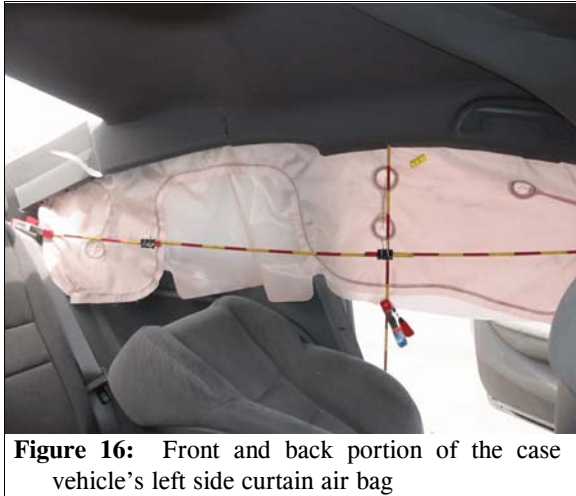
The left side curtain air bag was located along the left roof side rail, inside the head liner (Figures 16 and 17 below). The air bag extended along the side rail from the middle of the A-pillar, across the front left and back left seat positions to the "C"-pillar. The air bag was attached to the "A"-pillar by a cloth anchor cord approximately 20 centimeters (7.9 inches) in length. There was no evidence of damage during the deployment to the air bag. However, a small cut in the inboard surface of the air bag was observed on the front inflation chamber near the roof side rail (Figure 18 below). This was most likely related to broken glass as the driver exited the vehicle through the left front window. The left side curtain air bag was approximately 134 centimeters (52.8 inches) in length and 35 centimeters (13.8 inches) in height. It was constructed with two primary

Figure 16: Front and back portion of the case vehicle's left side curtain air bag

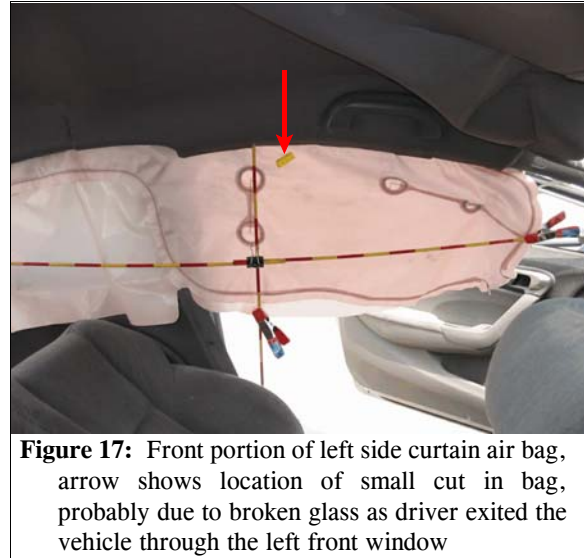
inflation chambers, one at the driver's head area and one at the left rear passenger's head area. The inflation chamber adjacent to the driver's seat had four circular, double-stitched areas where both sides of the air bag were sewn together. The inflation chamber adjacent to the back left seat had one of these double-stitched areas. Based on crash test videos, this appears to aid in shaping the air bag during inflation and to control the width of the air bag during deployment. While there were no obvious vent ports, an area of perimeter stitching at the front and rear of the air bag did not meet leaving an opening, presumably to allow the inflation gases to escape the inflation chambers.

Figure 17: Front portion of left side curtain air bag, arrow shows location of small cut in bag, probably due to broken glass as driver exited the vehicle through the left front window

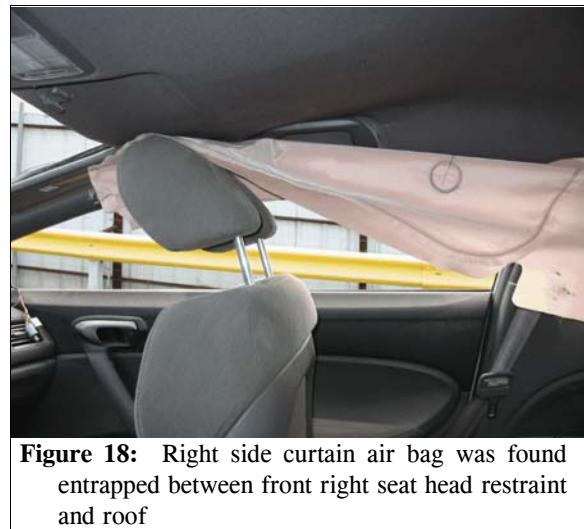
The right side curtain air bag was the same design and dimensions as the left side curtain air bag. The front portion of the air bag was found entrapped between the front right seat head restraint and the intruded roof (**Figure 18**). This most likely occurred during the sixth and final quarter roll as the case vehicle landed on its roof. Otherwise, the right side curtain air bag was unremarkable.

Figure 18: Right side curtain air bag was found entrapped between front right seat head restraint and roof
