Side Curtain and Side Air Bag Investigation/Vehicle to Vehicle
Dynamic Science, Inc./Case Number: DS06010
2006 Nissan Maxima
Washington
March 2006

1. Report No. DS06010	2. Government Accession No.		3. Recipient Catalog No.	
4. Title and Subtitle Side Curtain and Side Air Bag Investigation		5. Report Date July 19, 2006

This on-site investigation focused on the side curtain and side air bag systems in a 2006 Nissan Maxima.

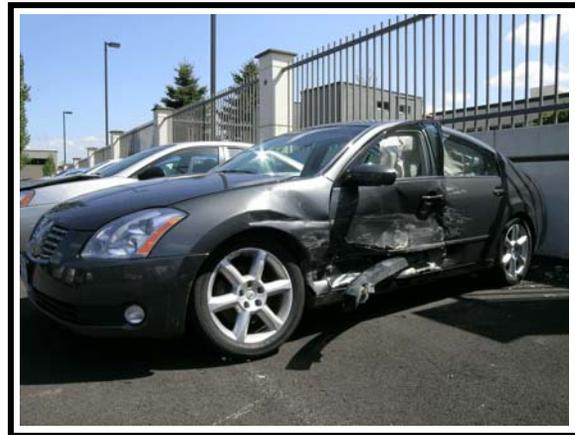
Figure 1. Front/Left 2006 Nissan Maxima

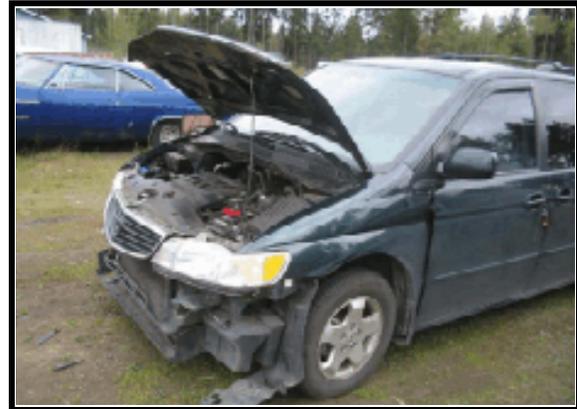
Figure 2. Front left, 2000 Honda Odyssey

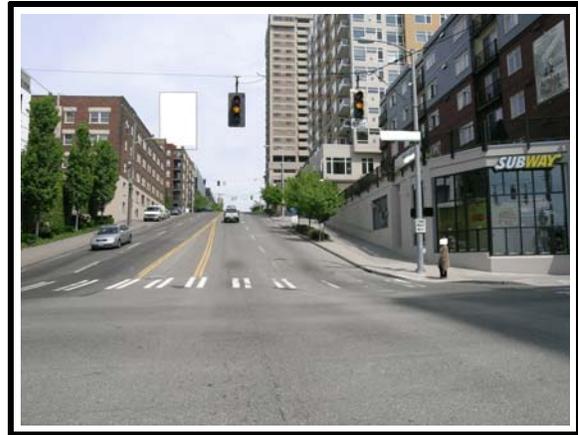
Figure 5. Area of impact (east)

The front of the Honda struck the left side of the Nissan (10LYEW2). The impact severity was moderate and resulted in the deployment of the Nissan's left front seat back mounted side air bag and left side curtain. The missing vehicle routine of the WinSmash program computed a total delta V of 13.0 km/h (8.1 mph) for the case vehicle. The longitudinal and lateral components were -6.5 km/h (-4.0 mph) and 11.3 km/h (7.0 mph), respectively.

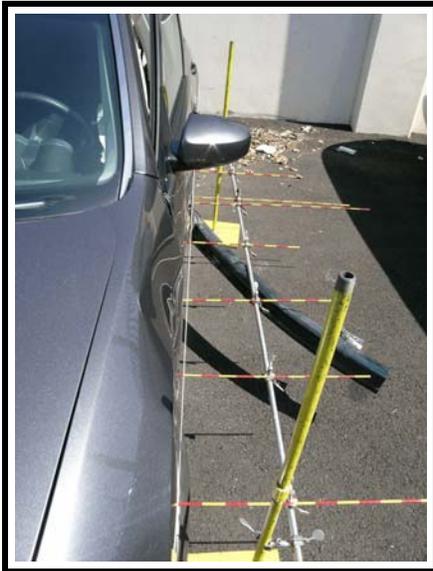
The 2006 Nissan Maxima sustained moderate left side damage as a result of the impact with the Honda Odyssey. The bumper backing bar from the 2000 Honda Odyssey was found embedded in the case vehicle's lower left front door panel and could not be removed. The Maxima sustained 259.0 cm (102.0 in) of direct damage along the left side beginning 82.0 cm (32.3 in) forward of the left rear axle, extending forward along the left side. Six crush measurements were documented beginning 96.0 cm (37.8 in) forward of the left rear axle, extending forward 191.0 cm (75.2 in). The crush measurements were as follows: C1=0.0 cm (0.0 in), C2=13.0 cm (5.1 in), C3=14.0 cm (5.5 in), C4=10.0 cm (3.9 in), C5=6.0 cm (2.4 in), C6=1.0 cm (0.4 in). An additional maximum crush measurement was taken 128.0 cm (50.4 in) forward of the left rear axle. There was 18.0 cm (7.1 in) of lateral crush at the maximum crush location. The maximum crush and C2 measurements were adjusted to account for the embedded bumper.

CDC:	10LYEW2	
Delta V:	Total	13.0 km/h (8.1 mph)
	Longitudinal	-6.5 km/h (-4.0 mph)
	Latitudinal	11.3 km/h (7.0 mph)
	Energy	16,703 joules (12,320 ft lbs)

Figure 6. Crush profile - 2006 Nissan Maxima

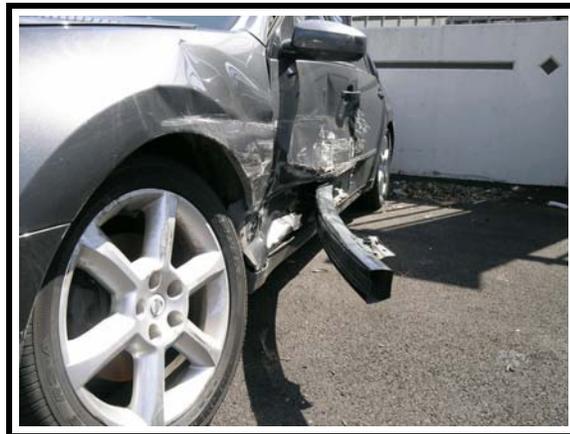
The dual front air bags in the Honda also deployed on impact. The case vehicle was pushed laterally from the impact and came to final rest in lane one, facing north. The Odyssey came to final rest near the northeast corner of the intersection, facing northeast. The Odyssey's front bumper was ripped off during the impact and was left tightly wedged in the Maxima's lower left front door panel.

Figure 7. Bumper of the 2000 Honda Odyssey still embedded in the left front door (2006 Nissan Maxima)

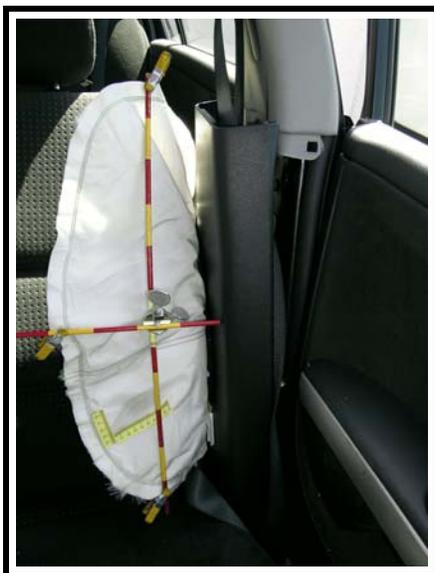
There was lateral intrusion into the driver's seating area, including intrusion of the left B pillar cover. The left B pillar itself did not intrude. There was also lateral intrusion of the lower left front door panel and the side panel located forward of the left A pillar. The specific passenger compartment intrusions were documented as follows:

Row/Position	Intruded Component	Magnitude of Intrusion	Direction
1L	B pillar cover	9.0 cm (3.5 in)	Lateral
1L	Lower LF door panel	3.0 cm (1.2 in)	Lateral
1L	Side panel forward of the A pillar	2.0 cm (0.8 in)	Lateral

Figure 8. Intrusion of the B pillar cover and scuff to the deployed outer driver side air bag

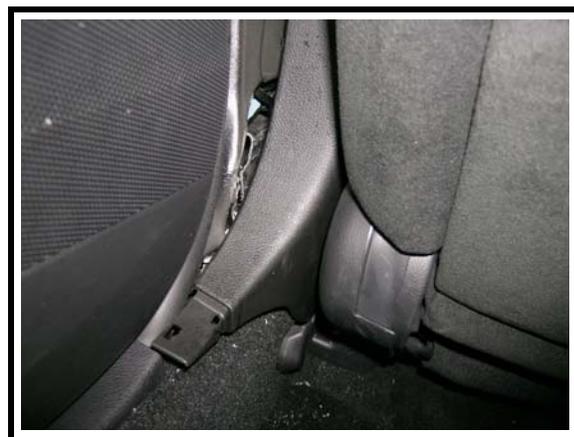
Figure 9. Intrusion - bottom of left B pillar cover. The RFBC of the Honda Odyssey intruded through the Maxima's LF door panel.

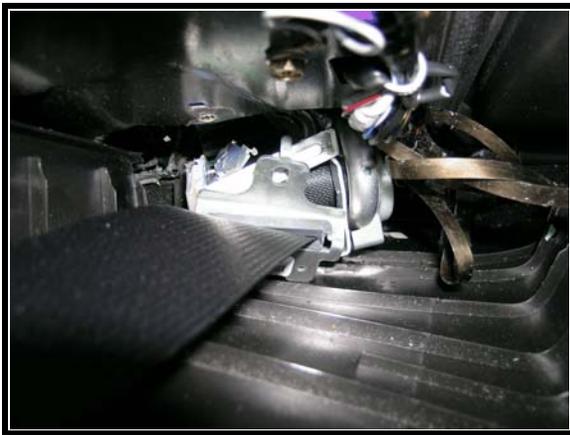
The case vehicle sustained minor interior damage due to occupant contacts and normal air bag deployment related damage. The driver's seat belt was locked in place post-crash, but it does not appear that the B pillar pretensioner actuated during the collision. When the Odyssey's front bumper intruded through the Maxima's left front door panel, it damaged the left front seat belt retractor. There were signs of occupant contact below the steering column and to the left front door panel and armrest.

Figure 10. Damaged LF seat belt retractor (2006 Nissan Maxima)

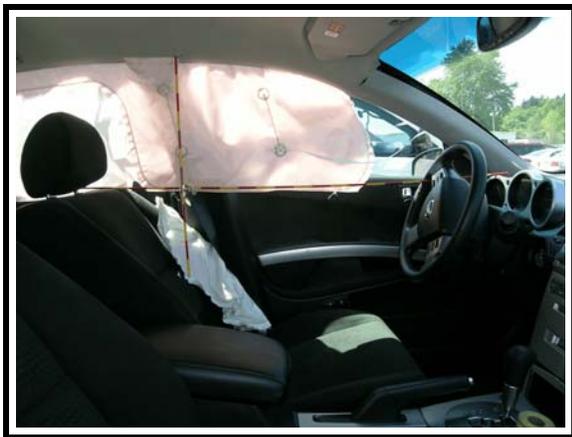
The deployed left side curtain extended from the A pillar to the C pillar. There was a small coverage gap present at the A pillar. The gap consisted of a triangular shaped area measuring 22.0 cm (8.7 in) in height at the forward aspect of the bag, 36.0 cm (14.2 in) in width along the belt line and 43.0 cm (16.9 in) in length along the A-pillar. The side curtain was rectangular in shape and in its deflated state, measured 162.0 cm (63.8 in) in length. The height of the front section of the curtain measured 38.0 cm (15.0 in) and the back section measured 26.0 cm (10.2 in). The air bag had one external tether, located at the front of the curtain at the A pillar. There was one 1.5 cm (0.6 in) diameter vent port located on the outer lower front corner of the bag. The side curtain deployed from the left roof side rail. There were black seat belt webbing transfers found on the outer material of the bag in the driver’s area. There were no visible signs of occupant contact or damage to the side curtain.

Figure 12. Deployed left side curtain (2006 Nissan Maxima)

<u>Injury</u>	<u>OIC Code</u>	<u>Injury Mechanism</u>	<u>Confidence Level</u>
Laceration (minor) left cheek	290602.1,2	Left side curtain air bag and/or driver's eyeglasses	Probable
Strain, cervical spine	640278.1,6	Impact forces	Certain

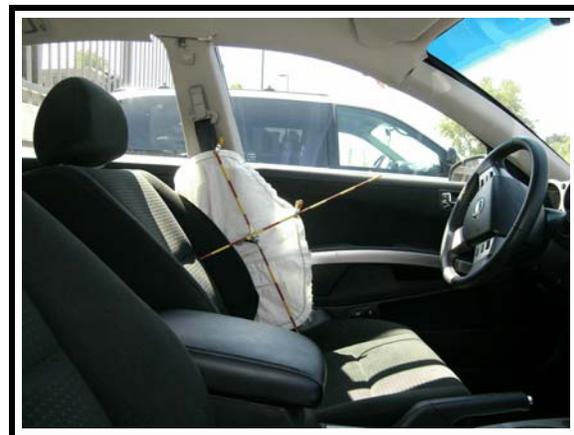
The deployed left seat back mounted side air bag was semi-circular in shape with a height of 54.0 cm (21.3 in) and an excursion of 20.0 cm (7.9 in) in its deflated state. There were no tethers or vent ports. Although there was some lateral intrusion of the B pillar cover into the side air bag deployment area, it appears that the air bag deployed properly. On the outer lower portion of the air bag there were black fabric transfers found. The transfers were most likely seat back fabric transfers and occurred during the deployment. There were no visible signs of occupant contact or damage.

Figure 13. Deployed driver side air bag (2006 Nissan Maxima)

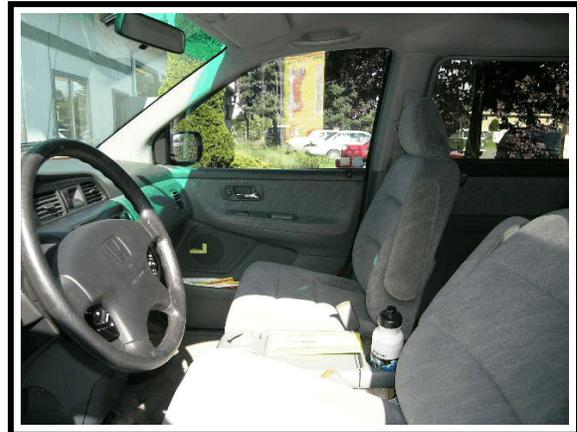
The Odyssey had been fully repaired, but there was occupant contact evidence still visible in the passenger compartment. According to the manager of the repair shop, there was no intrusion as a result of the crash and the only interior components that were replaced were the dual front air bag modules and both front seat belts. Both front seat belt B pillar pretensioners actuated during the collision and were locked in place post-crash. There were signs of occupant loading to both front seat belts and evidence of occupant contact to the right front door panel.

Figure 14. RF seat and possible occupant contact to the RF door panel (2000 Honda Odyssey)

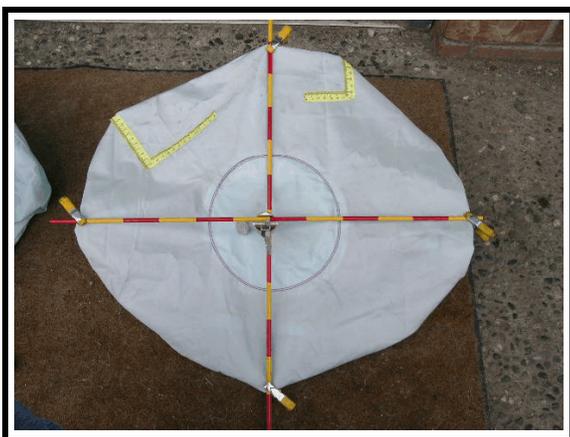
The driver's front air bag had been removed from the vehicle during repairs, but had been mounted in the center of the steering wheel hub. The air bag module cover flaps had a general H configuration. The top cover flap measurements were as follows: the upper flap edge was 17.5 cm (6.9 in) wide, the lower flap edge was 14.0 cm (5.5 in) wide and both side flap edges were 8.0 cm (3.1 in) tall. The bottom cover flap measurements were as follows: the upper flap edge was 13.5 cm (5.3 in) wide and the lower flap edge was 7.0 cm (2.8 in) wide. The side flap edges were 5.0 cm (2.0 in) tall. The air bag was circular in shape and measured 55.0 cm (21.7 in) high/wide in its deflated state. The air bag had one internal tether and two circular vent ports on the back of the bag at the 11 and 1 o'clock positions. There were a few cover flap streaks on the face and back of the bag, but there were no visible signs of occupant contact or damage to either side of the driver air bag.

Figure 15. Driver air bag - 2000 Honda Odyssey (removed during repair)

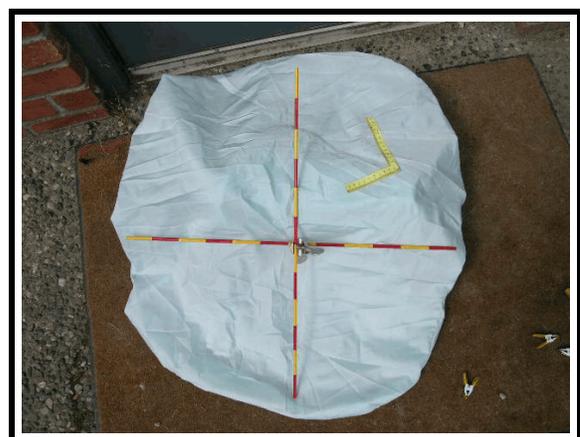
The passenger front air bag had also been removed during repairs, but had been mounted in the top portion of the right instrument panel. The single air bag module cover flap was rectangular in shape and measured 25.5 cm (10.0 in) wide and 10.5 cm (4.1 in) high. The air bag had a square shape and measured 75.0 cm (29.5 in) seam to seam laterally and 85.0 cm (33.5 in) in height in its deflated state. There were no tethers but there were two circular vent ports on the sides of the air bag at the 3 and 9 o'clock positions. There was no damage to the cover flaps or air bag. There was a light beige discoloration found in the upper right section on the front of the bag. This discoloration may have been dirt, as the modules had been pulled from a dumpster after the repair shop was contacted regarding the vehicle inspection. There were cover flap streaks found on the back of the air bag in several locations. There was no visible damage to the front or back of the air bag.

Figure 16. Front right passenger air bag - 2000 Honda Odyssey (removed during repair)

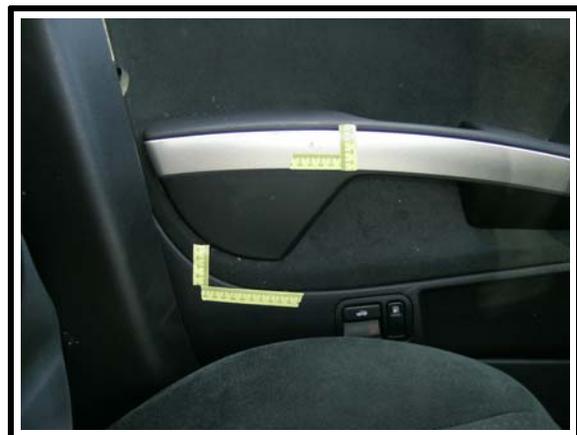
Figure 18. Possible occupant contact points to the LF door panel and armrest (2006 Nissan Maxima)

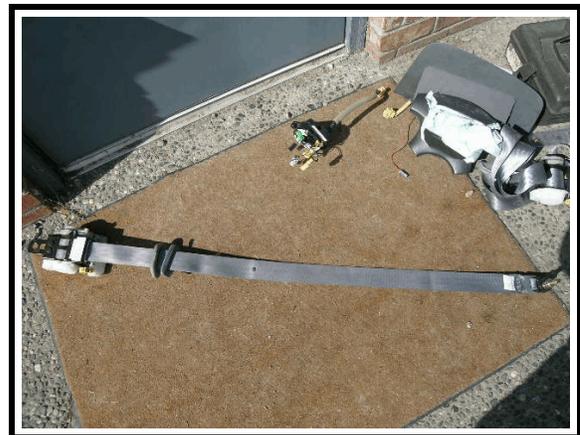
The 51-year-old female driver of the Honda Odyssey appears to have been seated in an upright posture in the cloth covered bucket seat and was restrained by the 3-point manual lap and shoulder belt. The shoulder belt anchorage adjustment was in the full down position. According to repair shop personnel, the seat was adjusted to the forward most track position. At the inspection, the seat back was reclined at a 116 degree angle and the seat bottom had a 20 degree angle. During the front end impact, the female driver initiated a forward and slightly lateral trajectory towards the 1 o'clock direction of force. The driver's side safety belt pretensioner actuated and the front air bag deployed. The vehicle's front bumper partially penetrated the Maxima's left front door, and was ripped off during the impact. The Odyssey rotated counterclockwise as it traveled towards the northeast corner of the intersection. The vehicle came to final rest still in the intersection, facing northeast. According to the driver of the Maxima, the driver of the Odyssey was able to exit the vehicle on her own and was ambulatory at the scene. According to the police report, this driver was not injured. According to repair shop personnel, this driver is approximately 165.0 cm (65 in) tall and has a slight build.

Figure 19. Driver's seat belt - removed during repair (2000 Honda Odyssey)

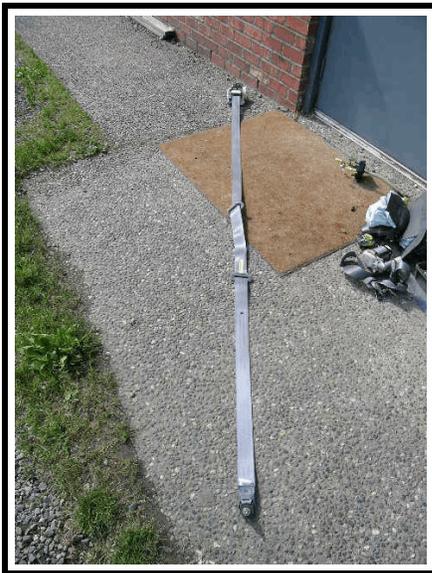
The 27-year-old front right male passenger was seated forward facing in the cloth covered bucket seat and was restrained by the 3-point manual lap and shoulder belt. The shoulder belt anchorage adjustment was in the full down position. According to repair shop personnel, the seat was adjusted to the forward most track position. At the inspection, the seat back was reclined at a 102 degree angle and the seat bottom had a 14 degree angle. During the front end impact, the male passenger initiated a forward and slightly lateral trajectory towards the 1 o'clock direction of force. The right front safety belt pretensioner actuated and the front air bag deployed. The vehicle's front bumper partially penetrated the Maxima's left front door, and was ripped off during the impact. The Odyssey rotated counterclockwise as it traveled towards the northeast corner of the intersection. It is likely that during the rotation, this passenger's right knee and/or lower right leg contacted the right front door panel, leaving a skin transfer. The vehicle came to final rest still in the intersection, facing northeast. According to the driver of the Maxima, this passenger was able to exit the vehicle on his own and was ambulatory at the scene. According to the police report, this passenger was not injured. According to repair shop personnel, this passenger is approximately 165.0 cm (65 in) tall and has a slight build.

Figure 20. RF passenger seat belt - removed during repair (2000 Honda Odyssey)

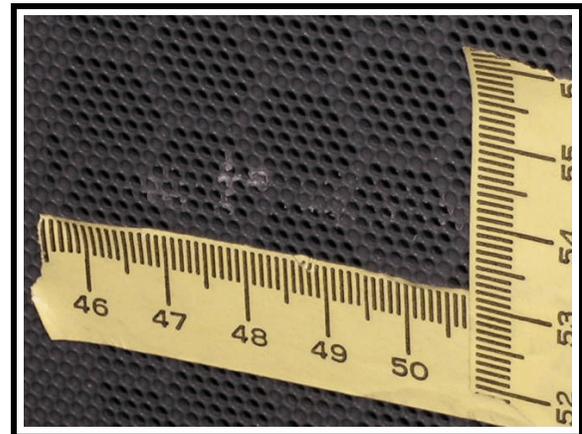
Figure 21. Close-up skin transfer to the RF door panel (2000 Honda Odyssey)
