ON-SITE CHILD AIR BAG-RELATED FATALITY INVESTIGATION

CASE NUMBER - IN-06-011

VEHICLE - 1995 FORD WINDSTAR GL

CRASH DATE - May 2006

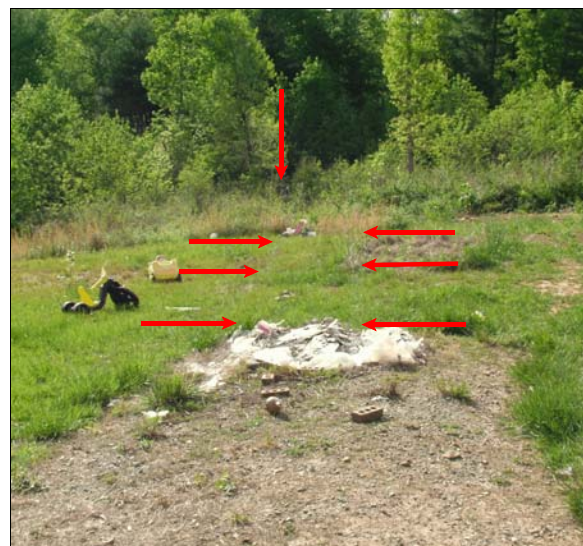
Figure 1: On-scene police photo showing area where case vehicle was parked, arrows show left and right tire marks in grass and rest position of case vehicle at bottom of hill

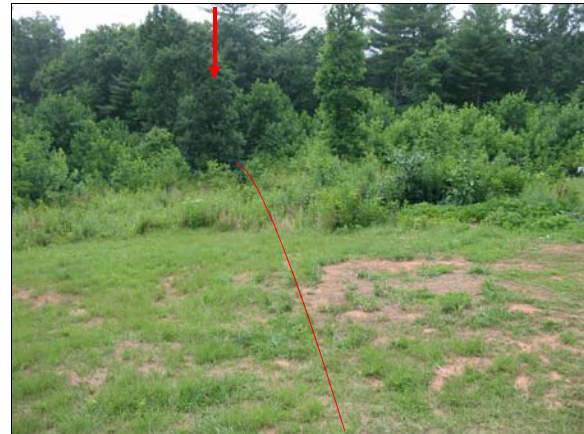
Figure 2: Overview of path of case vehicle down hill to impact with tree, arrow shows impacted tree, line shows approximate path to tree impact

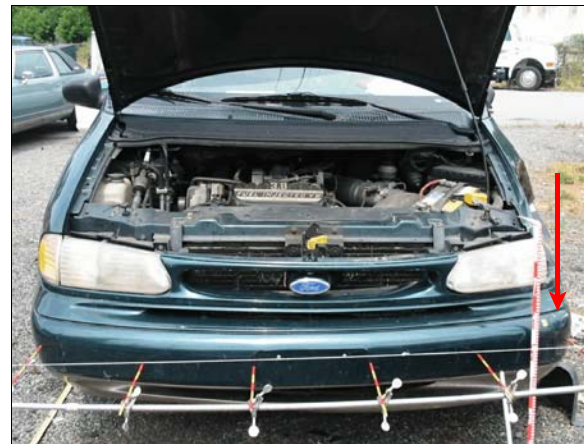
Crash: The left corner of the case vehicle's front bumper (**Figure 3**) impacted a tree (**Figure 4**). There was only minor engagement to the bumper. As the case vehicle swiped past the tree, the left fender (**Figure 5** below) engaged the tree and then the left front wheel engaged the tree causing the case vehicle's front air bags to deploy. The impact crushed the left front wheel rearward 11 centimeters (4.3 inches) and crushed the left fender inward. The case vehicle then separated slightly from the tree and the case vehicle's left side view mirror impacted the tree rotating the side view mirror inward (**Figure 6** below).

Figure 3: Overview front of case vehicle, arrow shows direct damage to front left bumper corner due to impact with tree

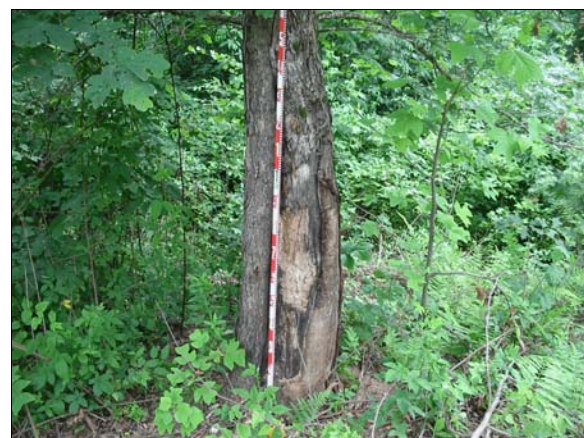
Figure 4: Tree impacted by case vehicle, numbers on scale are tenths of meter

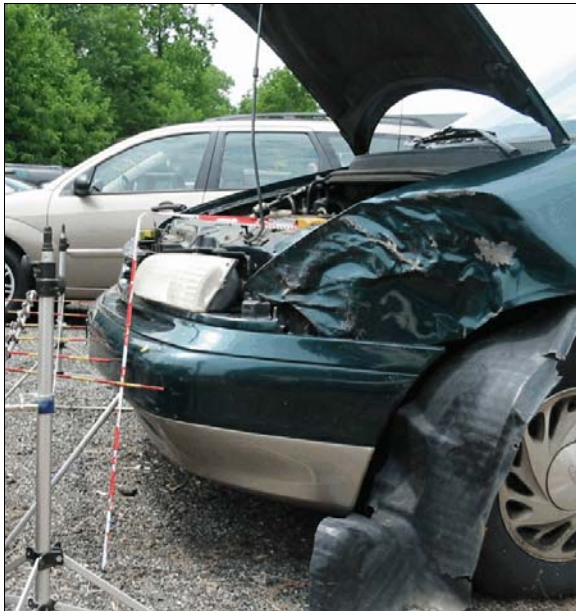
Figure 5: Damage to left corner of front bumper and left fender due to impact with the tree

Exterior Damage: The case vehicle’s impact with the tree involved 9 centimeters (3.5 inches) of direct contact to the front left bumper corner. The left fender and left front wheel then engaged the tree producing 73 centimeters (28.7 inches) of direct damage down the side of the fender and crushing the left front wheel rearward 11 centimeters (4.3 inches). The left front wheel was not jammed against the back of the wheelhouse at the inspection. However, a tire scuff mark was found on the back of the wheelhouse indicating the wheel had been dynamically crushed into the back of the wheelhouse during the crash. Crush measurements were taken at the bumper. The maximum residual crush was measured as 3 centimeters (1.2 inches) occurring at C₁ (**Figure 8**). The left fender was also crushed rearward approximately 5 centimeters (2 inches). In addition to the 11 centimeters (4.3 inches) reduction of the left side wheelbase, the right side wheelbase was reduced 5 centimeters (2 inches). Induced damage involved the front bumper and left fender, as well as the left headlamp/turn signal assembly and grille. The table below shows the case vehicle’s front crush profile.

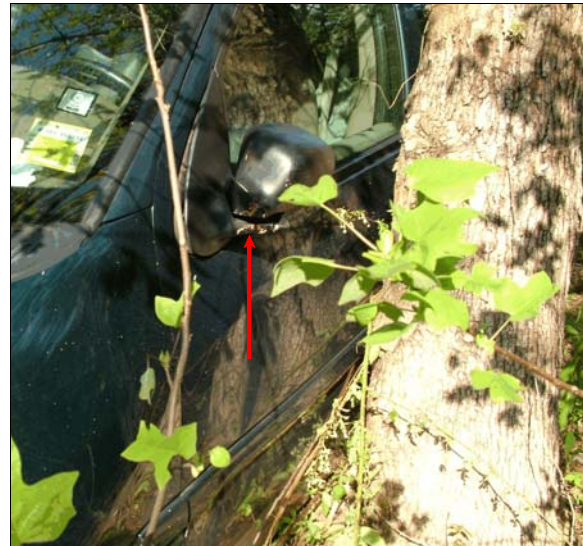
Figure 6: Arrow shows displacement of left side view mirror and bark transfer on mirror due to impact with the tree

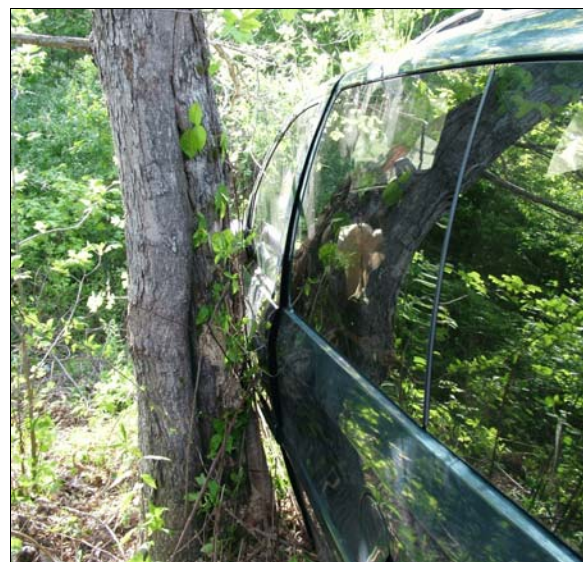
Post-Crash: The case vehicle came to rest adjacent to the tree (**Figure 7**). The 6-year-old occupant was found in the driver's seat on her knees leaning to the left of the steering wheel.

Figure 7: Police on-scene photo showing rest position of case vehicle adjacent to impacted tree

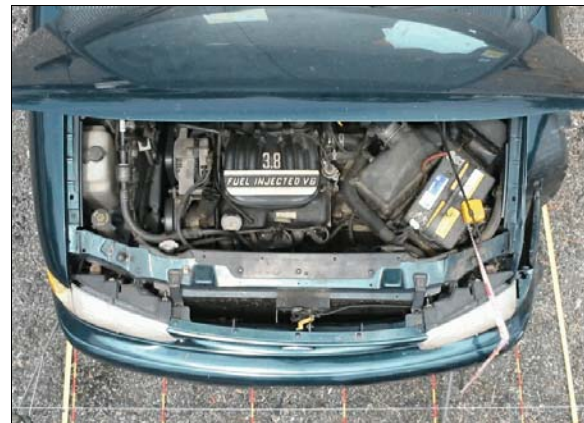
Figure 8: Top view of crush to case vehicle’s front bumper [baseline placement subsequently reduced 10 centimeters (4 inches) to establish case vehicle’s specification overall length, each increment on rods is 5 cm (2 in)]

Units	Event	Direct Damage		Field L	C ₁	C ₂	C ₃	C ₄	C ₅	C ₆	Direct	Field L
		Width CDC	Max Crush								±D	±D
cm	1	9	3	156	3	1	0	0	0	0	-76	0
in		3.5	1.2	61.4	1.2	0.4	0.0	0.0	0.0	0.0	-29.9	0.0

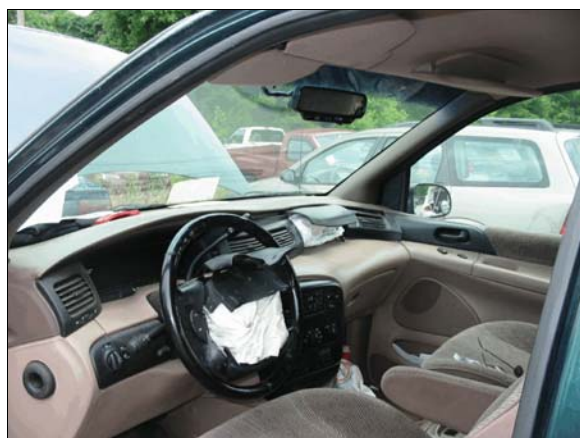
Vehicle Interior: Inspection of the case vehicle’s interior (**Figure 9**) revealed probable occupant contact evidence on the driver’s air bag, upper air bag module cover flap, the driver’s head restraint, and the rearview mirror was found knocked off its mounting bracket. In addition, two semi-circular black scuffs were observed on the driver’s air bag, which appeared to be caused by interaction of the deploying air bag against the steering wheel. There was no deformation of the steering wheel and no compression of the energy absorbing steering column (**Figure 10**). Lastly, there was no intrusion of the case vehicle’s passenger compartment.

Figure 9: Overview of case vehicle’s steering wheel, windshield, and instrument panel (Note: rearview mirror placed back on bracket during inspection)

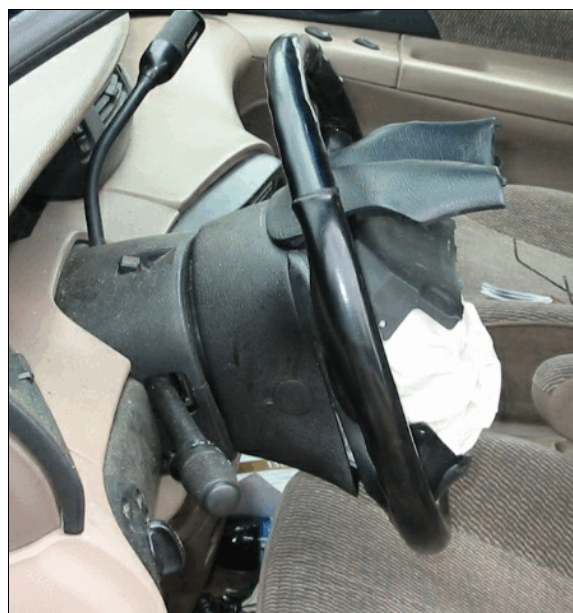
Figure 10: Left side view of case vehicle’s steering wheel showing lack of deformation

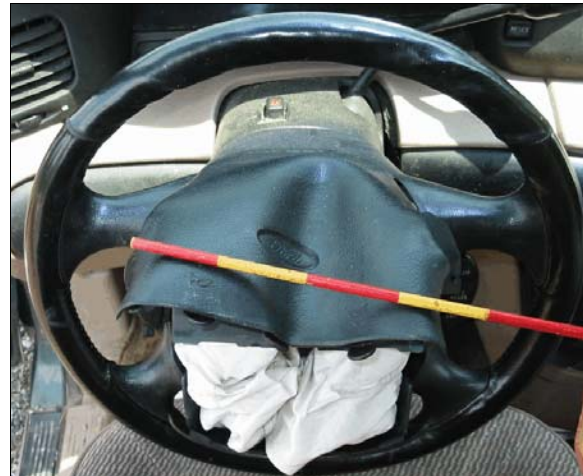
Figure 11: Deformation to top cover flap due to interaction with front left occupant during air bag deployment

The evidence indicated that the front left occupant was positioned over the air bag module at the moment of deployment and interacted with the air bag components during the deployment. The top cover flap impacted the occupant as the air bag deployed deforming the cover flap. The occupant's body interfered with air bag deployment causing the air bag to interact forcefully with the back of the top cover flap and the steering wheel causing the observed black scuff marks on the front and back of the air bag.

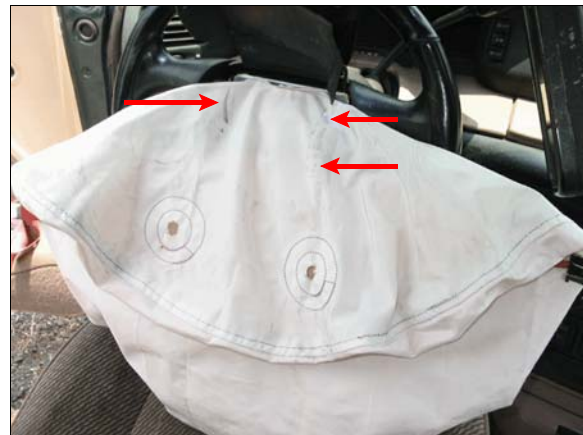
Figure 12: Arrows show linear black scuff marks on back of driver's air bag due to contact with back of top cover flap

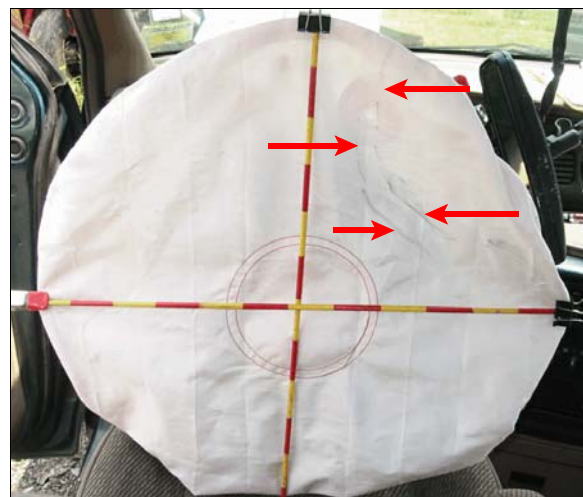
Figure 13: Case vehicle's driver air bag, arrows shows semi-circular black scuffs on air bag

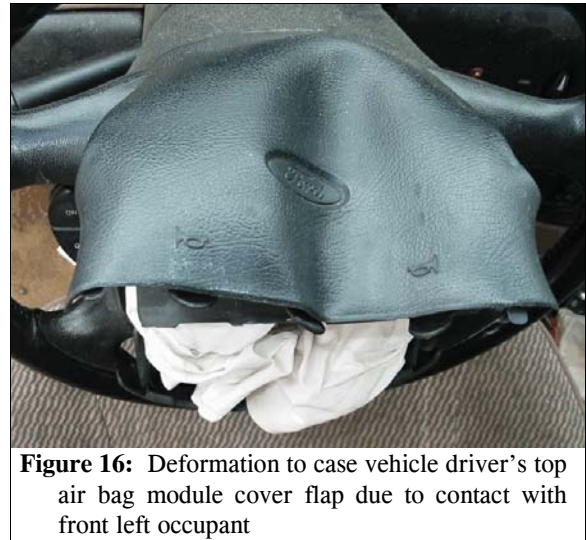
Figure 16: Deformation to case vehicle driver's top air bag module cover flap due to contact with front left occupant

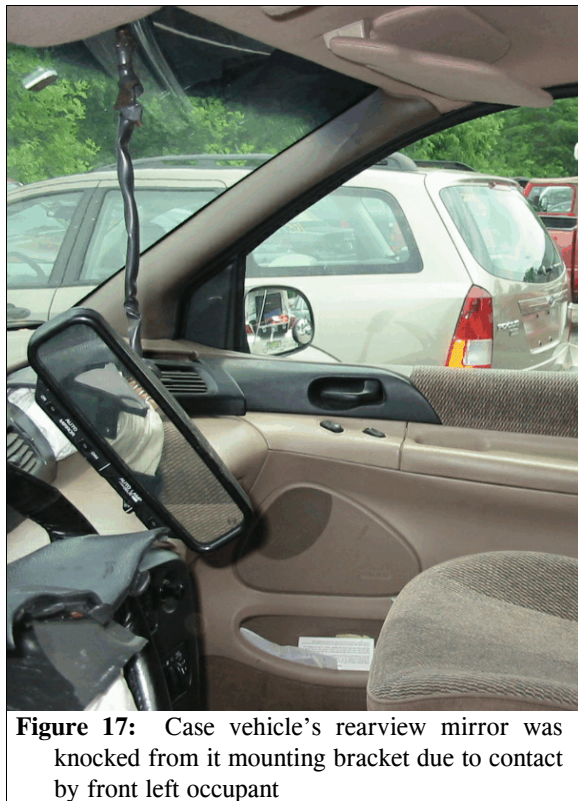
Figure 17: Case vehicle's rearview mirror was knocked from its mounting bracket due to contact by front left occupant

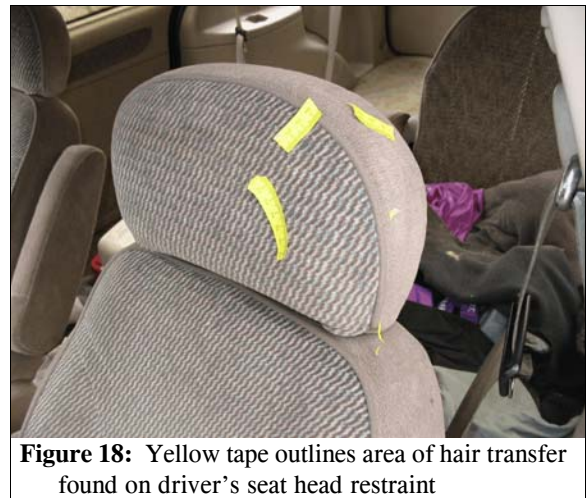
Figure 18: Yellow tape outlines area of hair transfer found on driver's seat head restraint
