**CALSPAN ON-SITE SIDE IMPACT PROTECTION SYSTEM CRASH  
INVESTIGATION**

**CASE NO: CA06-011**

**VEHICLE: 2006 HONDA CR-V**

1. Report No. CA06-011		2. Government Accession No.		3. Recipient's Catalog No.	
4. Title and Subtitle Calspan On-Site Certified Advanced 208-Compliant Vehicle Crash Investigation Vehicle: 2006 Honda CRV Location: State of New York				5. Report Date: October 2006

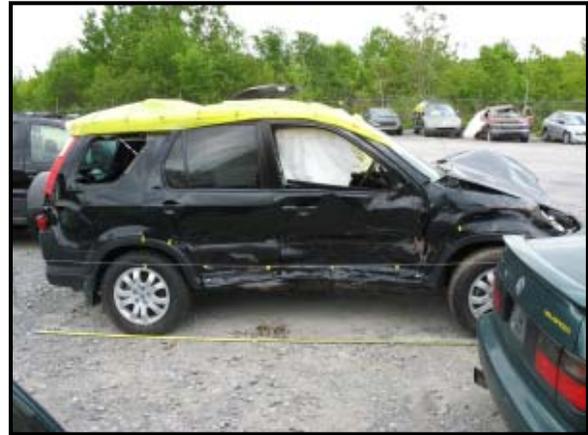
**Figure 2: Right side view of the Honda.**

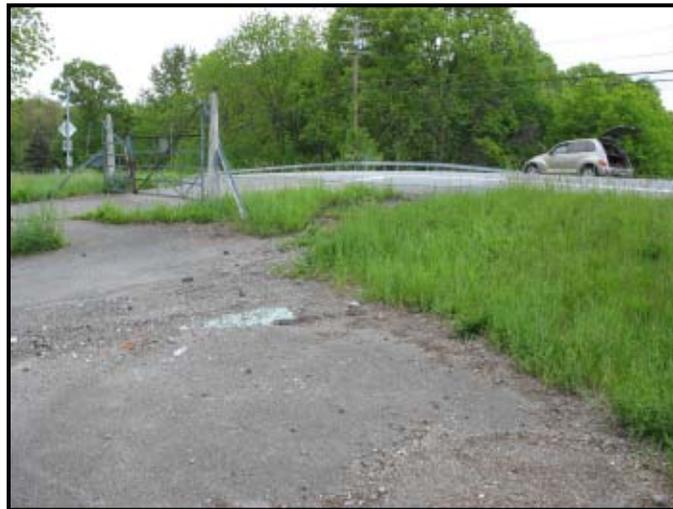
**Figure 6: View looking from the Honda's final rest toward the point of impact.**

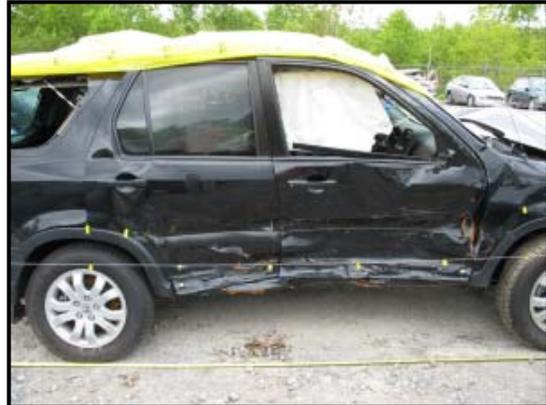
**Figure 7** is a close-up view of the right side impact damage. The direct contact began 28 cm (11.0 in) aft of the right front axle and extended rearward 206 cm (81 in). The direct contact ended on the rear aspect of the right rear door 27 cm (10.5 in) forward of the right rear axle. The combined length of the direct and induced damage measured 226 cm (89 in). The induced damage extended 20 cm (8.0 in) aft of the direct contact pattern and ended 6 cm (2.5 in) forward of the right rear axle. The crush profile was measured along the mid-door elevation which was the level of maximum deformation. The maximum lateral crush was located 118 cm (46.6 in) aft of the right front axle on the mid aspect of the left front door at C4. The residual crush profile measured as follows: C1 = 1 cm (0.4 in), C2 = 13 cm (5.1 in), C3 = 20 cm (7.9 in), C4 = 25 cm (9.8 in), C5 = 20 cm (7.9 in), C6 = 0. The right side doors were jammed shut by the deformation and were shifted rearward. The front right window glazing was disintegrated. The right wheelbase was reduced 2 cm (0.8 in) due to bending of the vehicle’s unibody. The left wheelbase was unchanged. The Collision Deformation Classification of the impact was 02-RYEW3.

**Figure 7: Right side impact damage.**

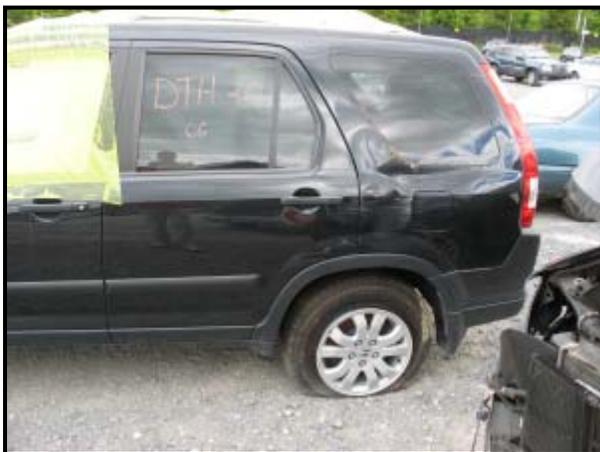
**Figures 8 and 9** are views of the Honda’s left side damage. The left rear tire was deboned and the face of the wheel rim was abraded. This occurred in the early stage of the rollover when the Honda encountered the side slope and began to fall-over. The weight shift to the left rear overloaded the tire and caused it to air out. The left plane contacted the ground exhibited by the longitudinal abrasions at the C-pillar and the debris embedded in the body seams. The left exterior mirror was fractured and separated from the vehicle. The left A-pillar was abraded and the left front window glazing disintegrated by subsequent ground contact. Both left doors were operational. The abrasion pattern extended forward onto the upper aspect of the left front fender and then wrapped onto the hood. The entire surface of the hood was abraded.

**Figure 8: Left side view of the Honda.**

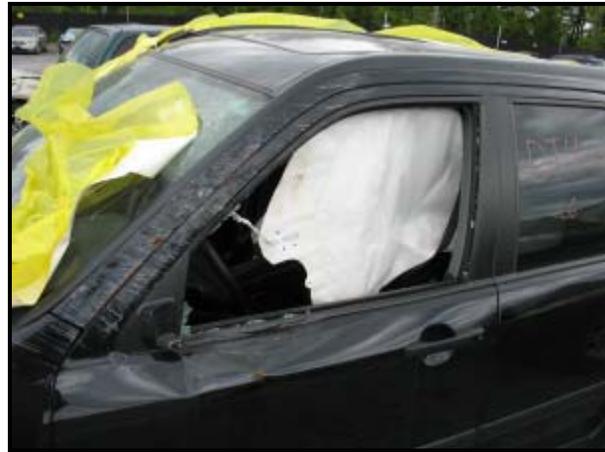
**Figure 9: Abrasions at the left A-pillar.**

The left A-pillar area of the roof exhibited a small area of abrasions localized to its forward left aspect. There was no noted left A-pillar deformation. There was no other damage to the roof. The plastic trim covering the respective roof-rails was not damaged. As the vehicle rolled through two-quarter turns, the right side plane contacted the ground. The abrasion pattern of the hood wrapped onto the right front fender. The right A-pillar, **Figure 10**, was abraded and debris was embedded in the door frame. There was no deformation of the pillar. The right exterior mirror was fractured and separated. As the vehicle came to final rest the right rear quarterpanel and D-pillar area contacted the ground, **Figure 11**. The ground contact caused a buckling of the body panel. The right rear window glazing disintegrated and the right rear taillight lens was fractured. Grass debris was embedded into the bead of the right rear tire indicative of ground contact. The Collision Deformation Classification of the rollover event was 00-TDDO1.

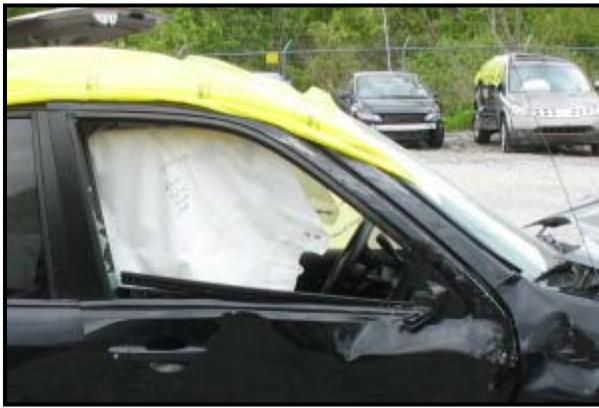
**Figure 10: Right A-pillar abrasions.**

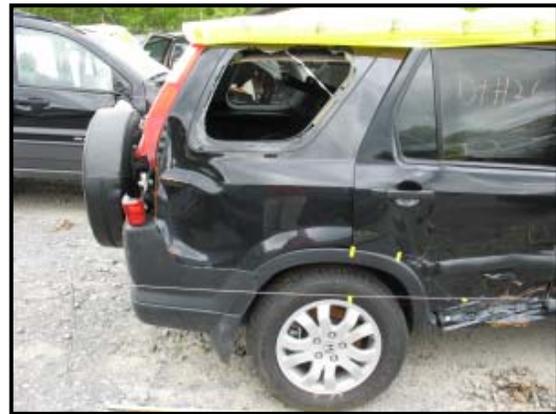
**Figure 11: Right rear quarterpanel damage.**

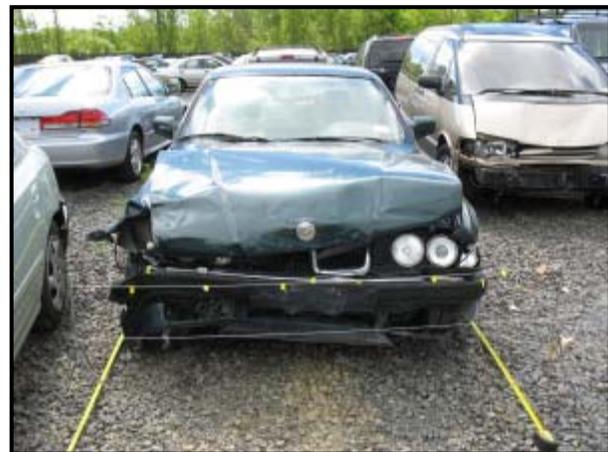
**Figure 13** is the front view of the BMW damage. The BMW sustained direct contact damage to the frontal plane that extended across the vehicle's entire 157 cm (62 in) front end width as a result of the impact with the Honda. The deformation was biased to the right indicative of the 11 o'clock direction of the impact force. The damage components included the front bumper structure, center grille, hood, right headlamp assembly, and right front fender. The maximum crush was located at the right front bumper corner (C6). The residual crush measured at the bumper elevation was as follows: C1 = 8 cm (3.1 in), C2 = 14 cm (5.5 in), C3 = 15 cm (5.9 in), C4 = 18 cm (7.1 in), C5 = 22 cm (8.7 in), C6 = 25 cm (9.8 in).

**Figure 12: Front view of the BMW.**

There was no change in the wheelbase measurements. All the doors remained closed during the crash and were operational at the SCI inspection. The windshield was fractured from contact by the cover flap of the deployed front right passenger air bag. All the glazing of the side windows

and the backlight were intact. The Collision Deformation Classification of the impact was 11-FDEW1.

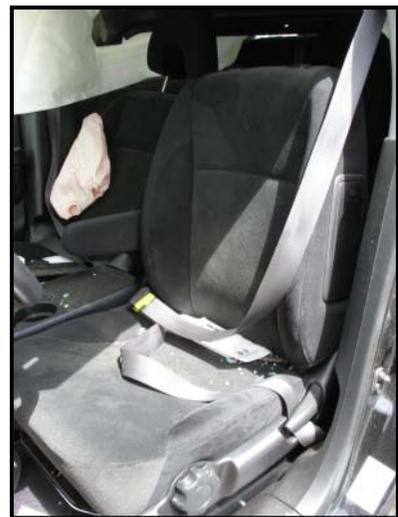
The manual restraint systems in the Honda CR-V consisted of 3-point lap and shoulder safety belts in all five seat positions. The driver's restraint, **Figure 13**, consisted of a continuous loop webbing, a sliding latch plate, an adjustable D-ring, and an Emergency Locking Retractor (ELR). The outboard anchor was attached to the floor. The inboard buckle was attached to the seat and was equipped with a pretensioner. The pretensioner fired as a result of the impact. The height of the buckle reduced approximately 5 cm (2 in) to the level of the seat cushion. Upon initial inspection, the driver's restraint was in the extended position. The ELR retractor was locked and the webbing would not retract. The length of the extended webbing measured 180 cm (71.0 in). Examination of the webbing revealed it was creased in the area of the latch plate. The crease was located 76

**Figure 13: Driver's restraint.**

cm to 83 cm (30.0 in to 32.5 in) from the outboard anchor. Examination of the latch plate revealed indicators of historical use. Additionally, the friction surface of the latch plate belt path was abraded indicative of loading. The D-ring was adjusted to the full up position. The surface of the D-ring did not reveal loading evidence. The evidence identified during the examination of the driver's restraint indicated the restraint was in use at the time of the crash.

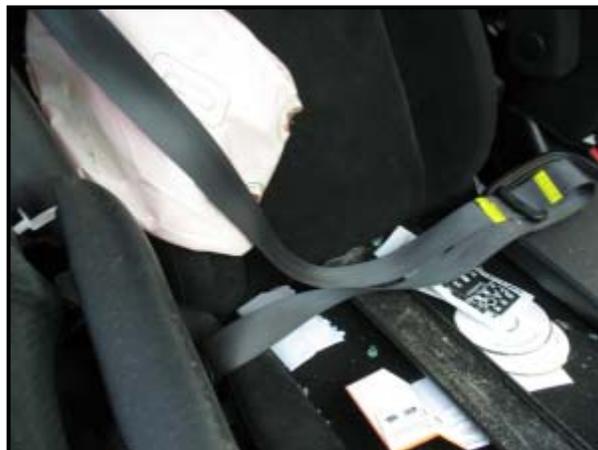
The front right passenger manual safety belt consisted of a continuous loop webbing, a sliding latch plate, an adjustable D-ring and a switchable Emergency Locking/Automatic Locking Retractor (ELR/ALR). The inboard buckle stalk was equipped with a pretensioner that fired as a result of the crash. Upon inspection, the webbing was extended and the retractor was locked due to the right B-pillar deformation. The length of the extended webbing measured 170 cm (67.0 in). The webbing was creased in the area of the latch plate. The location of the crease measured 67 cm to 75 cm (26.5 in to 29.5 in) from the outboard anchor. Examination of the latch plate revealed abrasions to the friction surface of the belt guide consistent with this loading. Minor historical use indicators were present on the tongue consistent with its use. The adjustable D-ring was in the full-down position. The surface of the D-ring was not abraded. The physical evidence identified during the course of the inspection confirmed the front right passenger was restrained at the time of the crash.

**Figure 14: Front right passenger safety belt.**

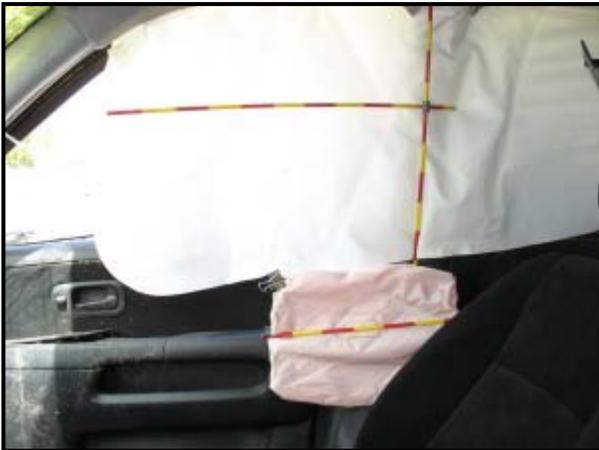
The thorax bag was housed in a module in the outboard bolster of the front seat back and expanded forward to offer a measure of inflatable protection between the occupant's chest and the door panel. The module measured 23 cm (9 in) in height and the base of the module was 20 cm (8 in) above the seat bight. The deployed bag was rectangular in shape and measured 33 cm x 27 cm (13 in x 10.5 in), length x height respectively. The referenced length dimension was measured to the module recessed within the seat bolster. The deployed bag extended 24 cm (9.5 in) forward of the seat bolster. The bag was tethered by a 5 cm (2 in) wide strap. It was vented by two 3.8 cm (1.5 in) ports located on the bag's forward vertical seam. There was no evidence of occupant contact to the right thorax bag.

**Figure 16: Deployed right side impact protection.**

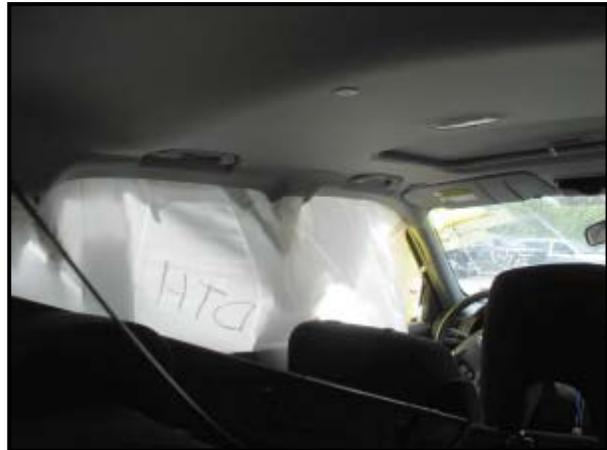
The inflatable side curtain deployed downward from its mounting in the vehicle's roof rail. The rectangular curtain provided coverage that extended from the A- to the C-pillars. Upon deployment, the curtain was inflated by compressed helium stored in a canister located in the roof-rail behind the C-pillar. The gross overall dimensions of the curtain measured 160 cm x 46 cm (63 in x 18 in), length by height, respectively. The curtain was tethered at the A-pillar and to the roof rail between the C- and D- pillars. **Figure 15** is a view of the deployed right side curtain and thorax air bag. **Figure 16** is a view of the deployed left side curtain. There was no residual evidence of occupant contact to the deployed side curtains.

**Figure 16: Deployed left side protection.**
