Certified Advanced 208-Compliant Air Bag Investigation/Vehicle to Vehicle  
Dynamic Science, Inc./Case Number: DS06014  
2006 Volkswagen Jetta  
Nebraska  
May 2006

1. Report No. DS06014	2. Government Accession No.	3. Recipient Catalog No.	
4. Title and Subtitle Certified Advanced 208-Compliant Air Bag Investigation		5. Report Date August 10, 2006

**Dynamic Science, Inc.**  
**Crash Investigation**  
**Case Number: DS06014**

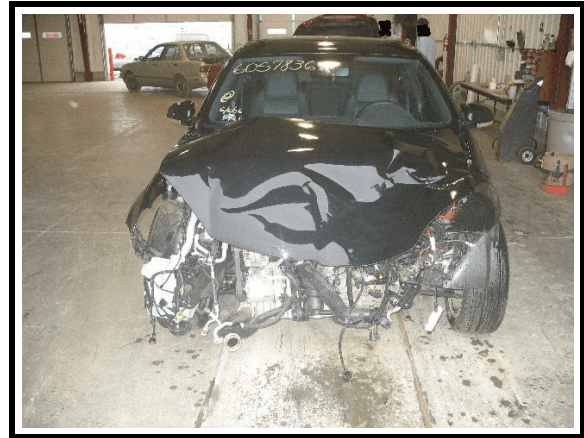
**Figure 1.** Front - 2006 Volkswagen Jetta

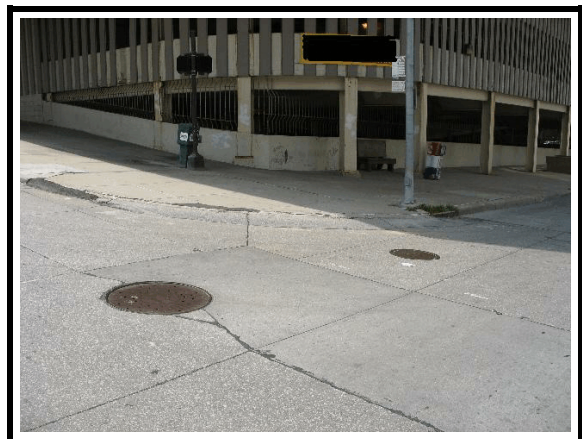
**Figure 4.** General rollover location - 1998 Mercury Mountaineer (northwest)

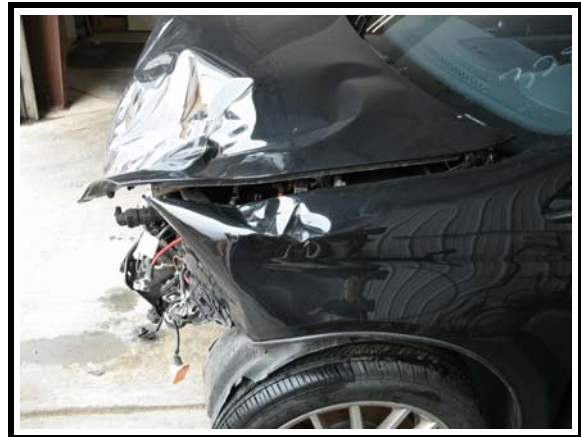
The 2006 Volkswagen Jetta sustained moderate front end damage as a result of the impact with the Mercury Mountaineer. The case vehicle sustained 84.0 cm (33.1 in) of direct damage along the front bumper beginning at the left front bumper corner, extending to the right. The bumper backing bar was no longer with the vehicle and a complete crush profile could not be obtained. Two crush measurements were documented at the left and right bumper mounting brackets as follows: C1=42.0 cm (16.5 in), C2=33.0 cm (13.0 in).

**Figure 5.** Left front damage

CDC:	11FDEW1	
Delta V:	Total	19.0 km/h (11.8 mph)
	Longitudinal	-16.5 km/h (-10.3 mph)
	Latitudinal	9.5 km/h (5.9 mph)
	Energy	22,146 joules (16,334 ft lbs)

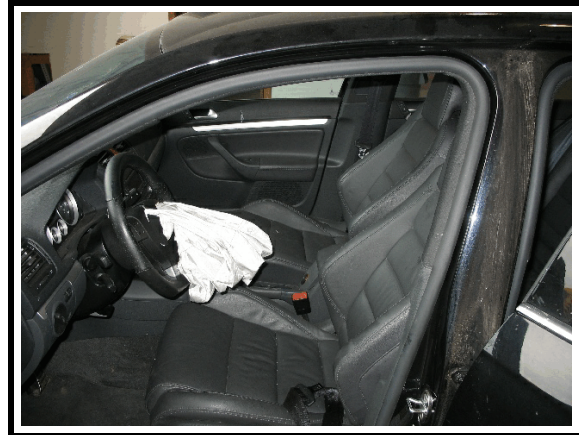
The 2006 Volkswagen Jetta sustained minor interior damage due to normal air bag deployment related damage.

**Figure 6.** Driver's seating area

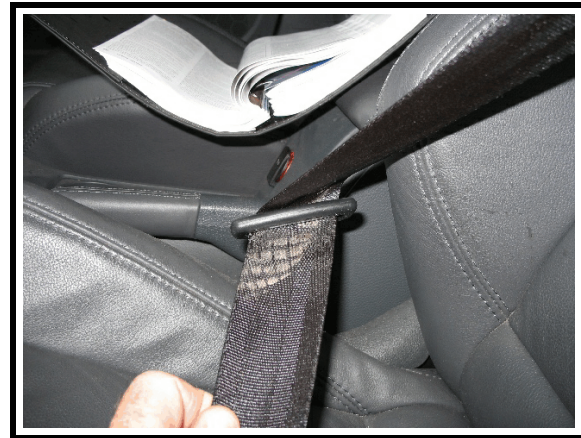
The driver's B pillar seat belt pretensioner actuated during the collision and was locked in place post-crash. There was evidence of occupant loading to the driver's seat belt, located 35.0 cm (13.8 in) from the belt's stop button and 78.0 cm (30.7 in) from the D ring. The second row outboard seating positions were equipped with seat belt retractor pretensioners that actuated during the collision and were locked in place post-crash.

**Figure 7.** Evidence of occupant loading to driver's seat belt

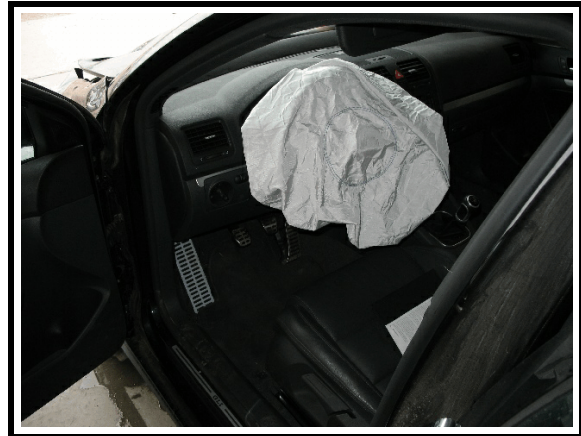
The driver’s air bag was mounted in the center of the steering wheel hub. The air bag module cover flaps had an ‘n’ configuration. The top cover flap was semi-circular in shape and measured 12.0 cm (4.7 in) in width along the upper edge, 6.0 cm (2.4 in) along the lower edge and 3.5 cm (1.4 in) along both sides. The left and right cover flap measurements were as follows: the inner flap edge heights were 7.0 cm (2.8 in), the upper flap edges were 3.5 cm (1.4 in) and the lower flap edges were 2.5 cm (1.0 in). The bottom cover flap measured 6.0 cm (2.4 in) wide and was 11.0 cm (4.3 in) tall. The air bag was circular in shape and measured 50.0 cm (19.7 in) high/wide in its deflated state. The center stitching measured 17.0 cm (6.7 in) in diameter. The air bag had one vent port on the back of the bag at the 12 o’clock position that measured 6.5 cm (2.6 in) in diameter. The material surrounding the vent port was blackened, with the darkened area more pronounced on the left side of the vent port. The air bag was not damaged and showed no sign of occupant contact.

**Figure 8.** Driver’s front air bag

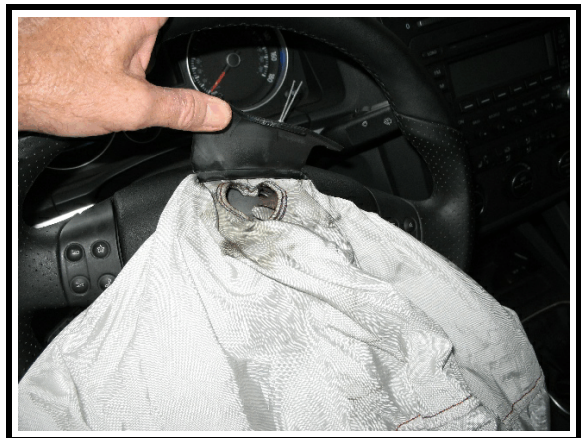
**Figure 9.** Driver’s front air bag vent port

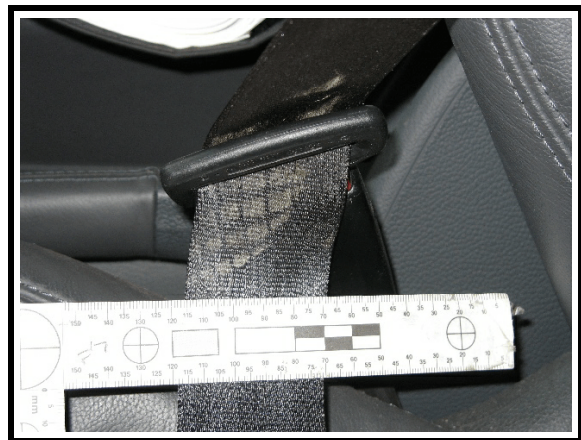
**Figure 10.** Close-up - evidence of occupant loading to driver's seat belt
