Certified Advanced 208-Compliant Air Bag Investigation/Multiple Vehicle  
Dynamic Science, Inc./Case Number: DS06015  
2006 Chevrolet Cobalt  
Nebraska  
April 2006

1. Report No. DS06015	2. Government Accession No.	3. Recipient Catalog No.	
4. Title and Subtitle  Certified Advanced 208-Compliant Air Bag Investigation		5. Report Date August 10, 2006

**Dynamic Science, Inc.**  
**Crash Investigation**  
**Case Number: DS06015**

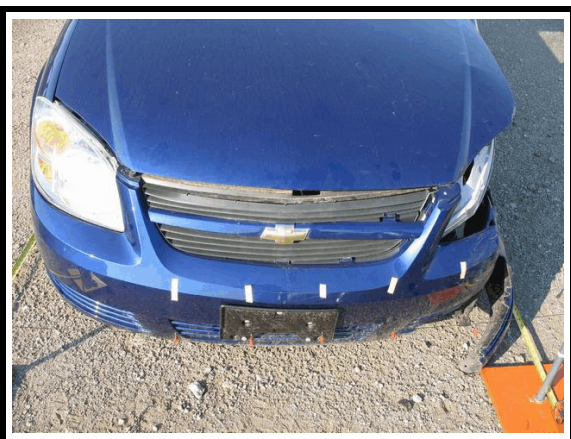
The 2006 Chevrolet Cobalt sustained moderate front end damage as a result of the impact with the Chevrolet Cavalier and the Nissan Quest. The case vehicle sustained 23.0 cm (9.1 in) of direct damage along the front bumper beginning at the left front bumper corner, extending to the right. The direct contact extended 143.0 cm (56.3 in) down the left side of the vehicle. The left front tire was restricted, the tire was debeaded, and the rim was damaged. The left wheelbase was shortened by 8.0 cm (3.1 in). Six crush measurements were documented along the front bumper as follows: C1=3.0 cm (1.2 in), C2=2.0 cm (0.8 in), C3=1.0 cm (0.4 in), C4=0.0 cm (0.0 in), C5=0.0 cm (0.0 in), C6=0.0 cm (0.0 in). The Collision Deformation Classification (CDC) for the impact with the Cavalier was 11FLEE6. The EDR reported estimated principle direction of force was 320 degrees. The damage caused by the impact between the Cobalt and the Quest overlapped with the damage from the first crash event and could only be classified with a partial CDC. The second collision event is likely to have been minor in nature. The Quest was able to be driven away from the crash scene. The Cobalt's electronic data recorder reported that the event recording was complete; it did not record the non-deployment (i.e., 2<sup>nd</sup>) crash event.

CDC:	Impact 1: 11FLEE6	
	Impact 2: 12F9999	
Delta V (Impact 1):	Total	11.0 km/h (6.8 mph)
	Longitudinal	-8.4 km/h (-5.2 mph)
	Latitudinal	7.1 km/h (4.4 mph)
	Energy	7,714 joules (5,690 ft lbs)

**Figure 5.** Front - 2006 Chevrolet Cobalt

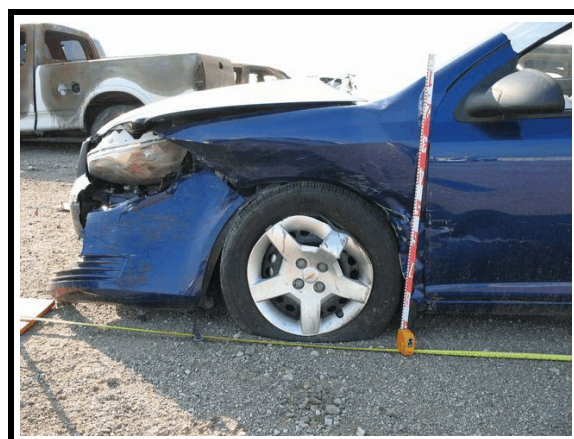
The 2006 Chevrolet Cobalt was equipped with Continental Touring Contact AS P195/60R15 tires. The manufacturer's recommended cold tire pressure could not be determined because the left front door was jammed shut post-crash and the tire placard was inaccessible. The specific tire information is as follows:

Position	Measured Pressure	Measured Tread Depth	Restricted	Damage
LF	Flat	8 mm (10/32 in)	Yes	Rim bent; tire debanded
LR	214 kPa (31 psi)	8 mm (10/32 in)	No	None
RR	200 kPa (29 psi)	9 mm (11/32 in)	No	None
RF	228 kPa (33 psi)	8 mm (10/32 in)	No	None

**Figure 6.** Left front damage - 2006 Chevrolet Cobalt

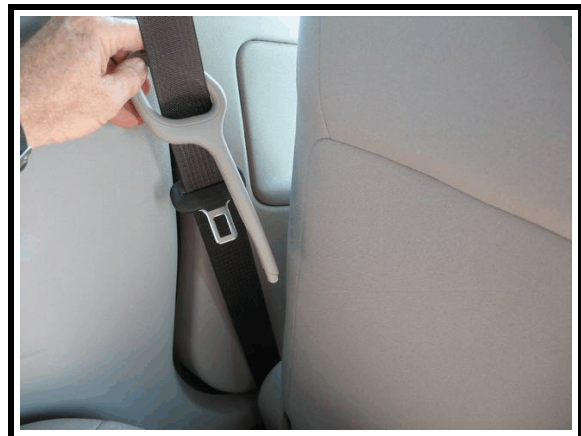
The driver and right front B pillar seat belt pretensioners actuated during the first crash event and were locked in the stowed position post-crash. The driver's plastic seat belt positioning device broke when the retractor pretensioner activated.

**Figure 8.** Broken left front seat belt positioning device (belt not in use at time of crash)

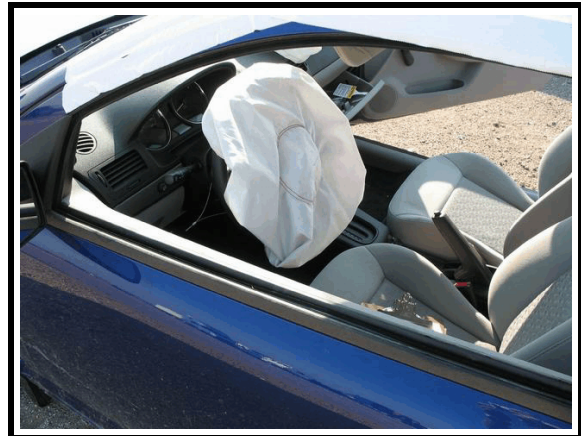
The driver's air bag deployed from the center of the steering wheel hub through symmetrical I-configuration cover flaps. Each flap measured 9.0 cm (3.5 in) wide and had two 2.0 cm (0.8 in) high facets surrounding a semi-circular cutout located in the center of the cover flaps. The deployed driver air bag measured 56.0 cm (22.0 in) in diameter in its deflated state. The air bag was tethered by a single internal strap and there were two circular vent ports located at the 11 and 1 o'clock positions on the rear of the air bag. There was no damage or occupant contact visible on either the cover flap or air bag, although it is likely that the unrestrained driver contacted the bag during the first crash event.

**Figure 10.** Deployed driver's front air bag

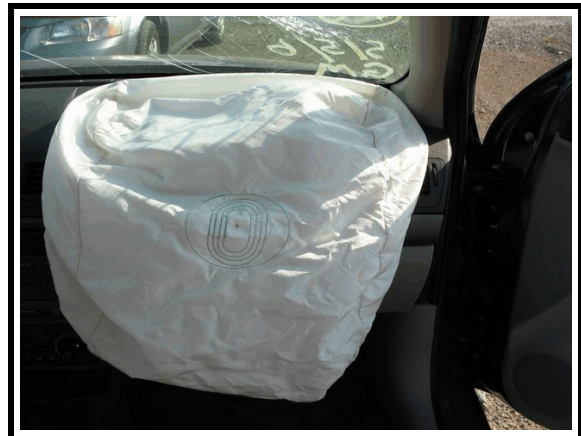
**Figure 11.** Deployed passenger front air bag

The passenger front air bag deployed from a top mounted single air bag module cover flap. The cover flap was generally rectangular in shape and measured 30.0 cm (11.8 in) wide along the top of the cover flap and 31.0 cm (12.2 in) wide along the bottom of the flap. The left side of the cover flap measured 22.0 cm (8.7 in) high and the right side measured 14.0 cm (5.5 in) high. The cover flap was slightly deformed, which likely occurred during the deployment. The air bag had a rectangular shape and measured 43.0 cm (16.9 in) seam to seam laterally and 64.0 cm (25.2 in) in height in its deflated state. The air bag had a maximum excursion of 57.0 cm (22.4 in) in its deflated state. There was one internal tether at the center of the bag and two circular vent ports on the sides of the air bag at the 3 and 9 o'clock positions. There was no occupant contact evidence visible on the cover flap and air bag, although it is likely that the unrestrained right front passenger contacted the bag during the first crash event.

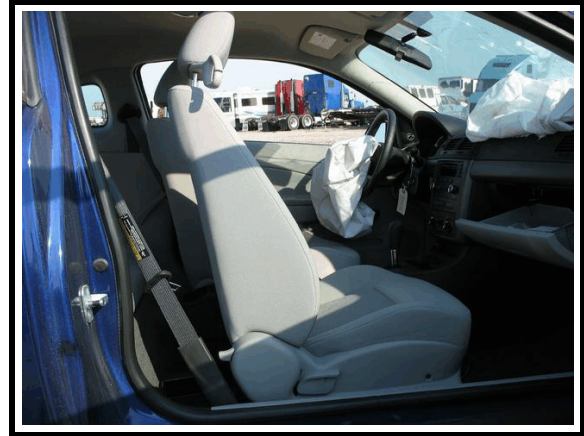
The 17-year-old female passenger appears to have been seated in an upright posture in the fabric covered bucket seat and was not restrained by the available 3-point manual lap and shoulder belt. The seat was adjusted to the center track position. The seat back was reclined at a 74 degree angle and the seat bottom had a 13 degree angle. During the initial impact, the passenger's front air bag deployed and the right side safety belt pretensioner actuated, although the belt was not in use at the time. The female passenger initiated a forward and slightly lateral trajectory towards the 11 o'clock direction of force, likely contacting the deploying passenger air bag. She may have contacted the rearview mirror with her left hand or lower left arm, pushing the mirror into the windshield, cracking it. The case vehicle was deflected to the right from the impact, entered the western leg of the intersection and struck the left front of the stopped Nissan Quest. According to the police report, this passenger sustained a visible injury to her elbow/lower arm/hand but she did not receive any medical treatment at the scene and was not transported.

**Figure 13.** Front right passenger's seating area

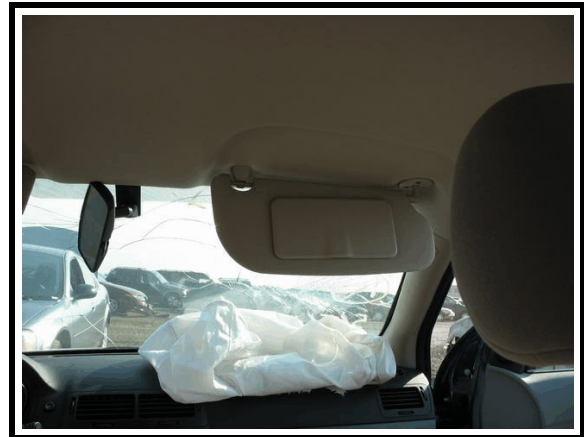
There was no intrusion and no integrity loss. The windshield was cracked near the rearview mirror. It is possible that the unrestrained right front passenger may have contacted the rearview mirror with her left lower arm and/or hand, causing the mirror to rotate left and impact the windshield. There was also damage in the lower right section of the windshield due to contact from the deploying passenger front air bag cover flap. The right front door remained closed and operational. The left front door was jammed shut due to damage.

**Figure 14.** Possible occupant contact to rearview mirror
