Advanced Occupant Protection/Knee Air Bag Investigation/Vehicle to Objects  
Dynamic Science, Inc./Case Number: DS06017  
2005 Toyota Avalon  
Arizona  
July 2006

1. Report No. DS06017	2. Government Accession No.		3. Recipient Catalog No.	
4. Title and Subtitle Advanced Occupant Protection/Knee Air Bag Investigation			5. Report Date September 20, 2006

**Dynamic Science, Inc.**  
**Crash Investigation**  
**Case Number: DS06017**

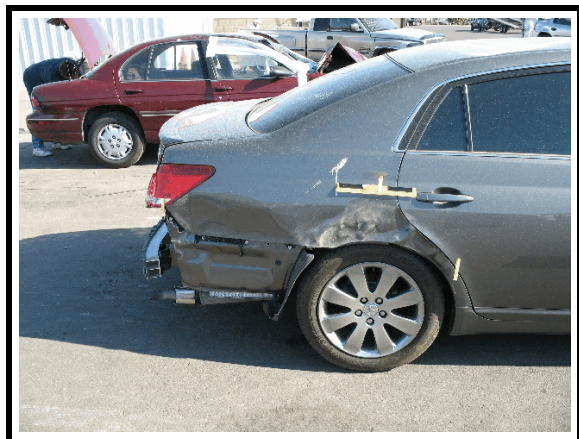
**Figure 2.** Right rear damage - 2005 Toyota Avalon

It appears that the case vehicle sideswiped one of the fence posts, resulting in minor right side damage. The Avalon sustained 130.0 cm (51.2 in) of direct damage along the right side of the vehicle beginning 38.0 cm (15.0 in) forward of the left rear axle, extending forward. The maximum lateral crush from this crash event was 3.0 cm (1.2 in). The location of maximum crush was above the right rear tire. The CDC for this impact was 12RZES1.

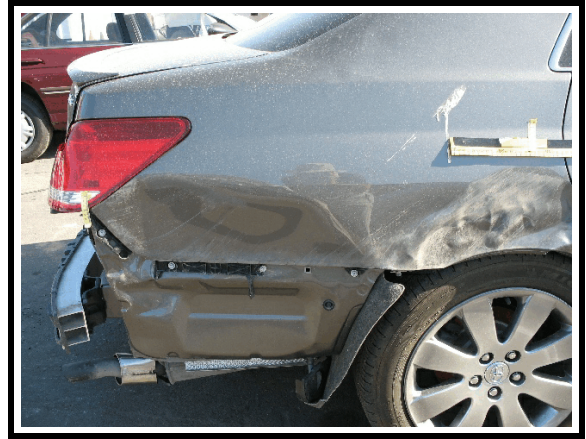
Figure 9. End of right rear damage

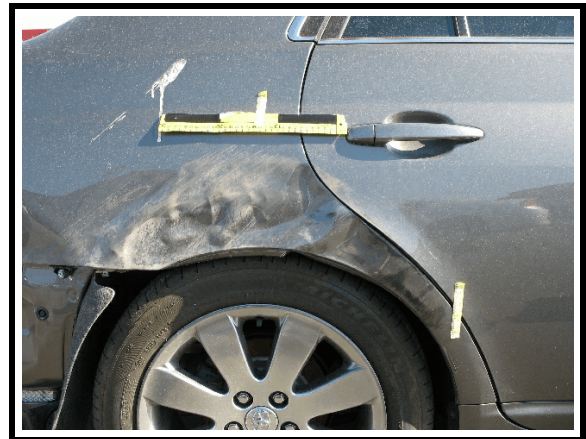
Figure 10. Beginning of right rear damage

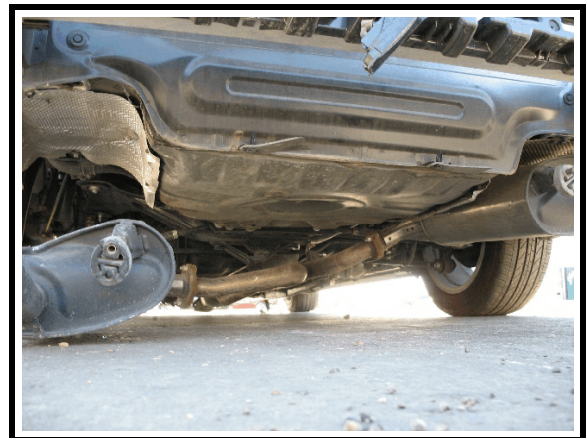
The Avalon sustained light damage to the undercarriage as a result of impacting the roadway during the crash events. The left muffler was knocked loose and the rear bumper fascia was no longer attached to the vehicle. The CDC for this impact was 00UDDW2.

Figure 11. Undercarriage damage

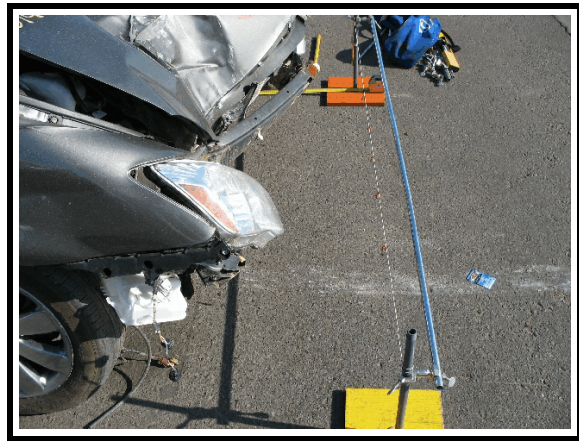
The Avalon sustained moderate front end damage as a result of the impact with the utility pole. The vehicle sustained 38.0 cm (15.0 in) of direct damage along the front bumper, beginning 54.0 cm (21.3 in) right of the left front bumper corner, extending to the right. The right front tire was restricted and the right wheelbase was shortened

by 5.0 cm (2.0 in). The left wheelbase was lengthened by 2.0 cm (0.8 in). The bumper cover and energy absorbing styrofoam were no longer attached to the vehicle. An exemplar vehicle was located and measured so that the appropriate freespace could be subtracted from the front crush profile. Six crush measurements were documented along the front bumper as follows: C1=0.0 cm (0.0 in), C2=17.0 cm (6.7 in), C3=43.0 cm (16.9 in), C4=55.0 cm (21.7 in), C5=51.0 cm (20.1 in), C6=18.0 cm (7.1 in). The location of maximum crush was C4. The CDC for this impact was 12FZEN3.

**Figure 12.** Front crush profile

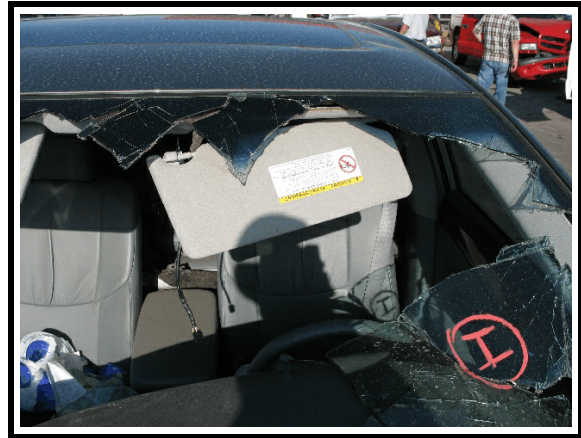
There was integrity loss to the passenger compartment. The windshield was out-of-place and holed from impact forces. At the inspection, parts of the windshield were laying on the instrument panel and other sections were found in the front and second rows of the passenger compartment. None of the other glazing was damaged and showed no sign of occupant contact. The Avalon's four doors remained closed and operational.

Figure 14. Windshield damage - left side

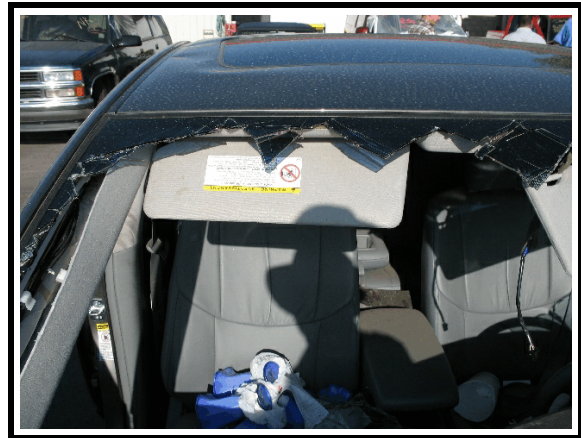
Figure 15. Windshield damage - right side

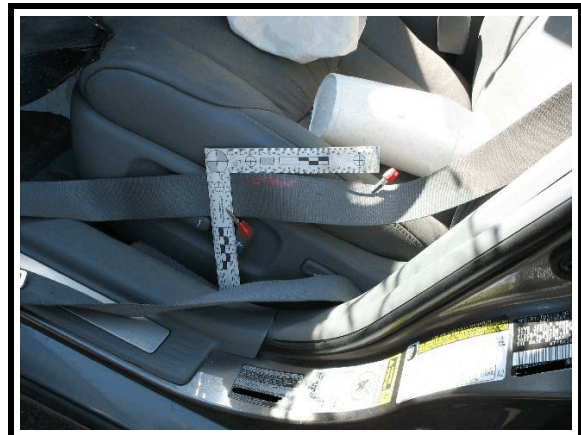
The driver's seat belt retractor pretensioner actuated during the impact between the case vehicle and the utility pole and was locked in place post-crash. The seat belt was being worn by the driver and showed signs of occupant loading near the D ring. There was a red transfer found on the shoulder portion of the driver's seat belt.

Figure 16. Transfer to the driver's seat belt

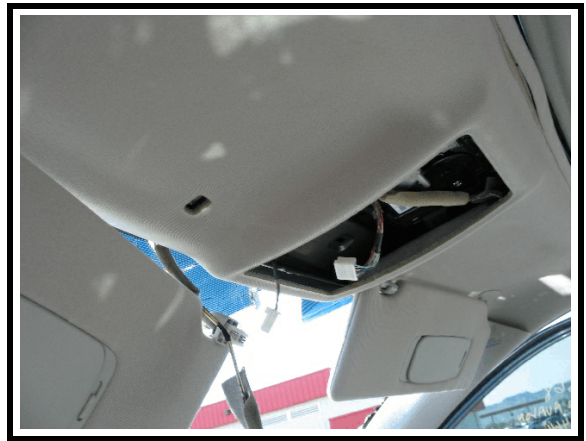
The rearview mirror was no longer attached to the windshield and the roof mounted light panel was out of position. There was a small amount of blood found on the front of the deployed driver's front air bag. The blood likely came from a nose laceration the driver sustained during the crash.

**Figure 17.** Roof mounted light and rearview mirror displaced

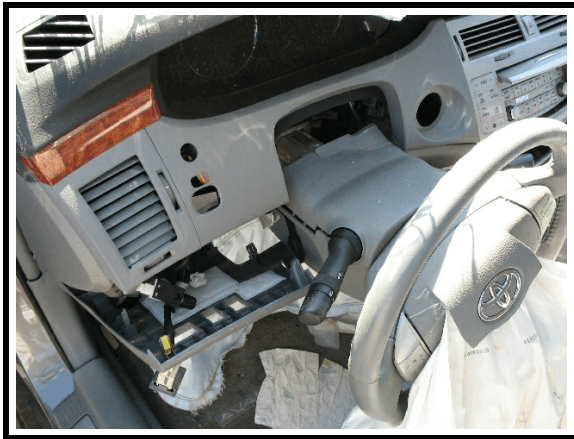
There was longitudinal intrusion of the left instrument panel into the passenger compartment. The specific passenger compartment intrusion was documented as follows:

Row/Position	Intruded Component	Magnitude of Intrusion	Direction
1L	Instrument Panel	10.0 cm (3.9 in)	Longitudinal

**Figure 18.** Instrument panel damage/intrusion & shear module separation

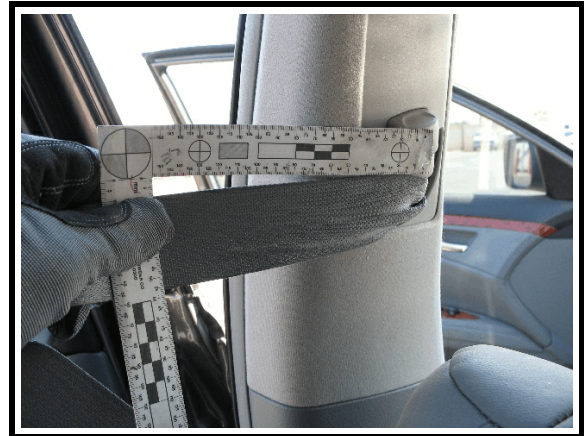
**Figure 20.** Evidence of loading to driver's seat belt

The driver's seat belt showed obvious signs of occupant loading near the D ring and there was a red transfer found on the driver's shoulder belt. The source of the transfer is not known. The driver reported that he was wearing a white T-shirt and shorts on the day of the crash.

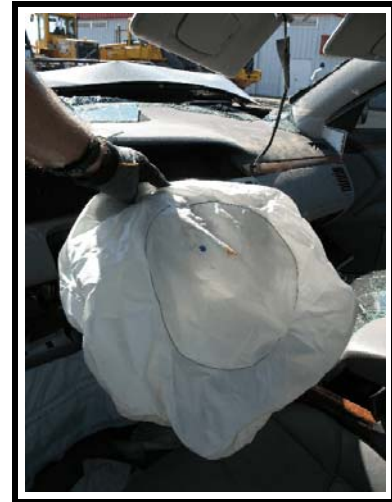
The driver's air bag deployed from the center of the steering wheel hub through H-configuration cover flaps. Both cover flaps measured 15.0 cm (5.9 in) in width and 7.0 cm (2.8 in) in height. The deployed driver air bag measured 58.0 cm (22.8 in) in diameter in its deflated state and the center stitching had a diameter of 29.0 cm (11.4 in). The air bag was tethered by a single internal strap and there were two vent ports located at the 12 o'clock position on the rear of the air bag. There was a small amount of blood on the front of the air bag, which was likely from a nose laceration the driver sustained during the crash. There was no damage or occupant contact visible to the cover flaps.

**Figure 21.** Deployed driver's front air bag

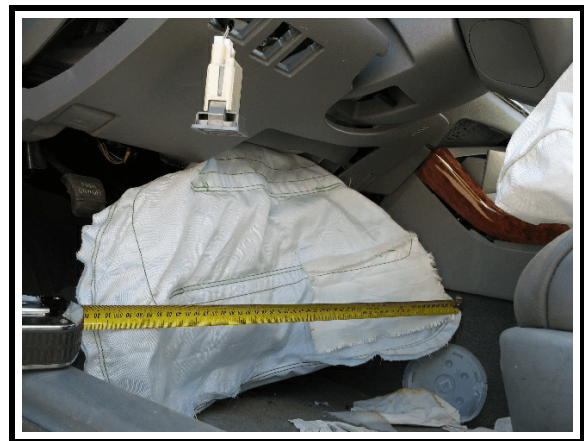
The driver's knee air bag was mounted below the steering column. The air bag module had an H configuration. Both cover flaps measured 29.0 cm (11.4 in) in width. The top flap measured 5.0 cm (2.0 in) high, the bottom flap measured 6.0 cm (2.4 in) high. The air bag was semi-rectangular in shape. The top section of the bag measured 30.0 cm (11.8 in) wide. The bottom section was 54.0 cm (21.3 in) wide. The height of the bag was 28.0 cm (11.0 in). There was a piece of fabric made of the same material as the air bag that was sewn onto the lower right section of the bag and measured 20.0 cm (7.9 in) wide by 12.0 cm (4.7 in) high. The knee air bag did not have tethers or vent ports. The knee air bag and cover flaps showed no signs of damage or occupant contact.

**Figure 22.** Deployed driver's knee air bag

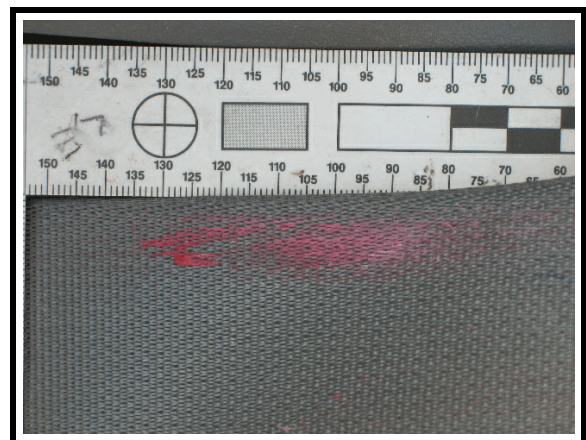
**Figure 23.** Close-up of transfer to driver's seat belt
