ON-SITE SIDE IMPACT INFLATABLE OCCUPANT PROTECTION INVESTIGATION

CASE NUMBER - IN-06-018

VEHICLE - 2006 MINI COOPER

CRASH DATE - May 2006

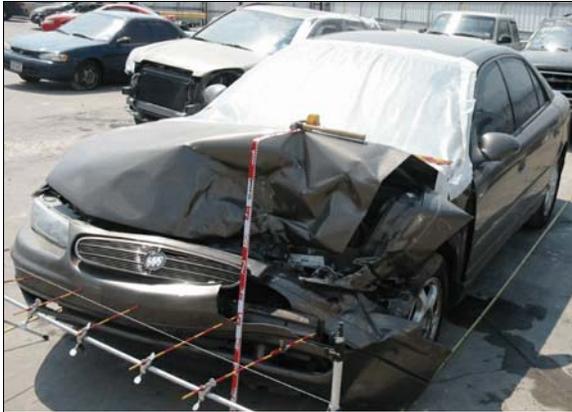
Figure 2: Overview of front damage to Buick from impact with back of case vehicle, vertical scale in tenths of meter, each increment on rods is 5 cm (2 in)

Exterior Damage: The Buick's impact with the back of the case vehicle involved the front left portion of the vehicle. The front bumper, grille, hood, left headlamp/turn signal assembly and left fender were directly damaged and crushed rearward. Direct damage began at the front left bumper corner and extended 44 centimeters (17.3 inches) across the bumper. Crush measurements were taken at the bumper level and the maximum residual crush was measured as 29 centimeters (11.4 inches) occurring at C₂. The table below shows the Buick's front crush profile.

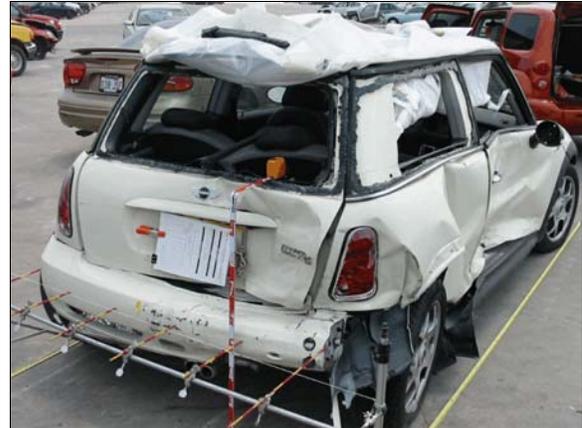
Figure 3: Overview of damage to back of case vehicle from impact with Buick and damage to right front door from impact with Subaru

Exterior Damage: The case vehicle's impact with the Buick (event 1) involved approximately the right half of the case vehicle's back end. The back bumper, hatch and back of the right quarter panel were directly damaged and crushed forward. The direct damage began at the back right bumper corner and extended 68 centimeters (26.8 inches) across the back bumper. The residual maximum crush was measured as 11 centimeters (4.3 inches) occurring at C₅ (**Figure 6**). The table below shows the case vehicle's back crush profile.

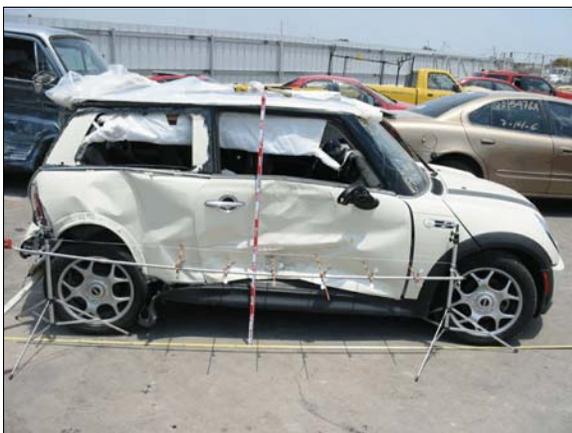
Figure 4: Damage to case vehicle’s right front door from impact with Subaru and induced damage to right quarter panel from back impact with Buick

The case vehicle's right side impact with the back left corner of the Subaru (event 2) involved the right front door and quarter panel. The right front door and a small area of the right quarter panel behind the right front door were directly damaged and crushed inward. The direct damage ended 73 centimeters (28.7 inches) rear of the right front axle and was measured as 96 centimeters (37.8 inches) in length. The residual maximum crush was measured as 18 centimeters (7.1 inches) occurring at C₃ (Figure 7). The table below shows the case vehicle's right side crush profile.

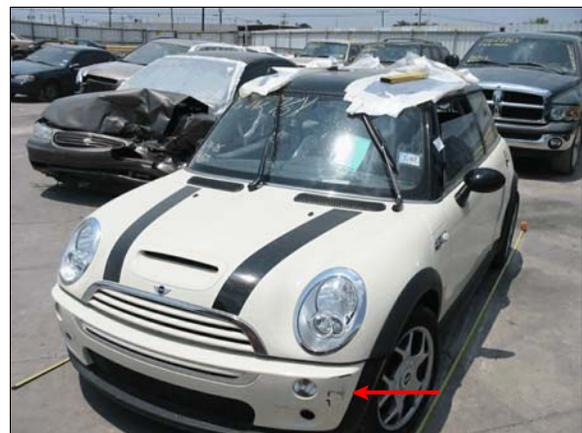
Figure 5: Arrow shows damage to front left bumper corner from impact with concrete median barrier

front left corner sustained a minor impact (**Figure 5** above) to the concrete median barrier (event 3). Deployment of the case vehicle's front air bags did not occur in this crash because the front impact with the barrier was not severe enough to require their deployment.

The case vehicle's front impact with the concrete median barrier involved the left corner of the front bumper. The direct damage began at the left bumper corner and extended approximately 8 centimeters (3.1 inches) across the bumper corner. There was no residual crush due to this impact.

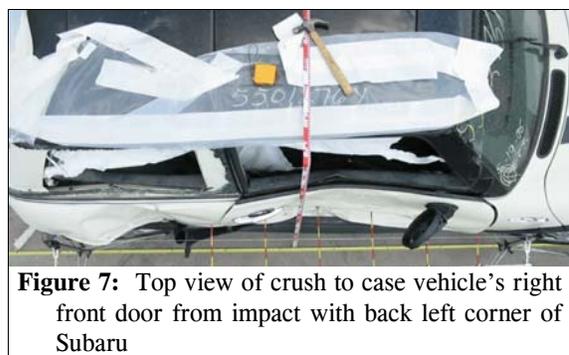
Figure 7: Top view of crush to case vehicle's right front door from impact with back left corner of Subaru

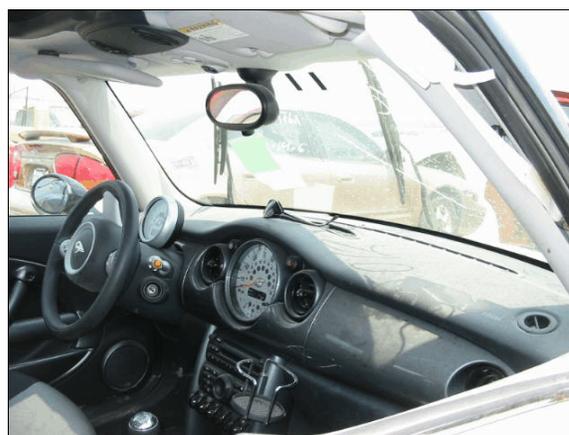
Vehicle Interior: Inspection of the case vehicle's interior (**Figure 8** and **Figure 9**) revealed no evidence of occupant contact to any of the interior surfaces or components. Intrusions involved the right front door, which intruded laterally 6 centimeters (2.4 inches) as did the right side panel rear of the "B"-pillar. In addition, the front seat backs intruded into the back seat area. Finally, there was no evidence of compression of the energy absorbing steering column or deformation of the steering wheel rim.

Figure 8: Overview of case vehicle's instrument panel, windshield and steering wheel

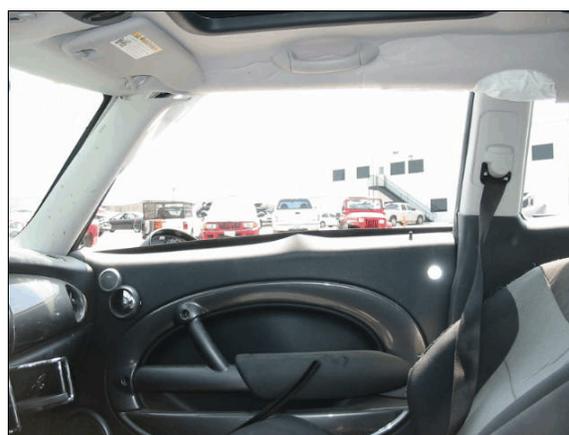
Figure 9: Case vehicle's right front door and side curtain air bag tucked into headliner

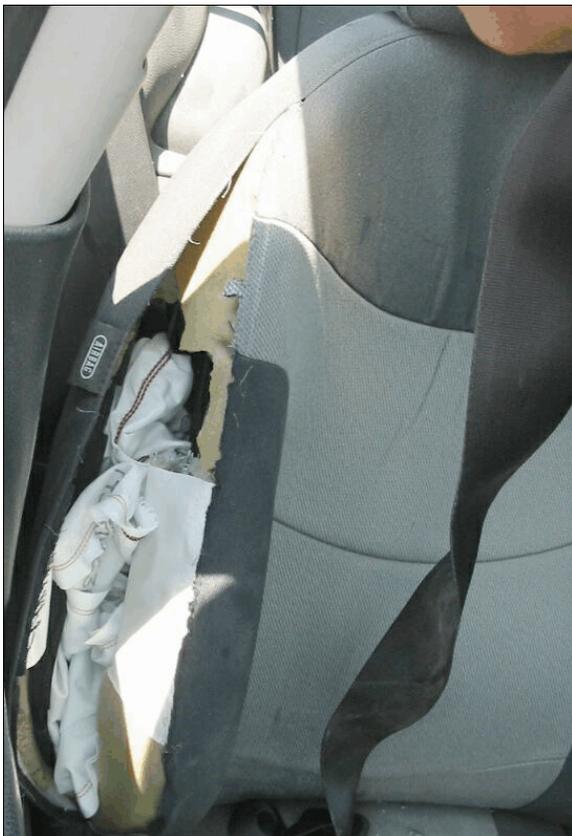
The front right passenger's seat back-mounted side impact air bag was located in the front right seat back (**Figure 10**). The deployed air bag was approximately oval in shape (**Figure 11**). The overall dimensions of the air bag were approximately 54 centimeters (21.3 inches) in height and 24 centimeters (9.5 inches) in width. The air bag was designed without tethers and vent ports. There was no module flap on the side of the seat back. The air bag deployed through a tear-seam in the side of the seat back. There was no evidence of damage to the air bag due to deployment. However, there were a few small holes in the outside surface of the air bag due to cuts from flying tempered glass fragments from the right front window. There was no evidence of occupant contact on the air bag. However, a few blood spots were found on the inside surface of air bag, which most likely came from a laceration the front right passenger sustained to her right upper arm due to flying side window glass fragments.

Figure 10: Case vehicle's front right passenger seat back-mounted air bag located in right side of seat back

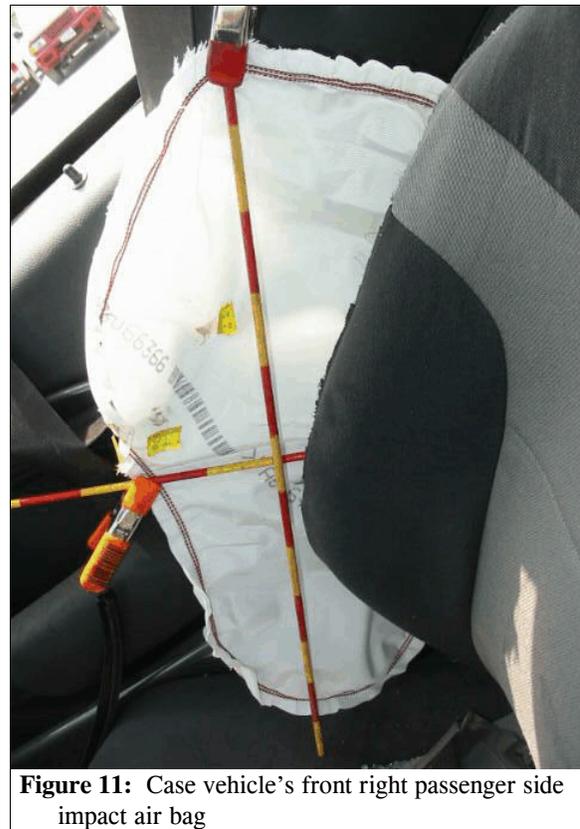
Figure 11: Case vehicle's front right passenger side impact air bag

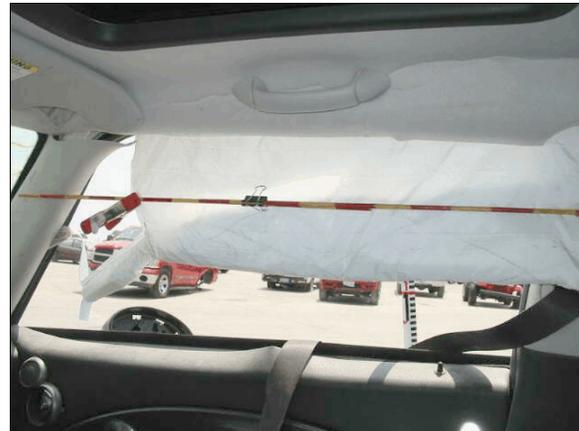
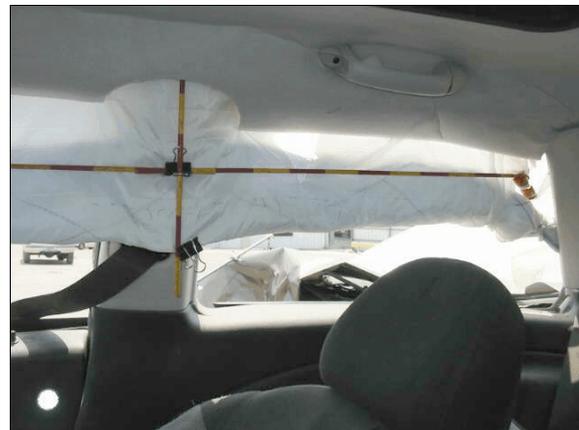
The right side curtain air bag was located along the right roof side rail (**Figures 12 and 13**) inside the headliner and extended along the front right and back right seat positions. The air bag appeared to be tubular-shaped. It was constructed of nylon mesh and was located inside an outer nylon bag (**Figure 14**). The air bag was anchored to the upper right “A”-pillar by an approximate 16 centimeters (6.3 inches) long nylon cord and to the right “C”-pillar by another nylon cord. The outer nylon bag was approximately 125 centimeters (49.2 inches) in length and approximately 21 centimeters (8.3 inches) in height. There was no evidence of occupant contact to the side curtain air bag.

Figure 12: Front portion of case vehicle’s right side curtain air bag

Figure 13: Back portion of case vehicle’s right side curtain air bag

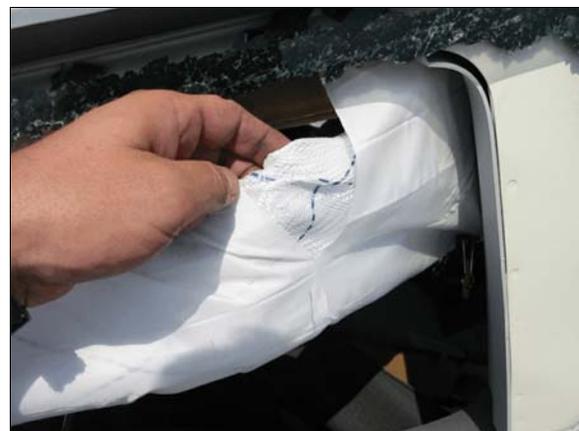
Figure 14: Mesh inner lining of side curtain air bag located inside outer nylon bag

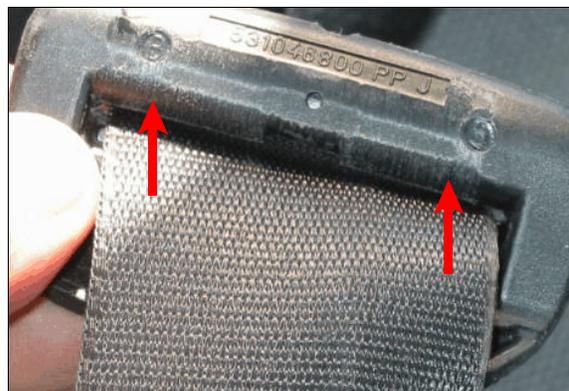
Based on the case vehicle inspection, the front right passenger was restrained by her manual, three-point, lap-and-shoulder, safety belt system. A load abrasion was found on the latch plate belt guide (**Figure 15** below). In addition, the buckle-mounted pretensioner had actuated.

Figure 15: Load abrasions on case vehicle’s front right passenger latch plate belt guide

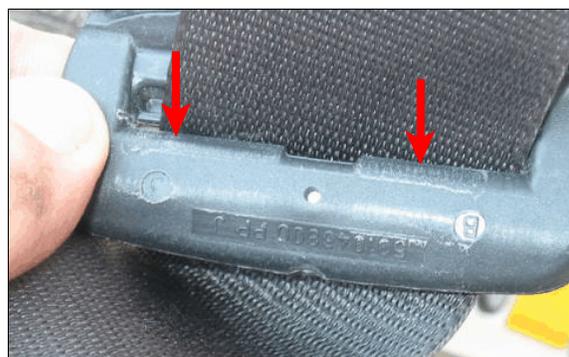
Figure 16: Load abrasion on case vehicle driver's latch plate belt guide

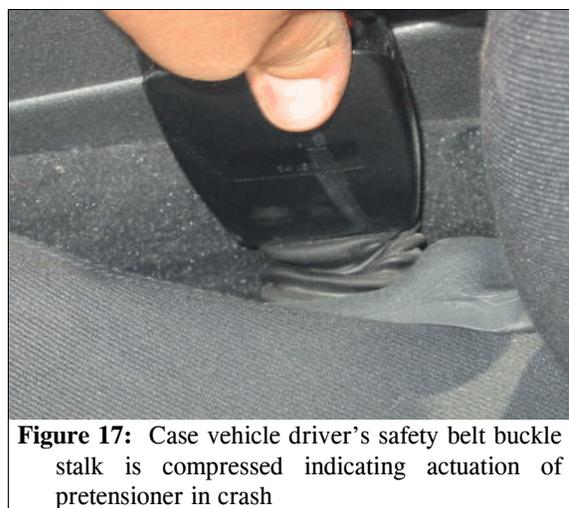
Based on the case vehicle inspection, the driver was restrained by his manual, three-point, lap-and-shoulder, safety belt system. A load abrasion was found on the latch plate belt guide (Figure 16). In addition, the buckle-mounted pretensioner had actuated (Figure 17).

Figure 17: Case vehicle driver's safety belt buckle stalk is compressed indicating actuation of pretensioner in crash
