ON-SITE VEHICLE ROLLOVER INVESTIGATION

CASE NUMBER - IN-06-019

VEHICLE - 2006 HYUNDAI TIBURON GL

CRASH DATE - May 2006

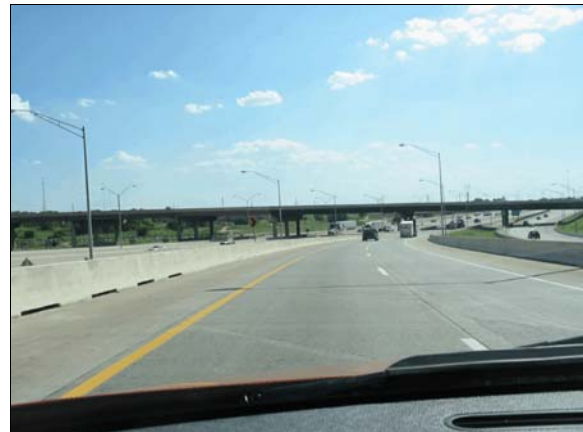
Pre-Crash: The case vehicle was traveling southwest in the outside through lane (**Figure 1**), and the driver was intending to continue southwestbound. A second vehicle was overtaking the case vehicle in the inside through lane. The initial impact occurred in the outside through lane. The case vehicle's driver most likely took no actions to avoid the initial impact.

Figure 1: Overview of case vehicle's southwestbound approach, police crash report indicates case vehicle was initially southwestbound in outside lane

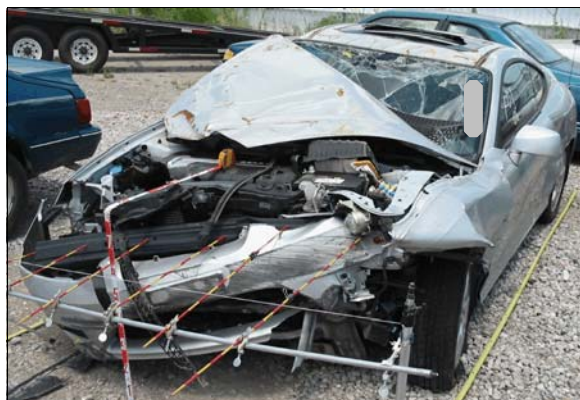
Figure 2: Damage to front of case vehicle from concrete median barrier impact and to top plane from rollover, increments on vertical scale are in tenths of meter, each increment on rods is 5 cm (2 in)

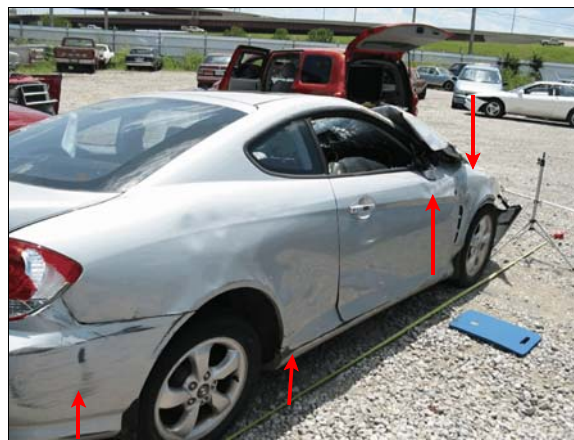
passenger air bags to deploy. The case vehicle's calculated impact speed range was approximately 72 to 77 km.p.h. (45 to 48 m.p.h.). The front left of the case vehicle then rode up the median barrier causing the case vehicle to roll over (event 3) two quarter rolls onto its right side (Figures 3 and 4) and onto its top (Figure 5).

Figure 3: Overview of rollover damage (arrows) to right side of case vehicle

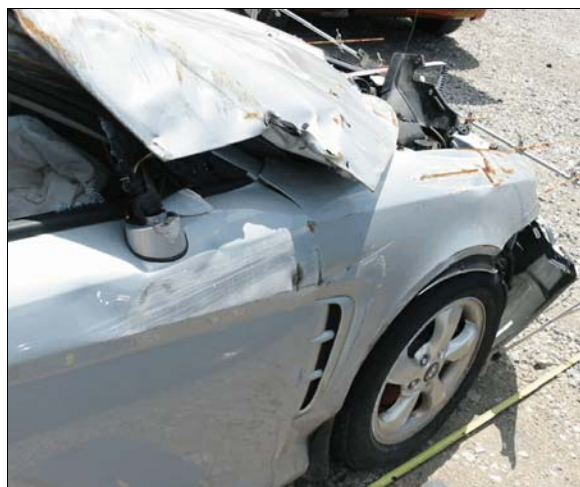
Figure 4: Rollover damage to right fender, hood, and right front door

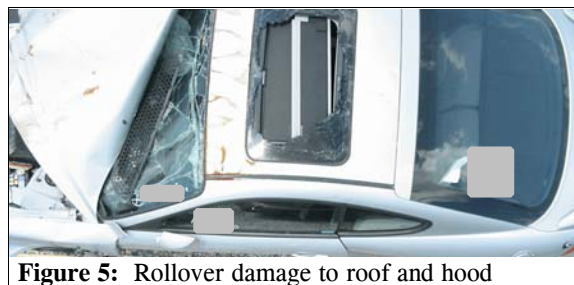
Figure 5: Rollover damage to roof and hood

vertical crush occurred in the center of the roof between the sunroof and windshield header and was approximately 3 centimeters (1.2 inches). There was no lateral roof displacement. The direct damage from the rollover also involved the right fender, right front door, right sill, right quarter panel and right side of the back bumper fascia. In addition, there were grinding marks on the rims of the right front and right rear wheels.

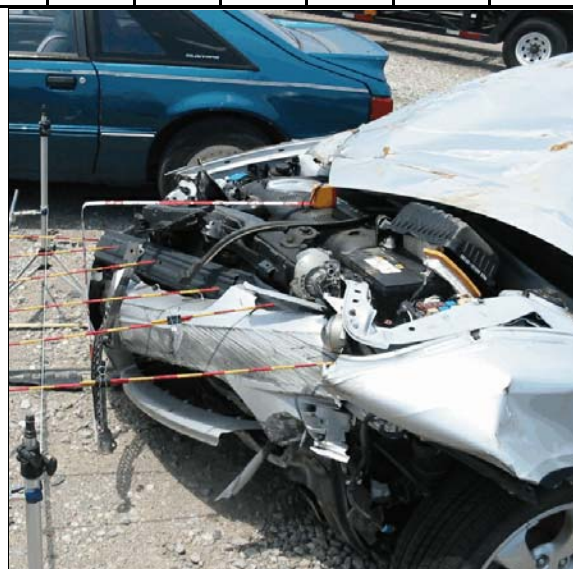
The case vehicle’s impact with the median barrier (event 2) involved the front of the case vehicle. The front bumper, hood, left headlamp/turn signal assembly and front of the left fender were directly contacted and crushed rearward. The direct damage began at the front left bumper corner and extended 116 centimeters (45.7 inches) across the bumper. Crush measurements were taken at the bumper and the maximum residual crush was measured as 51 centimeters (20.1 inches) occurring at C₁ (**Figure 6**). The table below shows the case vehicle’s front crush profile.

Figure 6: Crush to case vehicle’s front bumper from impact with concrete median barrier

Units	Event	Direct Damage		Field L	C ₁	C ₂	C ₃	C ₄	C ₅	C ₆	Direct	Field L
		Width CDC	Max Crush								±D	±D
cm	2	116	51	119	51	49	45	28	23	0	-13	0
in		45.7	20.1	46.9	20.1	19.3	17.7	11.0	9.1	0.0	-5.1	0.0

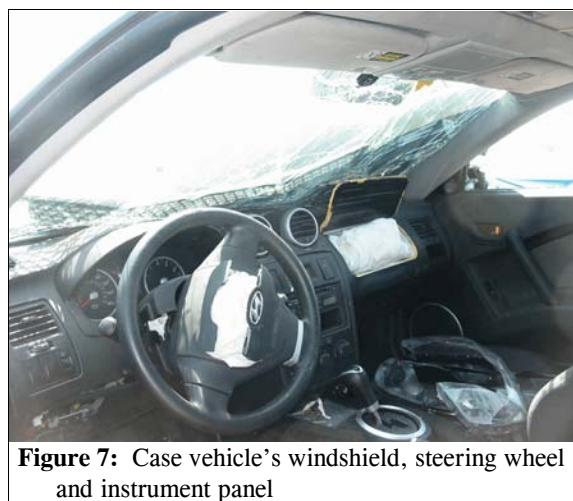
Vehicle Interior: Inspection of the case vehicle’s interior (**Figure 7**) revealed occupant contact to the knee bolster on both sides of the steering wheel. The knee bolster was loose and the fuse panel cover was knocked off. In addition, the steering column was displaced forward, which separated the plastic steering column housing at its assembly seam (**Figure 8** below), indicating the driver rode down the air bag during the impact with the median barrier and loaded the steering assembly. There was also 2 centimeters (0.8) of deformation of the upper half of the steering wheel. Lastly, the windshield intruded vertically 8 to 15 centimeters (3.1 inches to 6 inches) into the left, middle and right zones of the front seating row. The windshield header also intruded vertically approximately 3 centimeters (1.2 inches) into the center zone of the front seating area.

Figure 7: Case vehicle’s windshield, steering wheel and instrument panel

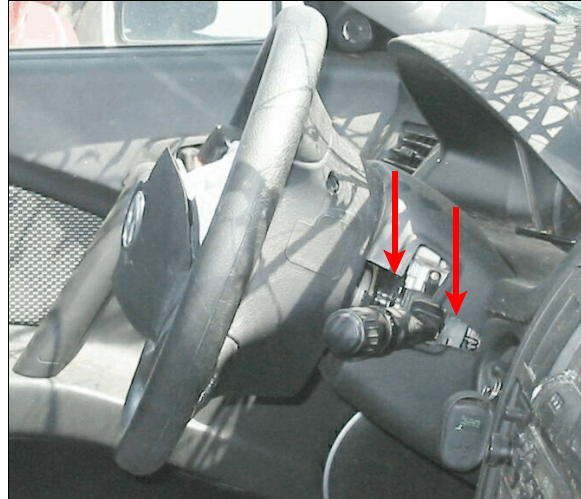
Figure 8: Case vehicle's energy absorbing steering column was compressed separating the steering column cover at assembly seam (arrows)

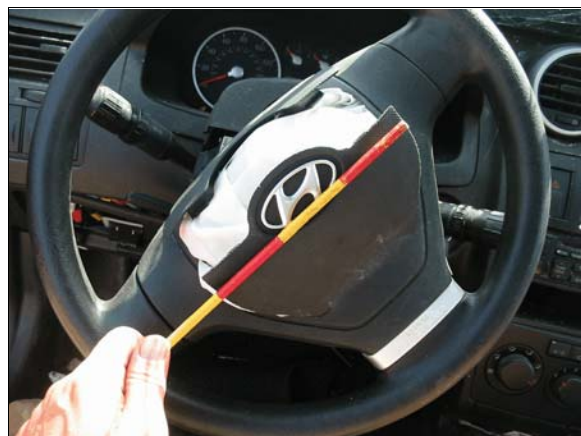
The case vehicle's driver air bag was located in the steering wheel hub. The air bag module cover consisted of two approximately triangular-shaped cover flaps (**Figure 9**) separated by a horizontal tear seam. They were constructed of pliable vinyl. The upper flap's overall dimensions were 15.5 centimeters (6.1 inches) in width and 4 centimeters (1.6 inches) in height. There was a semi-oval cut-out at the bottom center of the flap to accommodate the manufacturer's logo located in the top center of the lower flap. The overall dimensions of the bottom flap were 15.5 centimeters (6.1 inches) in width and 10 centimeters (3.9 inches) in height along the center of the flap. An inspection of the air bag module cover flaps and the air bag fabric revealed that the cover flaps opened at the designated tear points. There was no evidence of damage during the deployment to the air bag module cover flaps or the air bag. The deployed driver's air bag

Figure 9: Case vehicle driver's air bag module cover flaps

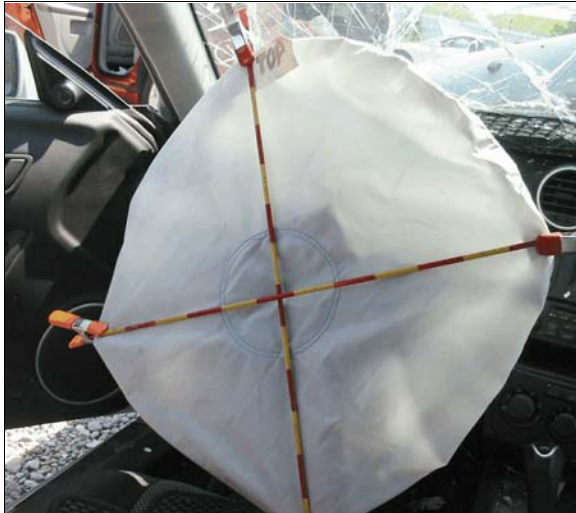
(**Figure 10**) was round with a diameter of approximately 62 centimeters (24.4 inches). The air bag was designed with two tethers, each approximately 12 centimeters (4.7 inches) in width and had two vent ports (**Figure 11**), each approximately 3.5 centimeters (1.4 inches) in diameter, located at the 10:30 and 1:30 o'clock positions. The distance between the mid-center of the driver's seat back, as positioned as the time of the vehicle inspection (i.e., seat between middle and forward-most track position, seat back slightly reclined), and the front surface of the air bag's fabric at approximate full excursion was 24 centimeters (9.4 inches). Inspection of the air bag fabric revealed no evidence of occupant contact.

Figure 10: Case vehicle's driver air bag

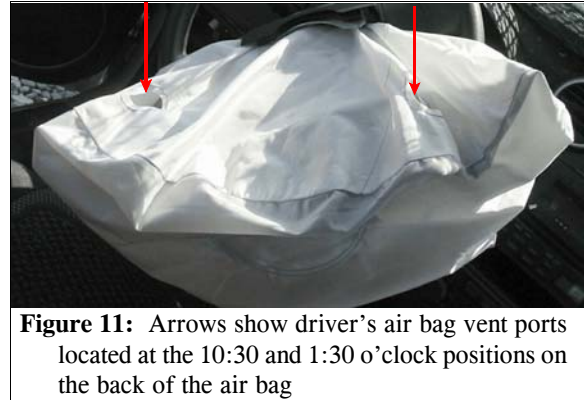
Figure 11: Arrows show driver's air bag vent ports located at the 10:30 and 1:30 o'clock positions on the back of the air bag

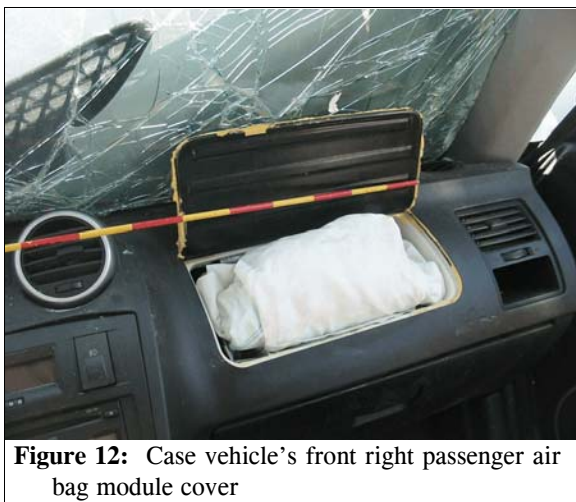
Figure 12: Case vehicle's front right passenger air bag module cover

The front right passenger air bag was located in the top of the instrument panel (**Figure 12**). The air bag module cover consisted of a single rectangular cover flap constructed of plastic and covered with thin, padded vinyl. Its overall dimensions were 30 centimeters (11.8 inches) in width and 15 centimeters (5.9 inches) in height. An inspection of the cover flap (**Figure 12**) and the air bag fabric revealed that the cover flap opened at the designated tear points. There was no evidence of damage during the deployment to the air bag module cover flap or the air bag. The deployed front right passenger's air bag (**Figure 13**) was rectangular in shape and was

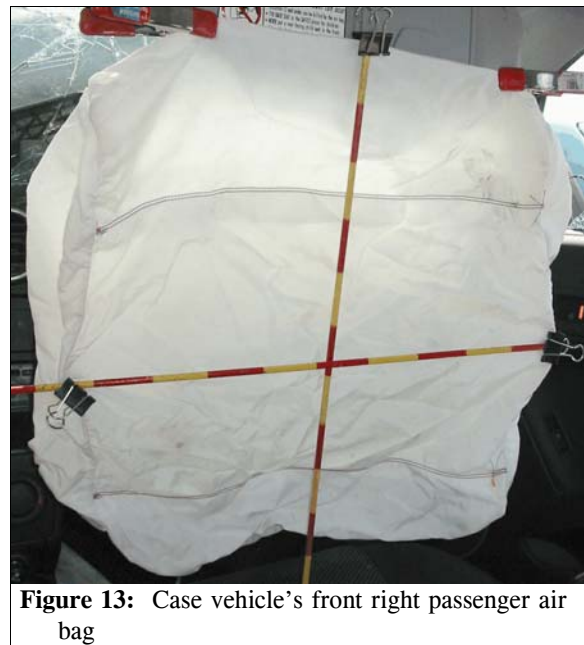
Figure 13: Case vehicle's front right passenger air bag

approximately 56 centimeters (22 inches) in height and 47 centimeters (18.5 inches) in width. The air bag was designed with two tethers, each approximately 40 centimeters (15.7 inches) in width and had two vent ports, each approximately 4.5 centimeters (1.8 inches) in diameter, located at the 8:00 and 4:00 o'clock positions. The distance between the mid-center of the front right passenger's seat back, as positioned as the time of the vehicle inspection (i.e., seat at forward-most track position, seat back slightly reclined), and the front surface of the air bag's fabric at approximate full excursion was 34 centimeters (13.3 inches). Inspection of the air bag was unremarkable with the exception of a few areas of dirt and grease that may have been related to post-crash handling of the air bag.
