Child Safety Seat Fatality Investigation / Vehicle to Pole
Dynamic Science, Inc. / Case Number: DS06020
2006 Toyota Matrix
California
September 2006

1. Report No. DS06020	2. Government Accession No.		3. Recipient Catalog No.	
4. Title and Subtitle Child Safety Seat Fatality Investigation			5. Report Date February 10, 2007

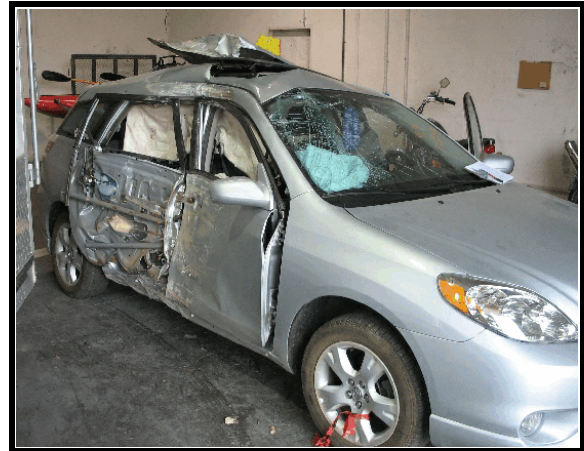
Figure 1. Damaged 2006 Toyota Matrix

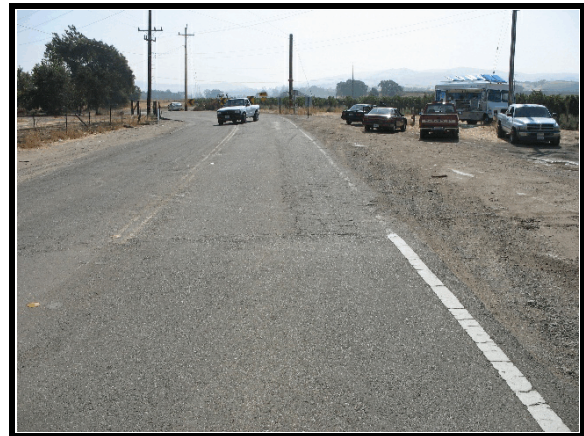
This single vehicle crash occurred in September 2006 at 1028 hours. The crash occurred in a semi-rural area of northern California. At the time of the crash, there were no adverse weather conditions and the worn asphalt surface was dry. The east/west roadway was configured with a single lane in each direction that were separated by a dashed yellow painted centerline. The roadway is bordered on both sides by dirt/gravel shoulders separated from the roadway by solid white lines. The approach to the crash site was straight. Just prior to the road departure and pole impact, the roadway curves to the left. There is a positive 5.8% roadway superelevation at the area of departure and a negative 10.2% for the area adjacent to the roadway approaching the pole. The pole was 2.7 m (8.8 ft) off the roadway and was 36.0 cm (14.2 in) wide. The posted speed limit was 72 km/h (45 mph).

Figure 3. Approach to pole impact

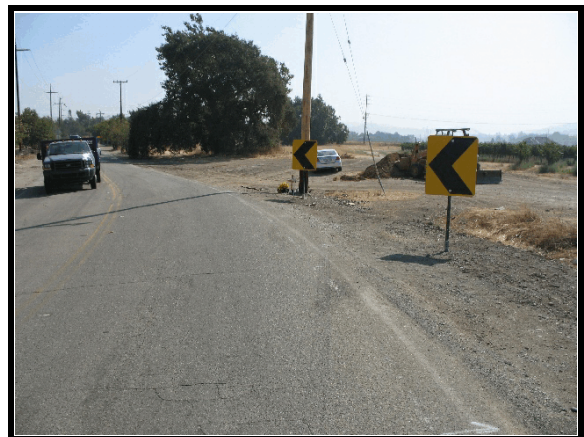
The 2006 Toyota Matrix was traveling westbound. The Matrix was occupied by a properly restrained 23-year-old female driver, a properly restrained 36-year-old female front right seat occupant, a 5-year-old female second row left occupant, and a 6-year-old female second row right occupant. The two rear seat occupants were seated in Cosco Alpha Omega convertible child safety seats that were being used as booster seats. Both occupants were improperly restrained; the vehicle shoulder harnesses had been placed behind the respective child safety seats. As the vehicle entered the left hand curve, the driver lost control of the vehicle and departed the roadway on the right side.

Figure 4. Area of roadway departure and impact with pole (pole has been replaced)

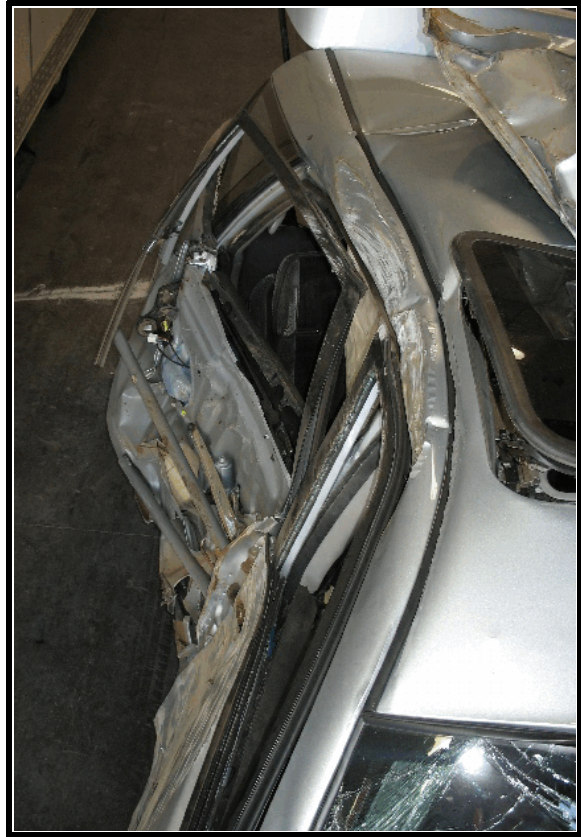
The 2006 Toyota Matrix sustained moderate right side damage as a result of the impact with the wooden pole. The direct damage began with an initial contact to the right mirror. This damage was located 84.0 cm (33.1 in) rear of the front right axle. The more substantive damage began at the door and was located 108.0 cm (42.5 in) rear of the front right axle. The direct damage measured 112.0 cm (44.1 in). Dark colored long brown hair and bloody fluids were found embedded, and on the rear of the right door near the C pillar. Body fluids were located on the front of the right rear passenger door frame. The external door panel layer from the right rear passenger door was sheared off, exposing the inside of the door. The front of the right rear door frame was shifted rearward, exposing the vehicle interior. Both right side doors were deformed and jammed shut. The side glass for each door had disintegrated. The direct damage extended vertically from the sill level to the roof level. The windshield header and roof sustained lateral buckling and the windshield was fractured from impact forces. The sun roof was dislodged from the lateral buckling. Small amounts of blood were found on the fuel door cover, in front of the right rear tail light, the left rear bumper and below the left tail light. Six crush measurements were documented at the mid door levels as follows: C1=0 cm (0 in), C2=3.0 cm (1.2 in), C3=14.0 cm (5.5 in), C4=27.0 cm (10.6 in), C5=8.0 cm (3.1 in), C6=0 cm (0 in). The Collision Deformation Classification (CDC) for the impact with the pole was 01RPAW3.

Figure 5. Overhead view of right side crush

Delta V:	Total	20.0 km/h (12.4 mph)
	Longitudinal	-17.3 km/h (-10.8 mph)
	Latitudinal	-10.0 km/h (-6.2 mph)
	Energy	23,524 joules (17,350 ft lbs)

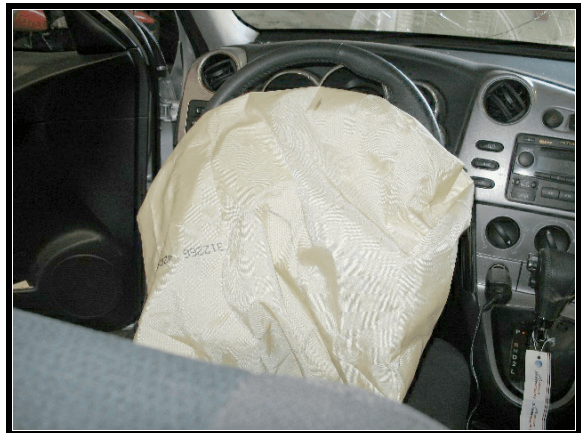
Figure 6. Driver's air bag

The driver's air bag deployed from the center of the steering wheel hub through Y configuration module cover flaps. The top flap measured 15.0 cm (5.9 in) in width and 4.0 cm (1.6 in) in height. The bottom flaps each measured 4.0 cm (1.6 in) vertically in the center and 8.0 cm (3.1 in) laterally. The deployed driver's air bag measured 60.0 cm (23.6 in) in diameter in its deflated state. The air bag was tethered by a single internal strap. The tether was attached to a 17.0 cm (6.7 in) circular stitch in the center of the air bag face. There were two circular vent ports that were located at the 10 and 2 o'clock positions. There was no damage to the air bag or indications of occupant contact.

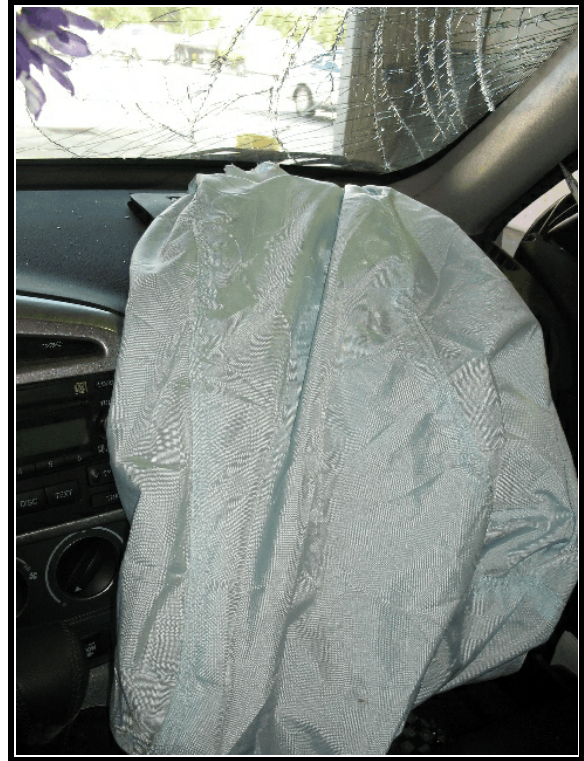
The front right passenger's air bag deployed from a top-mount module with H-configuration cover flaps. The top flap measured 24.0 cm (9.4 in) wide by 6.0 cm (2.4 in) high. The bottom flap measured 24.0 cm (9.4 in) wide by 7.5 cm (3.0 in) high. The deployed front right passenger's air bag measured 33.0 cm (13.0 in) wide seam to seam by approximately 60.0 cm (23.6 in) high in its deflated state. Two circular vent ports were located at the 3 and 9 o'clock aspects of each side panel of the air bag.

Figure 7. Front right passenger's air bag

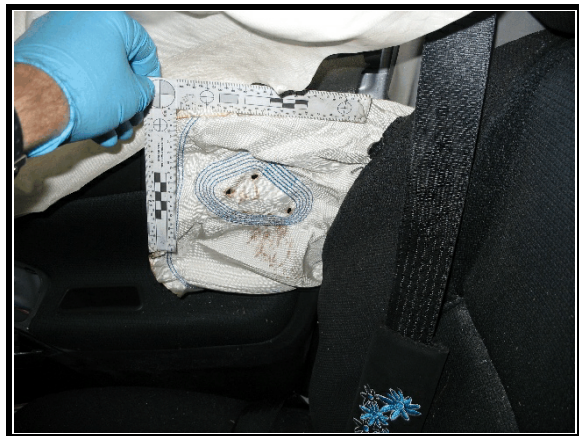
The front right passenger's side air bag deployed from the front right seat back in a forward direction. The deployed side air bag measured 25.0 cm (9.8 in) high by 18.0 cm (7.1 in) wide. There were three circular vent ports arranged in a triangular pattern in the center of the air bag. There was blood found on the inside facing portion of the air bag.

Figure 8. Front right passenger's side air bag

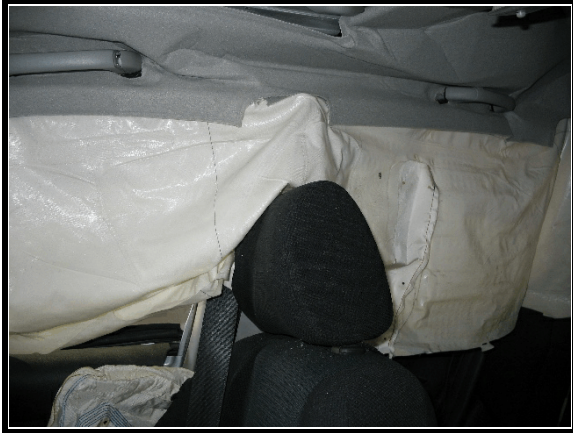
The right side air bag curtain deployed from the roof cladding on the right side of the vehicle. The side curtain was generally rectangular in shape and measured 152.0 cm (59.8 in) in length and 48.0 cm (18.9 in) in height. The curtain covered both right side seating positions. The bottom of the curtain fell 11.0 cm (4.3 in) below the bottom of the side window frame. The curtain was secured at the front by a 27.0 cm (10.6 in) long tether attached to the A pillar. The side air curtain may not have fully deployed. At a point approximately 66.0 cm (26.0 in) rear of the front of the curtain, the curtain was entrapped against the B pillar by the front right seat head restraint. There was blood and tissue found on the exterior of the side curtain at the right rear location.

Figure 9. Right side air curtain at B pillar

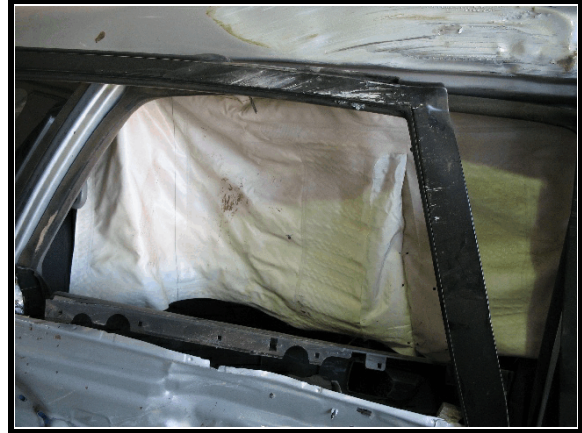
Figure 10. Overview of side curtain at right rear location

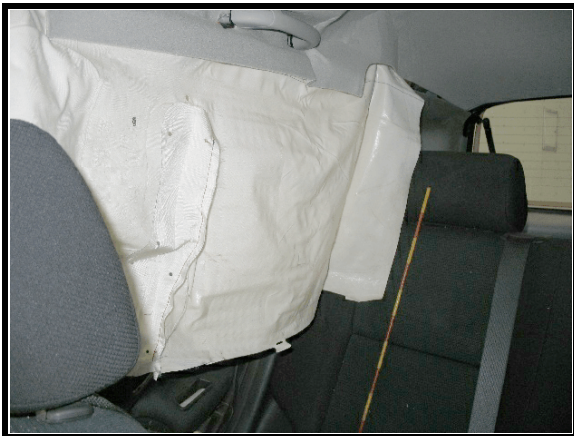
Figure 11. Right side air curtain at C pillar

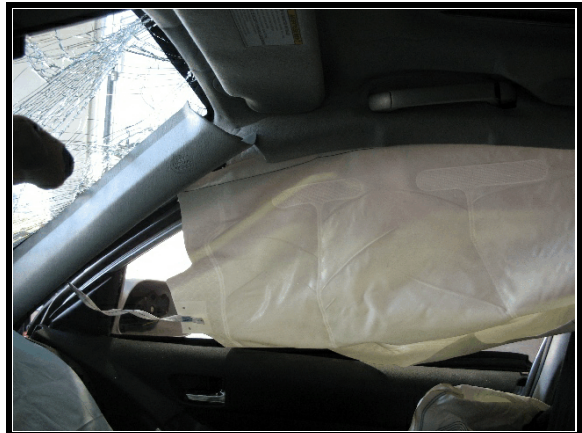
Figure 12. Right side air curtain at A pillar

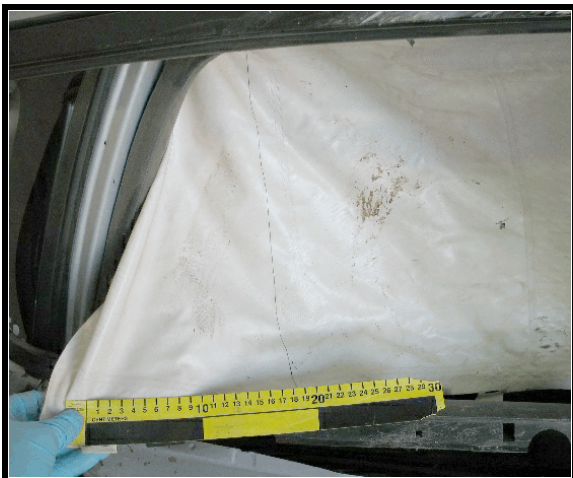
Figure 13. Close up of blood/tissue contacts to exterior of side air bag

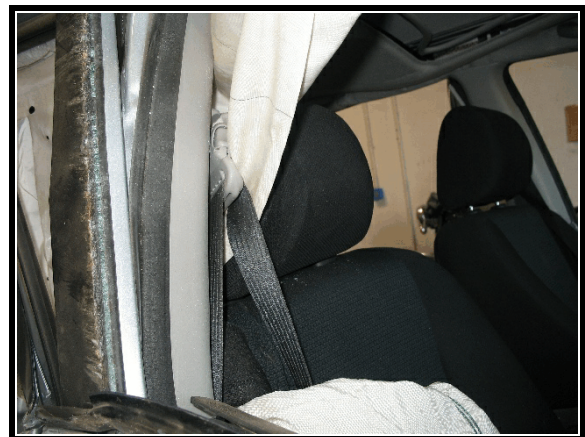
Figure 14. Side air curtain entrapped by head restraint at B pillar

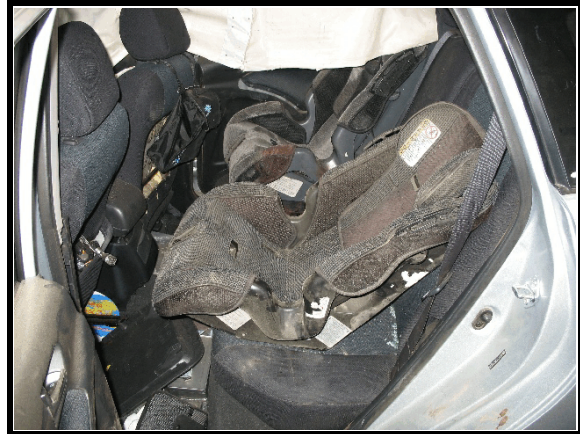
A Cosco Alpha Omega high back booster child safety seat was positioned in the left rear of the Matrix. The model number and manufacturer date label had been removed prior to the crash. The harnesses and buckles had been removed. The seat was being used as a booster seat. The reclining foot was found in the stowed position. The manufacturer recommended usage for this seat is for children weighing 2.3 to 36.2 kg (5-80 lbs) and who are between 48-130 cm (19-51 in) in height. A label on the seat outlined the recommended use of the seat as follows: Rear-facing 2.3 kg (5-22 lbs), forward-facing 10-18 kg (22-40 lbs). The child in this seat position weighed 30 kg (66 lbs) and was 112 cm (44 in) tall. At the time of the crash, the child was using this seat in conjunction with the lap belt only.

Figure 15. Cosco Alpha Omega seat, left rear

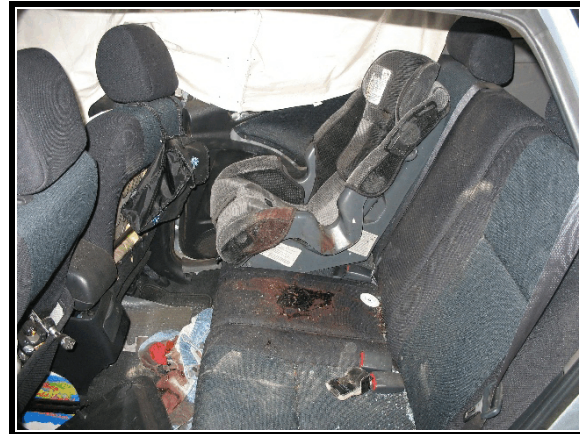
A Cosco Alpha Omega high back booster child safety seat was positioned in the right rear of the Matrix. The model number and manufacturer date label had been removed prior to the crash. The harnesses and buckles had been removed. The seat was being used as a booster seat. The reclining foot was found in the stowed position. The splitter plate was tied in a knot under the seat. The right shoulder belt guide comfort clip top screw was stripped out. Blood was found on the left side of the seat. The manufacturer recommended usage for this seat is for children weighing 2.3 to 36.2 kg (5-80 lbs) and who are between 48-130 cm (19-51 in) in height. The child in this seat weight 30 kg (67 lbs) and was 124 cm (49 in) tall, which was within the manufacturer's recommended weight guideline. A label on the seat outlined the recommended use of the seat as follows: Rear-facing 2.3-9.9 kg (5-22 lbs), forward-facing 10-18 kg (22-40 lbs). At the time of the crash, the child was using this seat in conjunction with the lap belt only. The shoulder harness had been placed behind the child seat back.

Figure 16. Cosco Alpha Omega seat, right rear

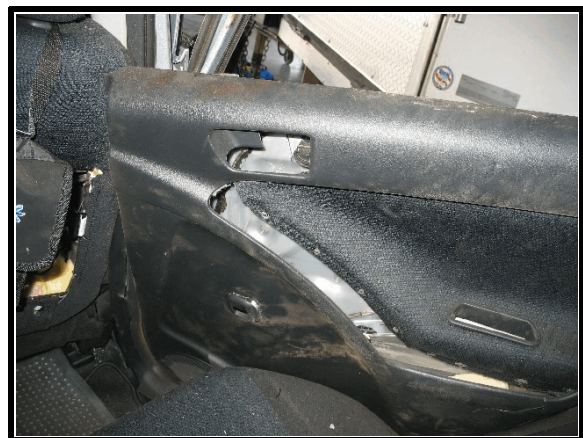
The 36-year-old female front right seat occupant was likely seated in an upright posture. She was wearing the 3-point manual lap and shoulder belt. The shoulder belt anchorage was in the full up position. The fabric covered bucket seat was adjusted to between the middle and rear most track position. The seat back was at a 30 degree angle from the vertical; the seat bottom was at a 13 degree angle from the horizontal. The driver was actively steering to the left and braking prior to impact. This passenger was likely leaning to the right to some degree in response to centrifugal forces. At impact, the frontal air bag, seat back mounted side air bag, and side air curtain deployed. The front right seat belt pretensioner actuated. The front right seat occupant initiated a forward and slightly right lateral trajectory. She likely loaded the seat belt to some degree as she pitched forward and to the right. The right side of her body likely contacted the door side panel, side air bag, and side air curtain. She sustained abrasions to her right elbow, right upper arm, and her forehead. She was transported by ground ambulance for treatment.

Figure 18. Right front door side panel

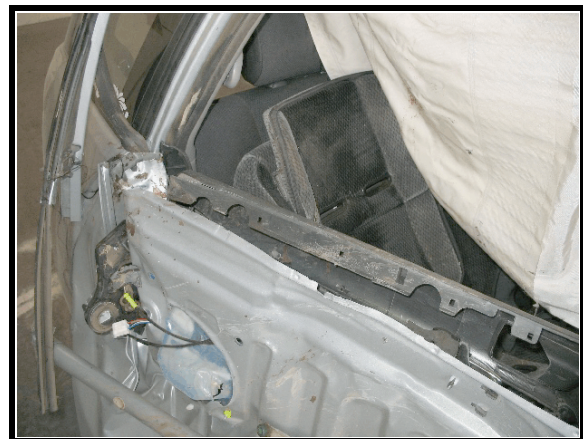
Figure 19. Exterior view of child seat, side air curtain

The second row right occupant was leaning to the right to some degree in response to centrifugal forces. Based on the evidence of injury to the exterior of the side air curtain, the skin and blood transfers on the vehicle exterior, and the report of skin and blood transfers to the struck pole, it is nearly certain that this occupant had pitched far to the right and may have engaged the side glass just prior to impact. At impact, the side air curtain deployed. This occupant's head was outside of the curtain and came into direct contact with the wooden pole. She was fatally injured with major head trauma. She rebounded from the impact and came to rest still seated in the child seat and leaning over the left side of the child seat. She had agonal respirations and was pulseless at the scene. She was treated at the scene and transported to a local emergency room. The triage start time was 1105 hours. She arrived unresponsive to all stimuli with a Glasgow Coma Scale (GCS) score of 3. She sustained major head and face trauma. Due to the severity of the injuries no resuscitation efforts were attempted and she was pronounced dead at 1109 hours.
