Rollover and Child Safety Seat Investigation / Rollover
Dynamic Science, Inc. / Case Number: DS06021
2006 Ford Freestar
Arizona
May 2006

1. Report No. DS06021		2. Government Accession No.		3. Recipient Catalog No.	
4. Title and Subtitle Rollover and Child Safety Seat Investigation				5. Report Date April 13, 2007

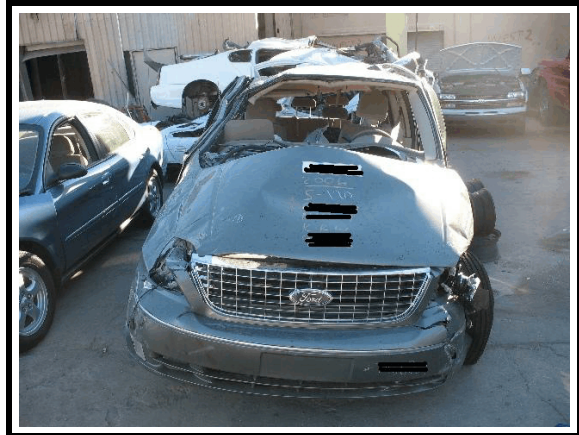
Figure 1. Front of case vehicle - 2006 Ford Freestar

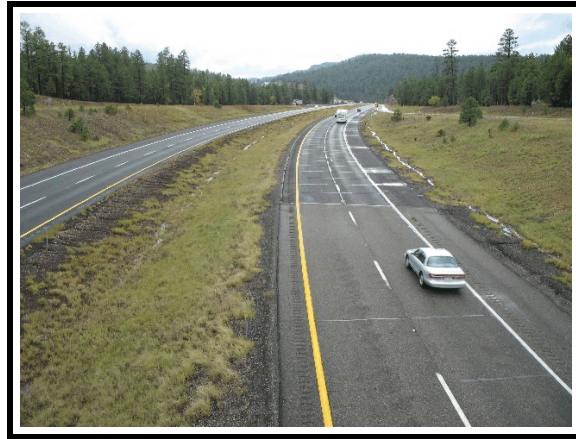
Figure 3. Precrash and rollover area

According to the police report, the northbound lanes have a “sweeping left turn” and a downhill grade. Based on the on-scene police photographs and SCI scene inspection, it was determined that the Ford Freestar’s precrash travel lanes curve to the right.

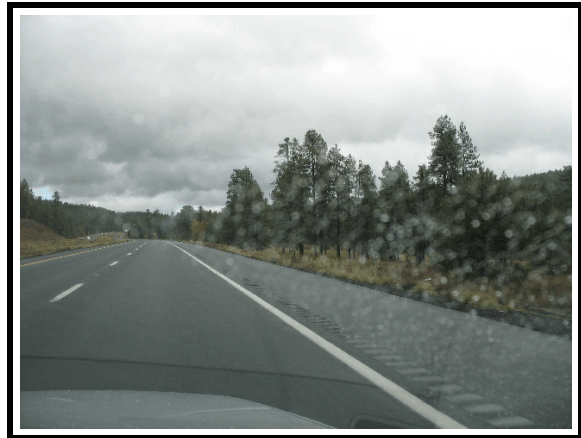
Figure 4. Rollover area

The minivan began to roll over (00TDDO3) as it continued north while in a clockwise yaw. It rolled an unknown number of times (see Figure 4). During the rollover event, the unrestrained 24-year-old female and 3-year-old male passengers were fully ejected. The female passenger's body came to rest on the solid white line separating the right lane from the right shoulder. The ejected child came to rest on a hillside adjacent to the freeway. The case vehicle came to final rest on its left side, facing southeast, with its front end on the east shoulder and its back end partially blocking the right lane (see Figures 5-6).

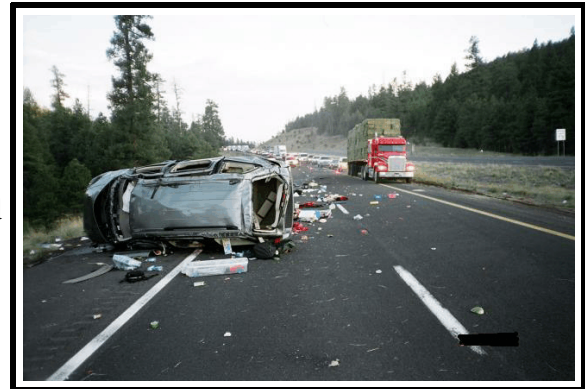
Figure 5. Vehicle at final rest (police photo)

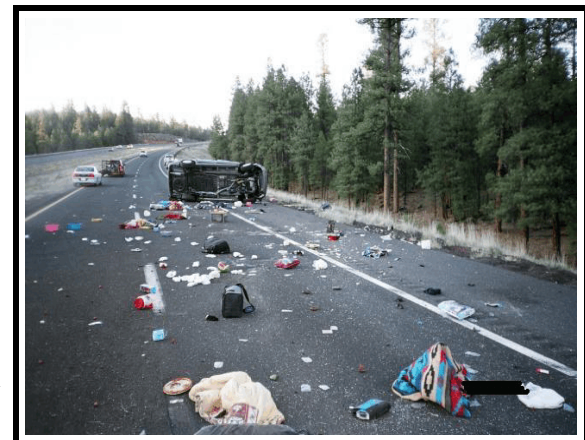
Figure 6. Final rest and debris field (police photo)

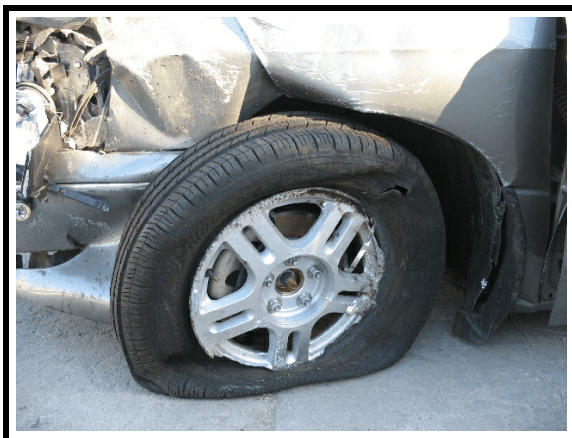
Position	Measured Pressure	Measured Tread Depth	Restricted	Damage
LF	Flat	8 mm (10/32 in)	Yes	Rim damaged; sidewall holed (see Figure 7)
LR	Flat	7 mm (9/32 in)	No	Tire debeaded; rim damaged (see Figure 8)
RR	Flat	7 mm (9/32 in)	No	Tire debeaded
RF	Unknown	Unknown	No	Unknown; tire sold/no longer with the vehicle

Figure 7. Left front tire/rim damage

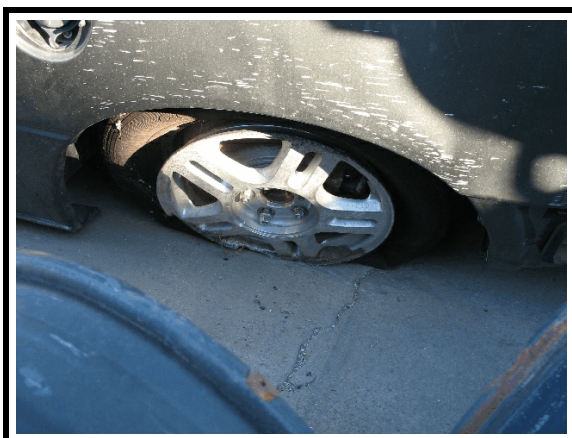
Figure 8. Left rear tire/rim damage

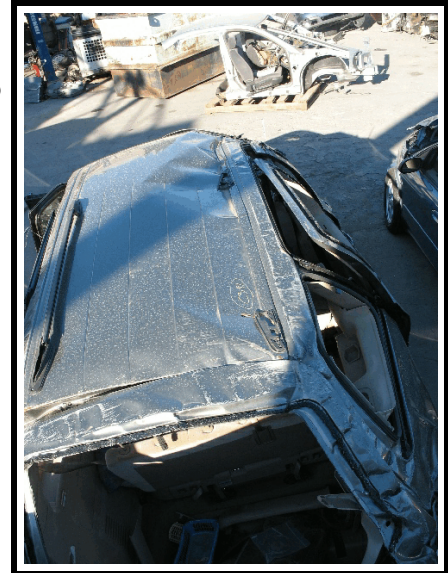
The left front door remained closed and operational. The right front door, left rear sliding door and rear liftgate were jammed shut post-crash. The right rear sliding door was able to be opened approximately 7.6 - 10.2 cm (3.0 - 4.0 in). As a result of the rollover damage, there were gaps present between the right roof rail and the upper right front and right rear door window frames.

Figure 9. Rollover damage & opening at upper right rear door

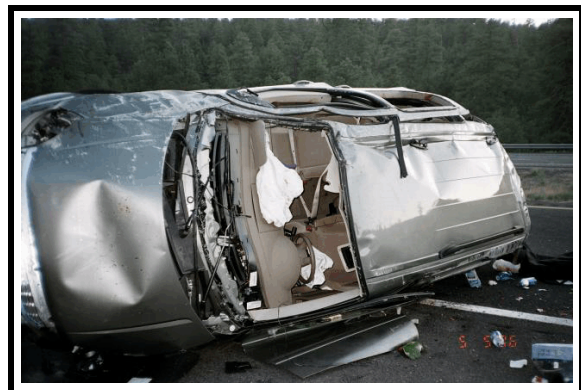
There was windshield integrity loss, although some of the damage may have been a result of the driver's post-crash passenger extrication efforts. The driver reported to police that he got out of the vehicle on his own and due to the fact the Freestar was laying on its left side, it is likely he exited the minivan through the windshield area. With the exception of the left front window, the back glazing and all of the side glazing disintegrated during the rollover event. The majority of the direct damage to the vehicle's top was to the right side pillars and to both roof side rails.

Figure 10. Windshield damage at the scene (police photo)

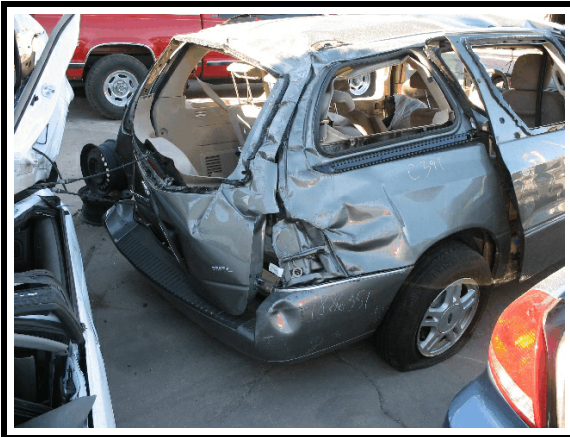
The case vehicle sustained vertical and lateral crush to the roof. The maximum vertical and lateral crush location was to the right A pillar. At this location, there was 19.0 cm (7.5 in) of vertical crush, the maximum crush for the rollover event (see Figure 14). The associated Collision Deformation Classification (CDC) for this event was 00TDDO3 (see Figures 9-10). The rollover was the only crash event (see Figures 11-13 for right side damage).

Figure 11. Right rear rollover damage

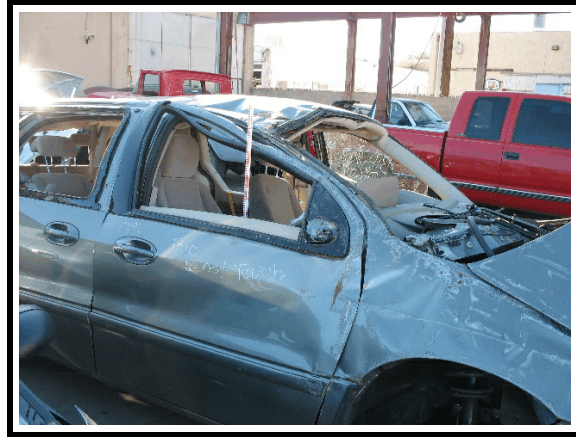
Figure 12. Right side passenger compartment rollover damage

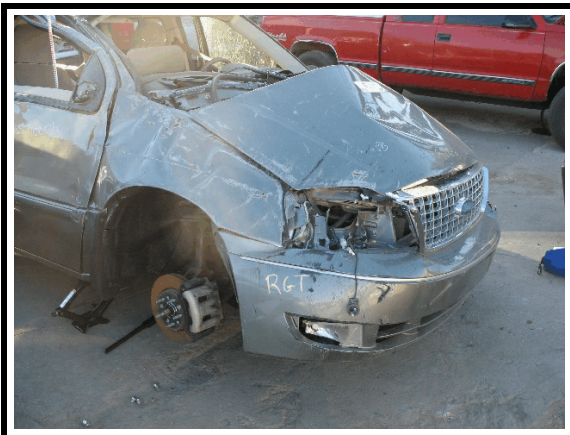
Figure 13. Right front rollover damage (RF tire removed/sold by wrecking yard)

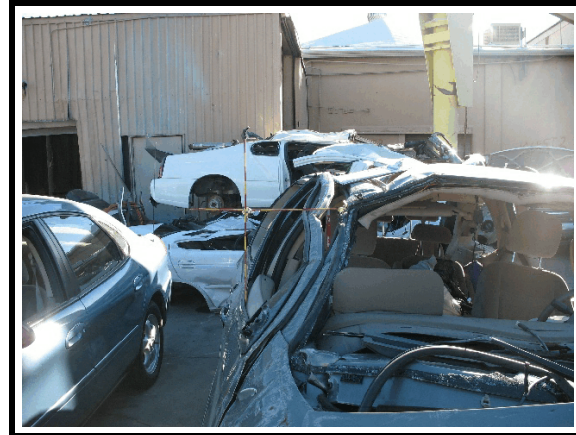
Figure 14. Location of max crush from the rollover event (right A pillar)

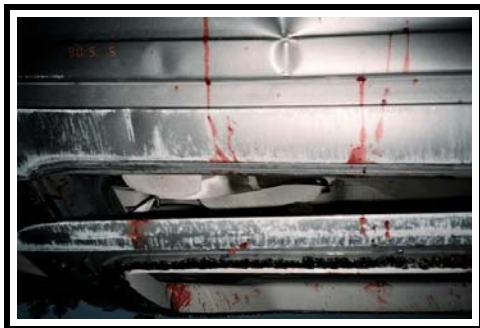
Figure 15. Blood - 2nd row right side window frame & roof side rail (police photo)

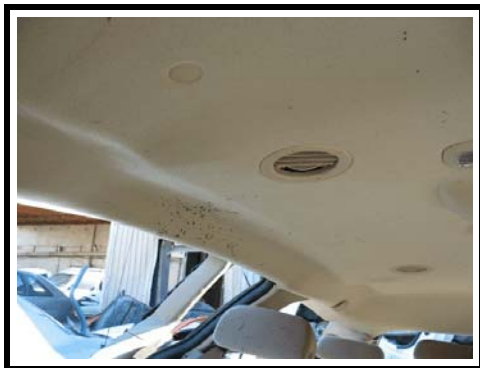
Figure 16. Blood splatter above second row right window glazing

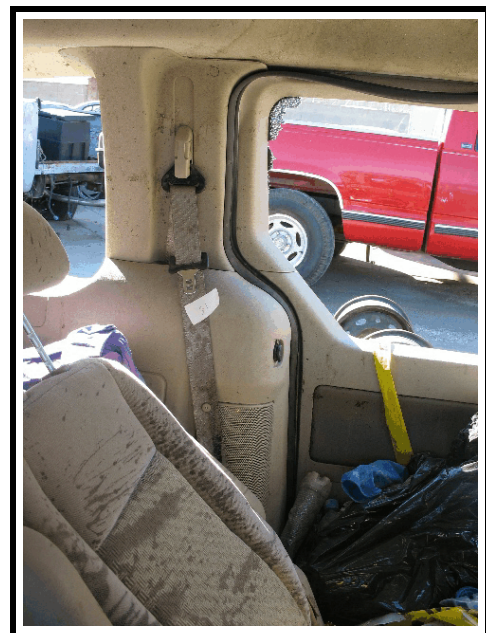
Figure 17. Blood found in the second row left seating area

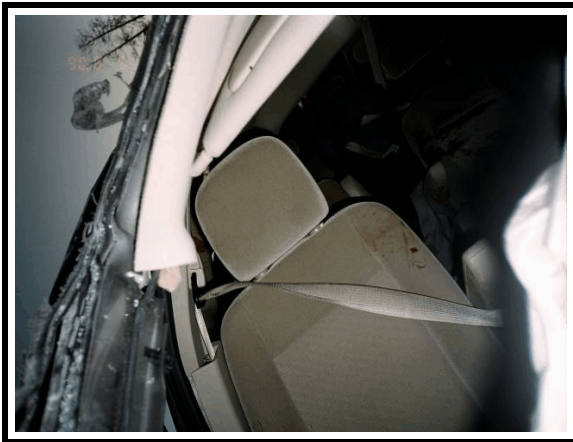
The vehicle sustained vertical intrusion of the roof, the right roof side rail, and the right A, B, C and D pillars (see Figures 18-19). The right D pillar also intruded laterally. The air vent located on the right side of the instrument panel was damaged due to the intruding right A pillar. Field measurements were obtained during the vehicle inspection and an exemplar vehicle was located in order to obtain comparative, undamaged measurements.

Figure 18. Passenger compartment intrusion - RF seating area (police photo)

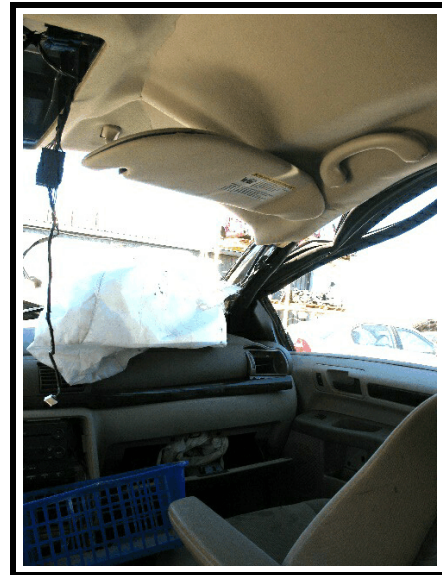
Figure 19. Intrusion into RF seating area

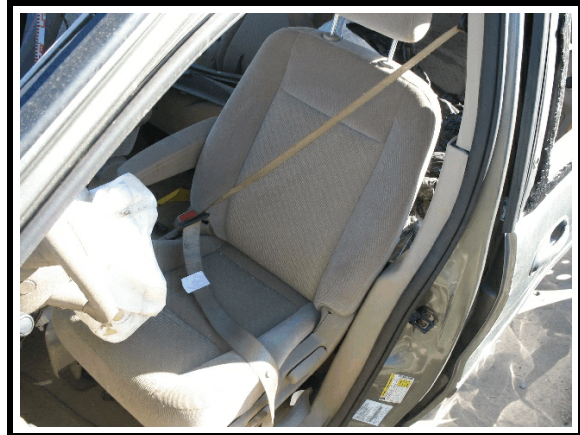
The driver's seat belt was equipped with a sliding latchplate and an Emergency Locking Retractor (ELR). The seat belt exhibited signs of usage during the crash; no failures were noted (see Figure 20). The remaining six passenger belts were equipped with sliding latchplates and switchable ELR/Automatic Locking Retractors (ALR). There was blood found on the right front seat belt webbing. This belt showed signs of being used during the crash and was found locked in the D-ring (see Figure 21). The second row left seat belt showed no visible signs of loading that would have been consistent with its having been used during the crash. The second row right seat belt showed signs of occupant loading and blood was found on both the lap and shoulder portions. The distance between the seat belt stop button and the evidence of occupant loading to this belt was 51.0 cm (20.1 in).

Figure 20. Driver's seat belt

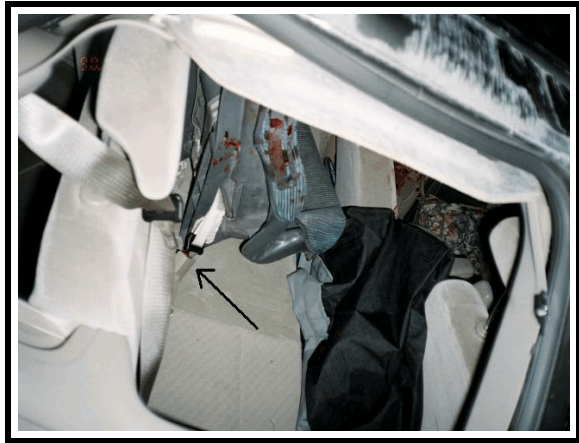
Figure 22. Child safety seat secured forward facing in the 3rd row center seat (arrow points to buckled seat belt - police photo)

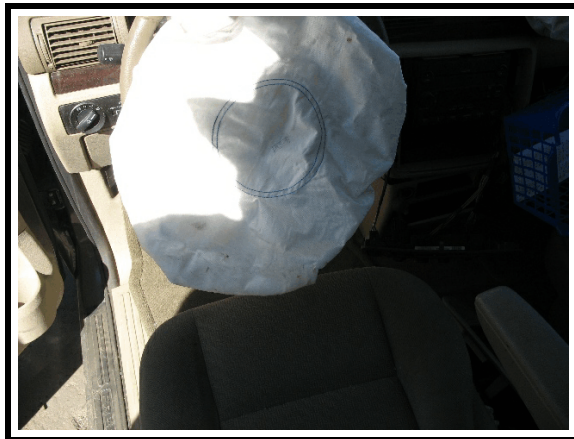
During the crash sequence, the driver and right front passenger air bags deployed. The driver’s air bag deployed from the center of the steering wheel hub through I-configuration cover flaps (see Figure 23). There was a third flap located at the top of the side flaps that measured 13.5 cm (5.3 in) wide by 6.0 cm (2.4 in) high. The top and bottom sections of the left and right cover flaps measured 8.0 cm (3.1 in) wide and both flaps were 9.5 cm (3.7 in) high. The deployed driver air bag measured 42.0 cm (16.5 in) in diameter in its deflated state. The air bag was tethered by a single internal strap and there were two circular vent ports located at the 11 and 1 o’clock positions on the rear of the air bag. There was blood on the lower center section of the back of the air bag which may have been a result of post-crash contact by one or more of the vehicle occupants (see Figure 24). There was no damage or occupant contact visible on the cover flaps.

Figure 23. Deployed driver front air bag

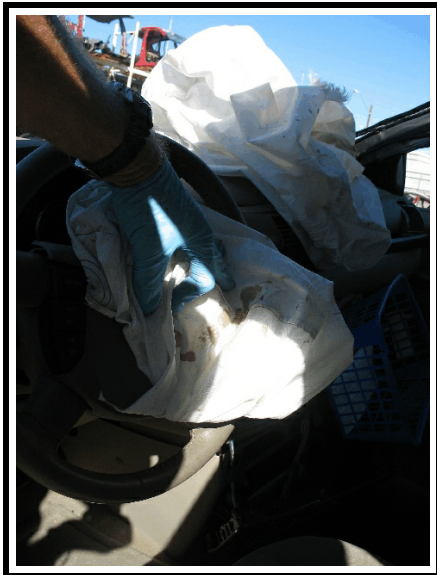
Figure 24. Blood on back/lower section of the driver's deployed front air bag

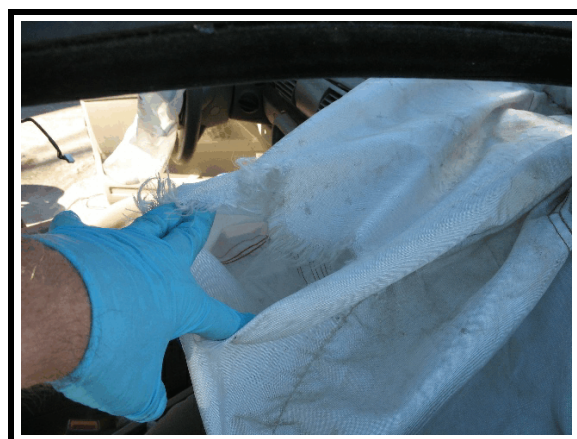
Figure 27. Damage to deployed passenger front air bag

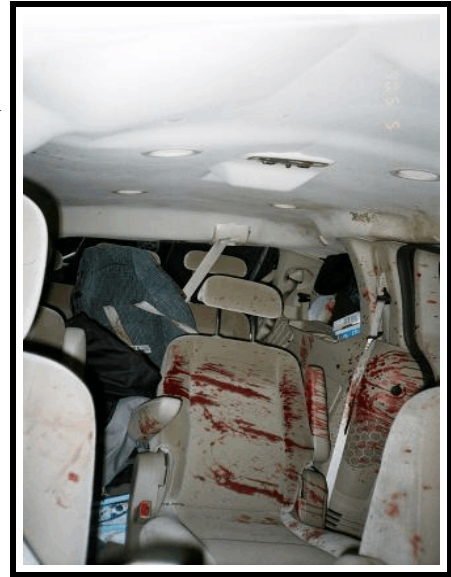
Figure 28. Child safety seat - 3rd row center seat (police photo)

It appears from an on-scene police photograph that at least one of the child safety seats was still in the vehicle after all of the occupants had been removed (see Figure 28). There were multiple items that had been thrown outside of the vehicle during the rollover, but no child safety seats are visible in the debris field. The third row center seating position contained a child safety seat that was positioned in a forward facing fashion. In the police photographs, the seat had visible bloodstains on its left side and appears to have been equipped with harness straps that were also stained with blood.

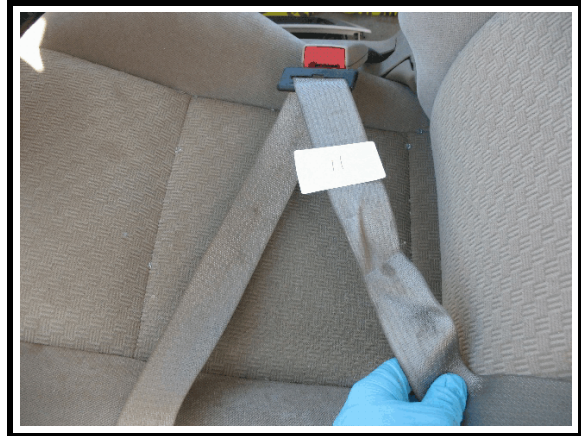
Figure 29. Evidence of occupant loading to driver's seat belt

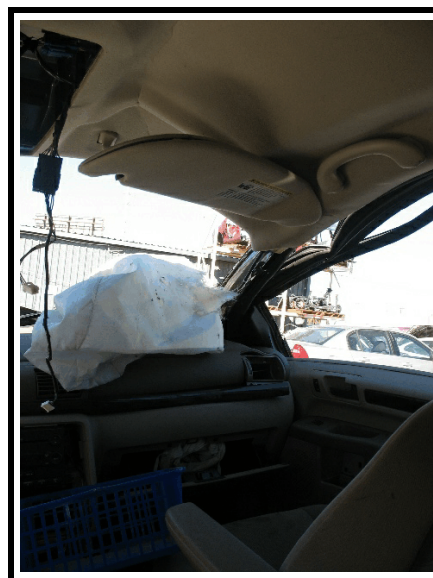
Figure 31. RF passenger's seating area & displaced roof-mounted light

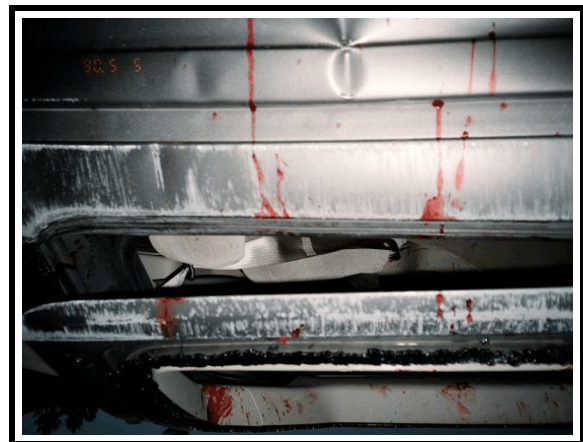
As the Freestar continued to rollover, this occupant was thrown around inside the passenger compartment. During the rollover event, this pregnant occupant was fully ejected from the vehicle. It is likely that she was ejected through the second row right window glazing, which had disintegrated during the crash. There was blood found on the right rear window frame and to the top outer portion of the right rear door and roof side rail.

Figure 33. Blood on the RR door and window frame (police photo)
