**CALSPAN ON-SITE POTENTIAL SAFETY-RELATED  
DEFECT CRASH INVESTIGATION**

**SCI CASE: CA06-022**

**VEHICLE: 1997 FORD EXPLORER  
LOCATION: TEXAS  
CRASH DATE: JUNE 2005**

<i>15. Supplementary Note</i> An investigation of an alleged tread separation on a 1997 Ford Explorer involved in a subsequent rollover crash.			
<i>16. Abstract</i> <p>This investigation will focus on the alleged tire failure and subsequent rollover crash of a 1997 Ford Explorer. The crash occurred during the evening hours of June 2005. It was dusk and the reported weather was clear and dry. The weather was not a crash factor. The crash occurred on a two-lane state highway in rural Texas. At the crash site, the two-lane roadway transitioned to a three-lane roadway by the addition of a southbound lane that created a passing zone. The asphalt roadway was straight and with a positive grade in the southbound direction. The speed limit in the area of the crash was 113 km (70 mph) daytime and 105 km/h (65 mph) nighttime. The 1997 Ford Explorer was southbound in the inboard lane as the Ford entered the passing zone. The vehicle was driven by a 25 year old restrained male. A 21 year old female was seated in the center

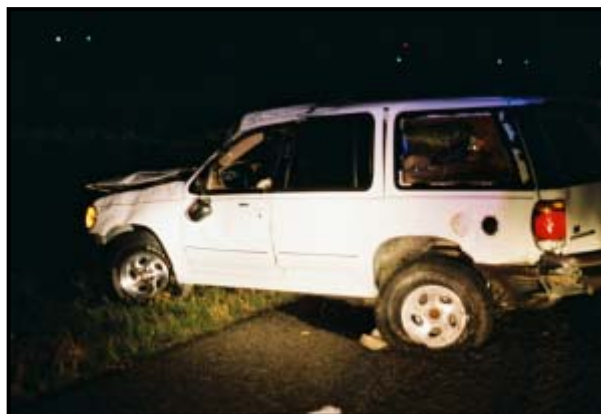
**Figure 1: Final rest position of the 1997 Ford Explorer.**

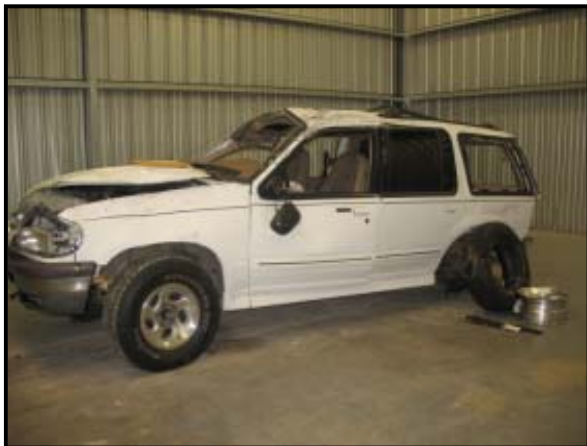
- Mileage: 252,176 km (156,699 miles)
- Left Rear Tire Failure
- Left Side Leading Roll – Eight Quarter Turns (possibly 12)
- Maximum lateral and vertical crush located on the right roof rail within the A-pillar area
  - Max Lateral Displacement: 1 cm (0.5 in)
  - Max Vertical Crush: 13 cm (5.3 in)
- Minor damage to left rear wheelhouse from partial detread slap
- Undercarriage: Good condition, all bushings and links tight, no leaking seals, no broken springs, brake lines intact, all parts appear to be good condition. Rear shocks were Sensa-track (possibly replacement) shocks.

Figure 2: Left side.

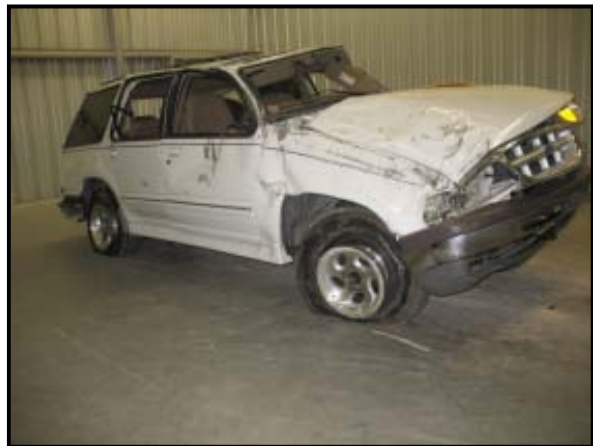
Figure 3: Right side.

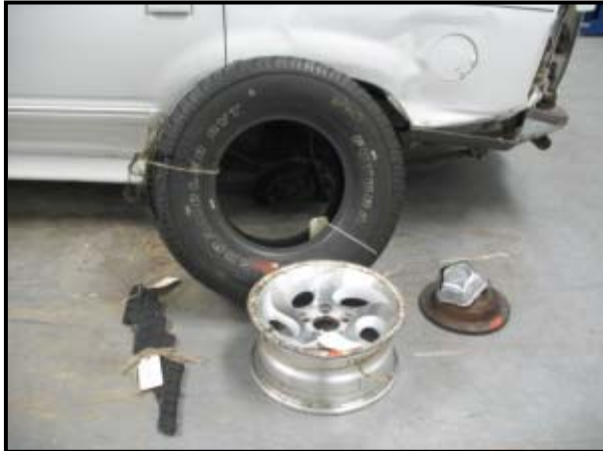
The overall general condition of the tire was considered to be good, **Figures 4 through 6**. There was adequate tread life remaining and the rubber did not appear dry rotted. The tire failed by a combination of a partial detread and destruction of the casing and sidewall. A radial oriented 11 cm (4.5 in) cut of the inboard sidewall was located at 80 degrees. This cut traveled across the tread width and extended down the outboard sidewall 8 cm (3 in). The outboard sidewall was holed at the 5 o'clock sector (150-160 degrees). The hole measured 11 cm x 7 cm (4.5 in x 2.8 in). A view of the failed casing is depicted in **Figure 7**. The detread section measured 64 cm (25.2 in) in length and separated from the tire between 350 to 100 degrees, **Figures 8 and 9**. The detread section separated diagonally from sidewall to sidewall along the direction of the top steel ply and detached between the two steel plys. Further examination of the casing revealed it had been holed and patched. The patch was located between 330 and 0 degrees. The patch adequately repaired the perforation and was completely adhered to the casing. A corresponding nail hole was identified in the groove between the first and second tread from the outboard sidewall. Refer to **Figures 10 and 11**. The failure of this tire was not a typical/classic tread separation.

**Figure 4: Overall view of LF rear and wheel.**

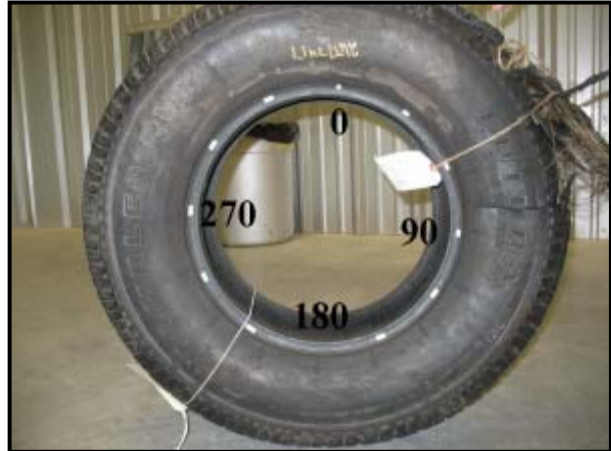
**Figure 5: DOT side of tire (inboard).**

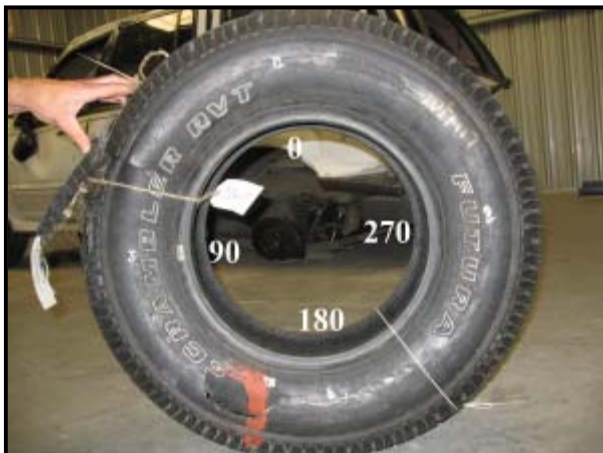
**Figure 6: Non-DOT side of tire (outboard).**

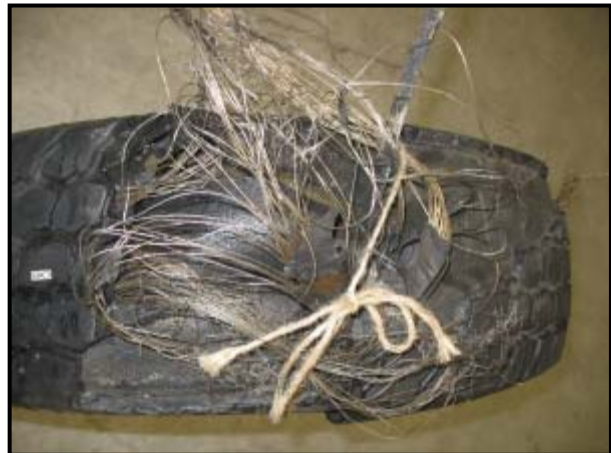
**Figure 7: View of the failed casing.**

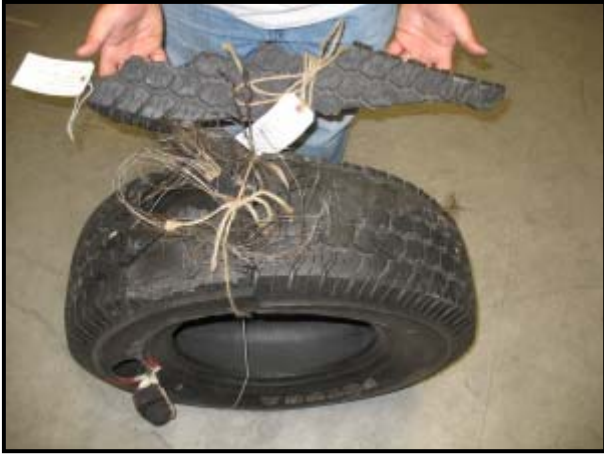
**Figure 8: Exterior surface of detread section.**

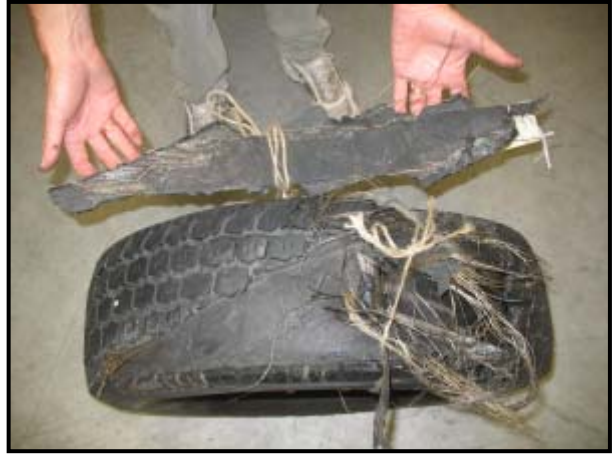
**Figure 9: Interior side of detread section.**

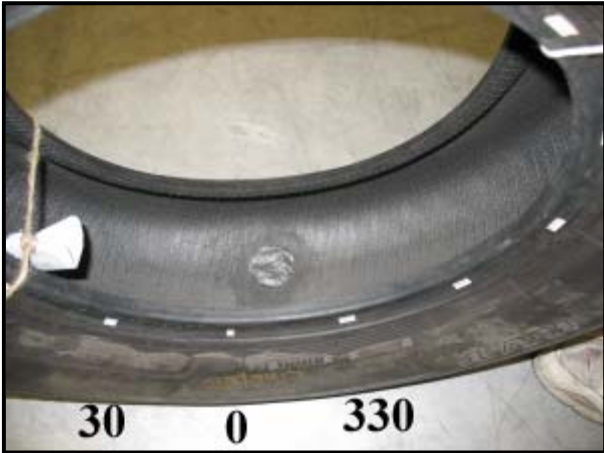
**Figure 10: View of the patched tire casing.**

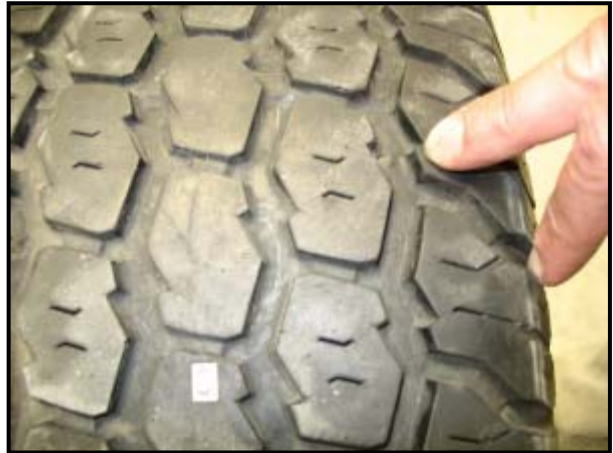
**Figure 11: Location of the nail hole**
