ON-SITE CERTIFIED ADVANCED 208-COMPLIANT VEHICLE INVESTIGATION

CASE NUMBER - IN-06-023

VEHICLE - 2005 TOYOTA SEQUOIA

CRASH DATE - June 2006

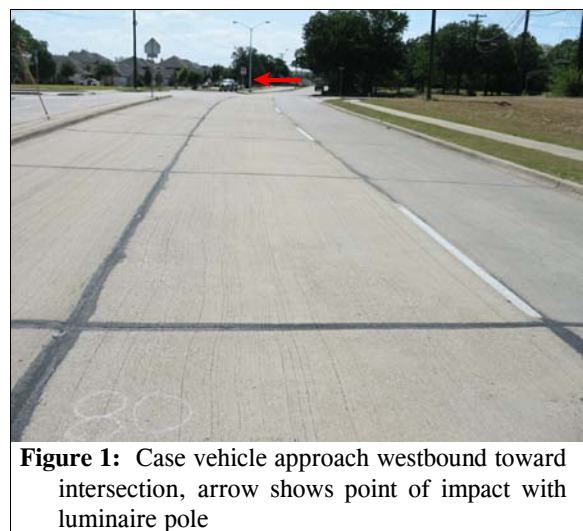
Pre-Crash: The case vehicle was traveling west in a slight right curve (**Figure 1**) in the inside through lane at a driver estimated speed of approximately 56 km.p.h. (35 m.p.h.). The case vehicle's driver was intending to continue westbound. The driver indicated that she briefly took her eyes off the roadway to look at her purse, which was sitting on the console. Due to this distraction, the case vehicle drifted left as it was traversing through the intersection and ran onto the raised concrete median. The driver took no avoidance actions prior to the crash, which occurred in the median.

Figure 1: Case vehicle approach westbound toward intersection, arrow shows point of impact with luminaire pole

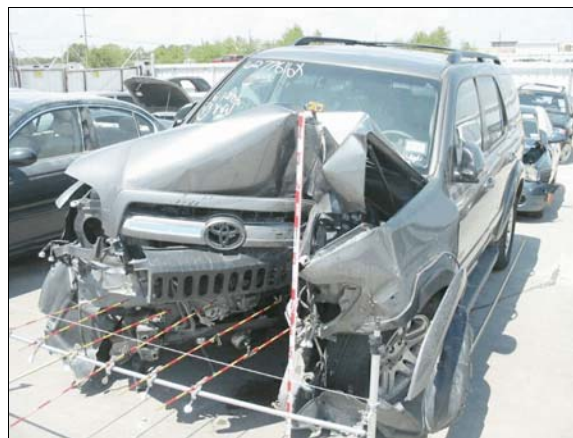
Figure 2: Overview of damage to front of case vehicle from impact with luminaire pole

Exterior Damage: The case vehicle’s contact with the luminaire pole involved the front plane. The front bumper, bumper fascia, grille, radiator, and hood were directly damaged and crushed rearward. The case vehicle’s front bumper had been broken off the vehicle and was not present at the inspection. Therefore, measurements were made in relation to the lower sheet metal panel located behind the bumper and adjusted for the missing bumper. The direct damage began 63 centimeters (39 inches) left of the right end of the lower sheet metal panel and extended approximately 30 centimeters (11.8 inches) along the front of the vehicle. Crush measurements were taken along the lower sheet metal panel, and the residual maximum crush was determined to be 77 centimeters (30.3 inches) occurring at C₂. The table below shows the case vehicle’s front crush profile.

Damage Classification: Based on the vehicle inspection, the CDC for the case vehicle was determined to be: **12-FYEN-3 (0 degrees)** for the front impact. Yielding object impacts are out-of-scope for the WinSMASH reconstruction program; therefore, the program could not be used to determine the case vehicle's Delta Vs. However, the WinSMASH program was used to determine a Barrier Equivalent Speed (BES) based on the case vehicle's front crush. The BES was calculated as 33.6 km.p.h (20.9 m.p.h.). The case vehicle was towed due to damage.

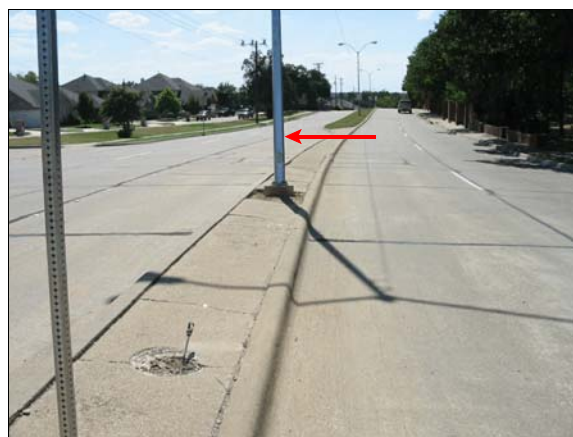
Post-Crash: After impacting the luminaire pole, the case vehicle rotated counterclockwise slightly and came to final rest facing southwest. The impact broke the luminaire pole off its base.

Figure 3: Arrow shows location of impacted luminaire pole, which has been replaced

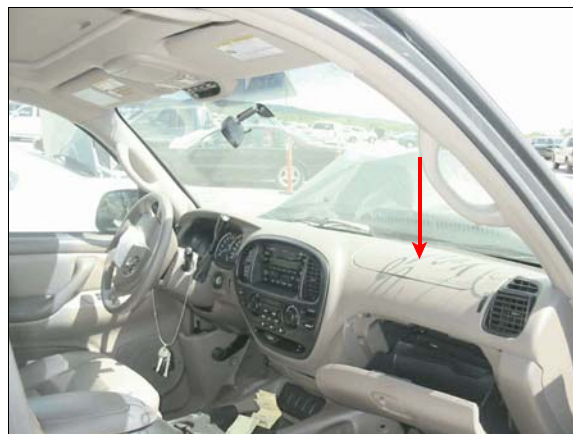
Vehicle Interior: Inspection of the case vehicle's interior (**Figure 4**) revealed no evidence of occupant contact to any interior surfaces or components. Intrusions were noted at the left and right toe pans, which were intruded longitudinally 7 and 5 centimeters (2.8 and 2 inches), respectively. There was no evidence of compression of the energy absorbing steering column or deformation of the steering wheel rim (**Figure 5**).

Figure 4: Case vehicle's instrument panel, windshield and steering wheel, arrow shows location of front right passenger air bag

The front right passenger's air bag was located in the middle of the instrument panel (Figure 4 above). This air bag did not deploy. The 12-year-old male passenger was reportedly seated in a slumped position with his buttocks on the front edge of the seat and his back against the seat back. His position on the seat most likely displaced enough of his weight away from the case vehicle's weight sensor that the sensor determined the weight on the seat was below the air bag system's threshold and suppressed deployment of the front right air bag.

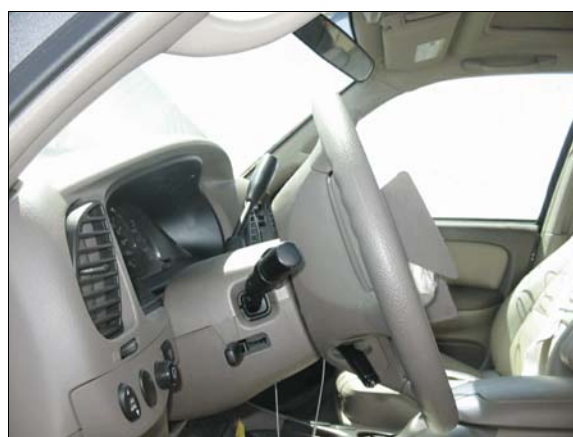
Figure 5: Left side view of case vehicle's steering wheel and steering column showing lack of deformation

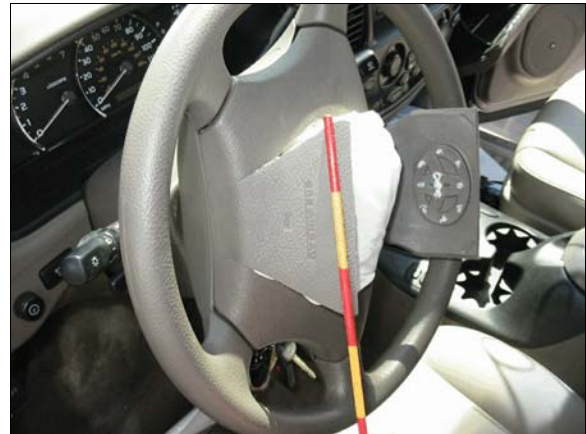
The case vehicle's driver air bag was located in the steering wheel hub. The air bag module cover consisted of asymmetrical, essentially, "H"-configuration cover flaps made of pliable vinyl. The upper flap was 13 centimeters in width and 8 centimeters in height. The lower flap was trapezoidal-shaped and was 13 centimeters (5.1 inches) in width along the horizontal tear seam, 5 centimeters (2 inches) in width at the bottom and 7.5 centimeters (3 inches) in height. An inspection of the air bag module cover flaps (**Figure 6** below) and the air bag fabric revealed that

the cover flaps opened at the designated tear points. There was no evidence of damage during the deployment to the air bag or the cover flaps. The driver's air bag was designed with two tethers, each approximately 10 centimeters (3.9 inches) in width. The deployed driver's air bag (Figure 7) was round with a diameter of 60 centimeters (23.6 inches) and had two vent ports (Figure 8), each measuring 5 centimeters (2 inches) in length and 1 centimeter (0.4 inches) wide, located at approximately the 11 and 1 o'clock positions. The distance between the mid-center of the driver's seat back, as positioned at the time of the vehicle inspection (i.e., seat at middle track position, seat back slightly reclined), and the front surface of the air bag's fabric at approximate full excursion was 28 centimeters (11 inches). An inspection of the driver's air bag fabric revealed no evidence of occupant contact on the front of the air bag.

Figure 6: Case vehicle's driver air bag cover flaps, each stripe on rod is 5 cm (2 in)

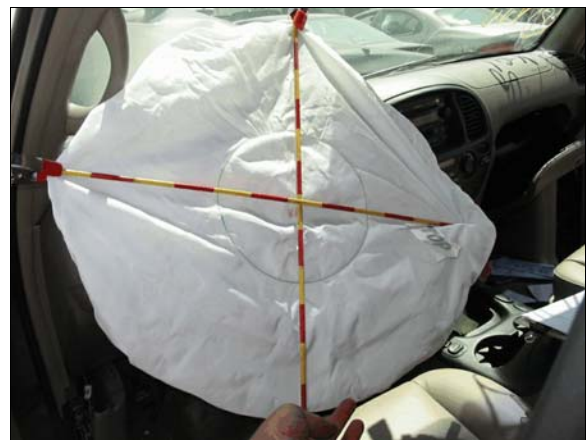
Figure 7: Case vehicle's driver's air bag.

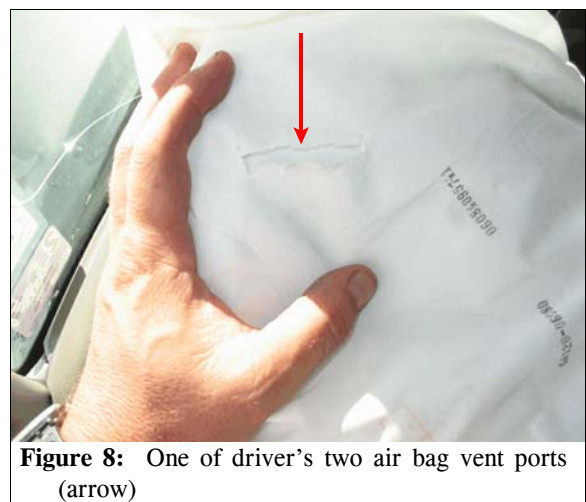
Figure 8: One of driver's two air bag vent ports (arrow)

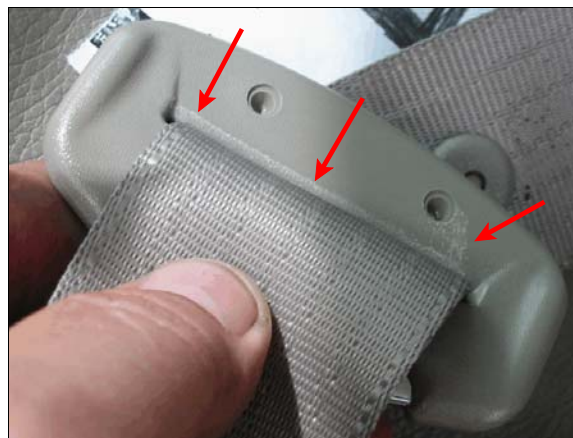
Based on this contractor's vehicle inspection and supported by the driver's interview, the case vehicle's driver was restrained by her manual, three-point, lap-and-shoulder safety belt system. There were load abrasions on the sliding latch plate (**Figure 9**) and D-ring, and the driver sustained a fracture to her left collar bone from loading the shoulder belt. In addition, the safety belt was equipped with a retractor-mounted pretensioner and force load limiter housed within the B-pillar. The driver's safety belt was found

Figure 9: Arrows show load abrasions on driver's sliding latch plate

spooled out of the retractor and would not retract, indicating actuation of the pretensioner and usage of the safety belt in the crash.

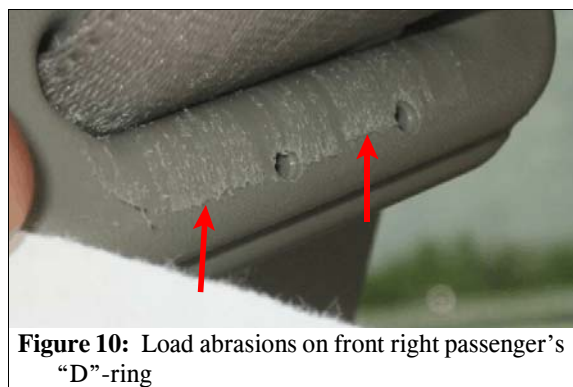
Based on this contractor's vehicle inspection, the case vehicle's front right passenger was restrained by his manual, three-point, lap-and-shoulder safety belt system. Load abrasions were observed on the sliding latch plate and D-ring (**Figure 10**). In addition, the safety belt system was equipped with a retractor-mounted pretensioner and force load limiter housed within the "B"-pillar. The front right passenger's safety belt was found spooled out of the retractor and would not retract, indicating actuation of the pretensioner and usage of the safety belt in the crash.

Figure 10: Load abrasions on front right passenger's "D"-ring
