**NOT-IN-TRAFFIC SURVEILLANCE
CALSPAN ON-SITE BACKOVER INJURY INVESTIGATION**

SCI CASE NO: CA06-024

**VEHICLE: 2003 CHEVROLET AVALANCHE
LOCATION: VIRGINIA
CRASH DATE: OCTOBER, 2006**

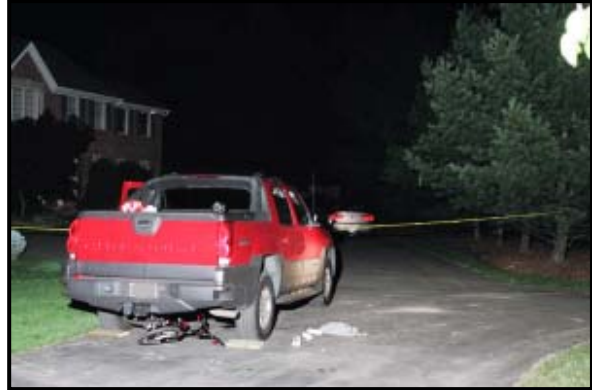
Figure 1: Final rest of the Chevrolet.

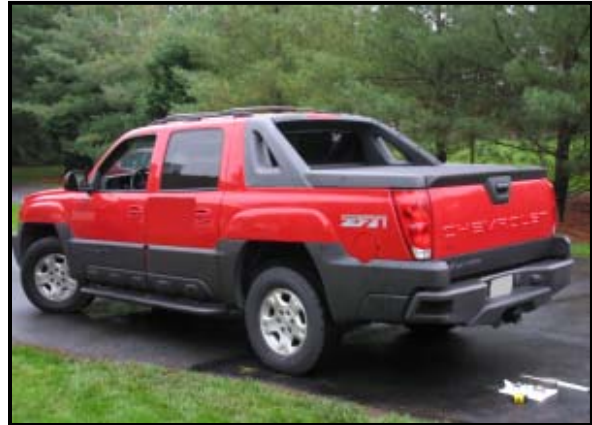
The 2003 Chevrolet Avalanche, **Figure 2**, was identified by the Vehicle Identification Number (VIN): 3GNEK13T73G (production sequence deleted). The five passenger, four-wheel drive, ½ ton sport utility vehicle was configured on a 330 cm (130 in) wheelbase. The power train consisted of a 5.3 liter/V8 engine linked to a four-speed automatic transmission. The service brakes were a four-wheel disc system with ABS. The leather upholstered interior was configured with two front row bucket seats and a second row 60/40 split bench seat. The head restraints for all

Figure 2: 2003 Chevrolet Avalanche.

the seats were in the full down position. The driver seat was adjusted to a mid-track position that measured 11 cm (4.5 in) forward of full rear. The total seat track travel measured 22 cm (8.5 in). The front row windows were AS-2 tempered glazing. The rear windows and backlight were OEM AS-3 (tinted) glazing. The Avalanche was equipped with P265/70R17 tires. The installed tires were the OEM recommended tire size for this vehicle. Inspection of the undercarriage did not find any evidence of after-market modification, i.e. lift kits or altered suspension. The Chevrolet was not damaged in the crash. There was no damage or contact evidence to the rear bumper or undercarriage. The ground heights of the rear bumper and undercarriage components were measured. The clearance heights are summarized below:

- Height of rear deck: 140 cm (55 in)
- Height at top of bumper: 71 cm (28 in)
- Bumper bottom clearance: 43 cm (17 in)
- Trailer hitch clearance: 36 cm (14.2 in)
- Spare tire (aft) clearance: 36 cm (14.2 in)
- Spare tire (forward) clearance: 29 cm (11.5 in)
- Sway bar clearance: 29 cm (11.5 in)
- Differential clearance: 22 cm (8.5 in)

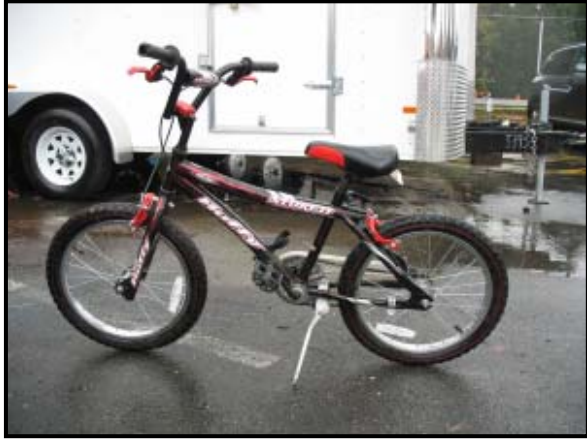
The Huffy bicycle, **Figure 3**, was examined at the police impound. The bicycle frame measured 51 cm (20 in) in height and was constructed of tubular steel. The tires measured 46 cm (18 in) in diameter. The wheelbase measured 82 cm (32.2 in). The handle bars measured 56 cm (22 in) across its width. The seat was adjusted to a ride height of 64 cm (25 in) above the ground. The front brake was out of adjustment. The pads did not retard the front wheel when the brake was depressed. The rear caliper brake was operational and locked the freewheeling tire.

The only noted damage to the bicycle was the orientation of the handle bars relative to the front wheel and a scuff/abrasion to the vertical surface of the left pedal. The handle bars were rotated approximately 30 degrees clockwise. The vertical (outboard) surface of the pedal was scuffed

Figure 3: Huffy Bicycle.

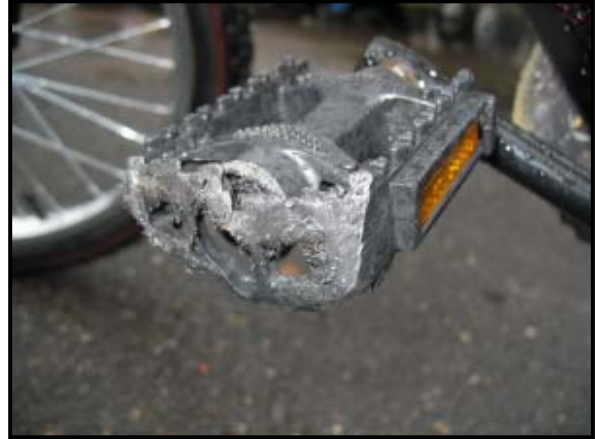
and abraded from contact with the driveway, **Figure 4**. These damages were caused during the backover and are further explained in the *Reconstruction* section of this report.

Figure 4: Left pedal abrasion.

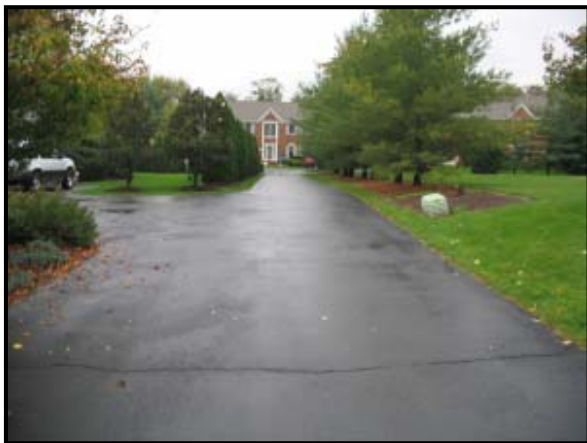
Figure 5: Northward approach.

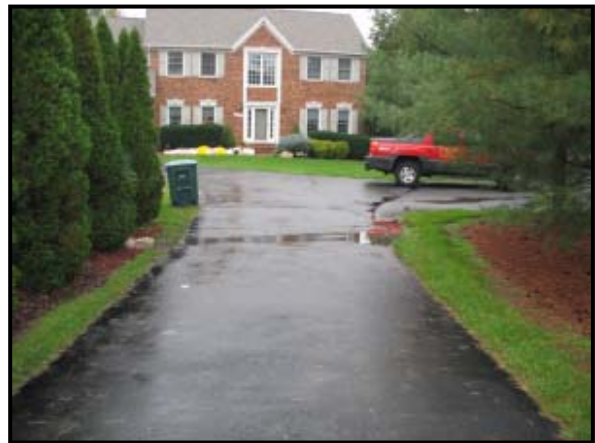
Figure 6: Northward approach near the common area.

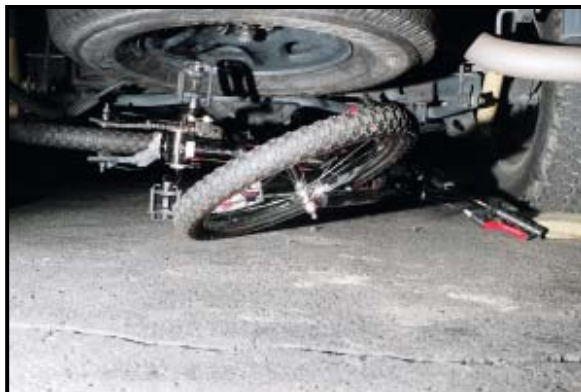
Figure 7: View of the undercarriage and bicycle.

After the child was removed by the EMS, the police documented the scene. Figure 7 is a view depicting the orientation of the bicycle and the undercarriage of the Avalanche. An inspection/examination of the rear bumper cover revealed the fascia was not damaged. The police investigation documented scuff marks in the area of the rear axle/differential that possibly resulted from the contact with the bicycle helmet. After documentation the bicycle was slid out from under the vehicle. The bicycle was not entangled with the undercarriage but was simply pulled out. The lack of vehicle damage and entanglement with the undercarriage indicated that the rear aspect of the vehicle had passed over the top of the child and bicycle. Then as the rear axle/differential contacted the bicycle helmet, the helmet crushed and the child was injured.

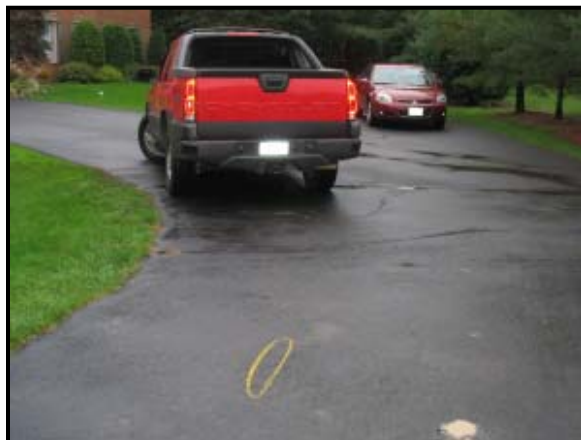
A 61 cm (24 in) scratch was identified on the driveway oriented in an east/west direction. The scratch was in alignment with the left pedal of the bicycle. **Figure 8** is a view of the scratch location relative to the reconstructed position of the Avalanche. As the Chevrolet backed up, the

Figure 8: Scratch location relative, to the Chevrolet.

bicycle was pushed westward. This action abraded the left pedal and scratched the asphalt surface of the driveway. During this movement, the handle bars of the bicycle contacted the undercarriage and the bars rotated approximately 30 degrees about the center pivot.

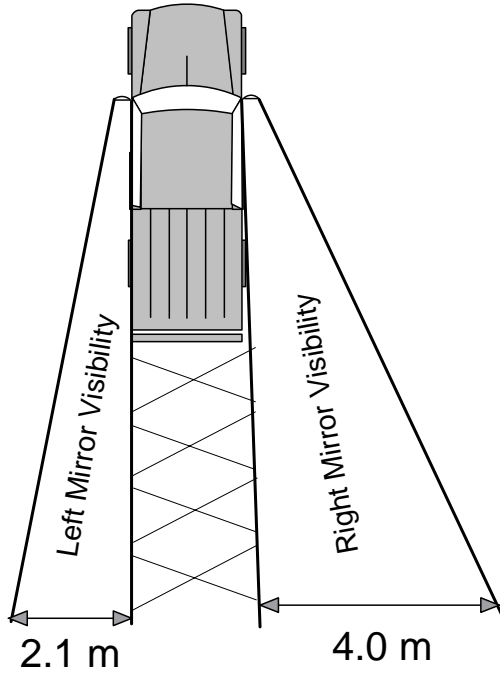
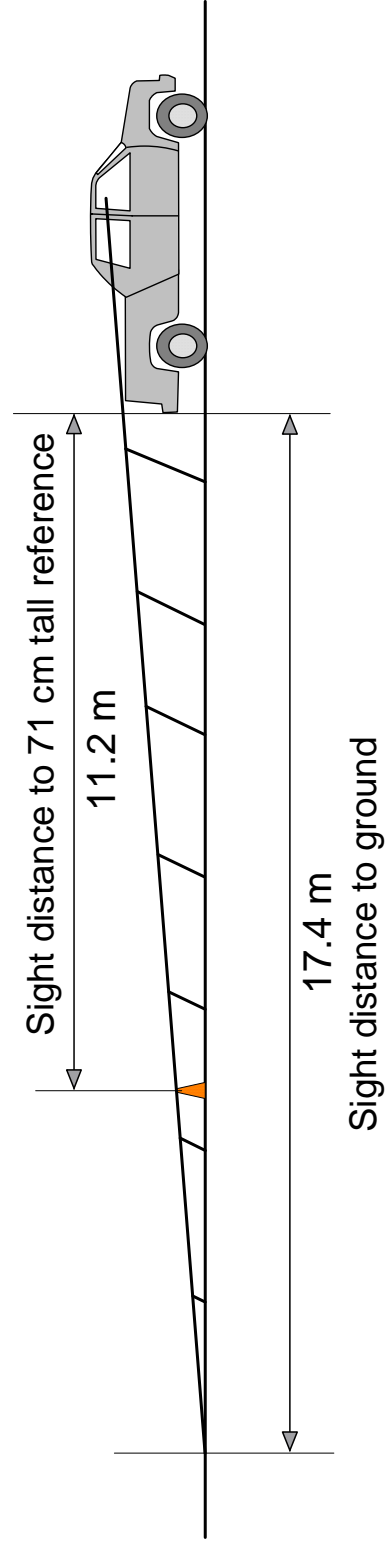
**On-Site Rear Visibility Diagram
CA06-024**

The rear visibility of the Chevrolet was measured with the vehicle located at the point it first began to back up. The actual driver involved in this backover crash was used in this study. A 71 cm (28 in) tall red reflective target was placed on the vehicle's centerline and moved rearward to a location where the driver could first see the red target by looking over his right shoulder. The centerline visibility distance was measured from the rear bumper. A second measurement was taken with the target placed at ground level. The measured distance is summarized below:

- Sight distance to 71 cm (28 in) target: 11.2 m (36.8 ft)
- Sight distance to ground level target: 17.4 m (57.1 ft)

Cones of visibility were also established using the outside mirrors. A 4.6 m (15 ft) distance from the rear bumper was used as an arbitrary reference location. The driver was asked to locate the 71 cm (28 in) target laterally relative to the centerline in a normal seated position. The cone for the left mirror began 0.8 m (2.75 ft) left of center and ended 3.0 m (9.7 ft) left of center. The cone for the right mirror began 1.2 m (3.8 ft) right of center and ended 5.2 m (17.2 ft) right. These visibility measurements are depicted graphically at the end of this report. The measured visibility fields confirmed the fallen bicyclist was not visible to the driver as the Chevrolet backed up.

Note: Cone of mirror visibility measured 4.6 m aft of rear bumper
