Certified Advanced 208-Compliant Air Bag Investigation / Multiple Vehicles
Dynamic Science, Inc. / Case Number: DS06028
2005 Chevrolet Trailblazer LS
Washington
October 2006

1. Report No. DS06028	2. Government Accession No.		3. Recipient Catalog No.	
4. Title and Subtitle Certified Advanced 208-Compliant Air Bag Investigation			5. Report Date May 7, 2007

Background

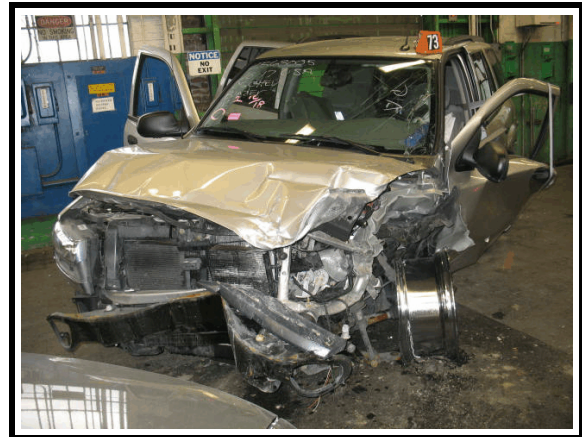
Figure 1. Front/Left - 2005 Chevrolet Trailblazer

Damage Description: The 2005 Chevrolet Trailblazer sustained moderate front end damage as a result of the impact with the back of the trailer. The vehicle sustained 110.0 cm (43.3 in) of direct damage along the front bumper, beginning 25.0 cm (9.8 in) right of the precrash center point of the vehicle, extending to the left front bumper corner. The bumper cover was no longer attached to the vehicle and was found in the passenger compartment. The left front tire was debanded and the left wheelbase was shortened by 35.0 cm (13.8 in).

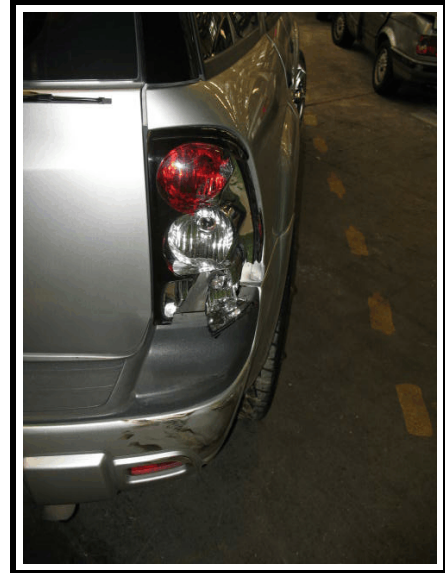
Figure 3. Back/right damage - 2005 Chevrolet Trailblazer

The case vehicle sustained light back end damage as a result of the secondary impact with the Acura. The vehicle sustained 19.0 cm (7.5 in) of direct damage along the back bumper, beginning 66.0 cm (26.0 in) right of the vehicle's precrash center point, extending to the right. Six crush measurements were documented along the back bumper as follows: C1= 0.0 cm, C2=0.0 cm, C3=0.0 cm, C4=0.0 cm, C5=0.0 cm, C6=0.0 cm. Even though there was no crush from the event, the location most representative of maximum crush was at the right rear bumper corner. The CDC for this event was 06BREN1.

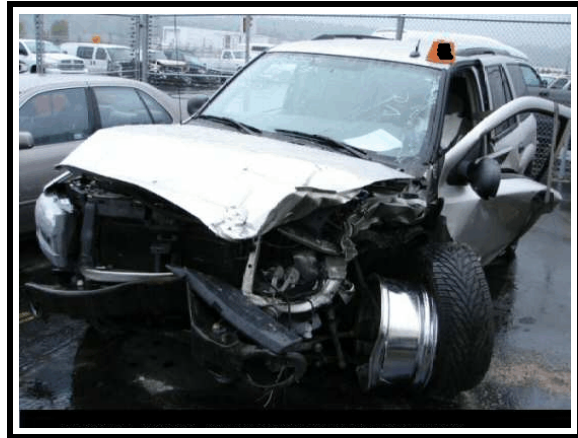
Figure 7. Debeaded LF tire (not with vehicle at the inspection)

Position	Measured Pressure	Measured Tread Depth	Restricted	Damage
LF	Flat	Unknown	Yes	Tire debeaded
LR	207 kPa (30 psi)	7 mm (9/32 in)	No	None
RR	207 kPa (30 psi)	7 mm (9/32 in)	No	None
RF	172 kPa (25 psi)	7 mm (9/32 in)	No	None

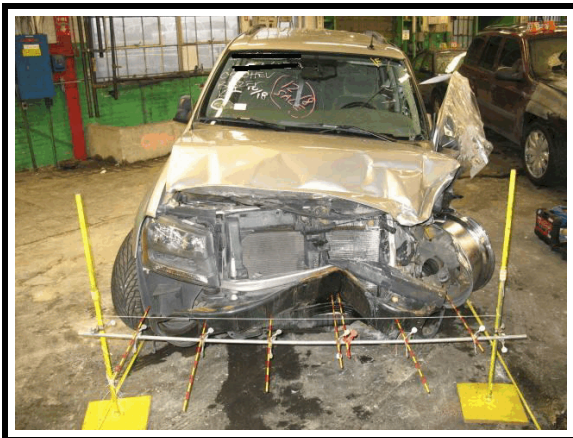
The front of the case vehicle underode the back of the semi tractor-trailer, resulting in substantial above bumper damage. Crush profiles were taken at both the bumper level and the above bumper level. Six crush measurements were documented along the front bumper as follows: C1= 23.0 cm (9.1 in), C2=7.0 cm (2.8 in), C3=32.0 cm (12.6 in), C4=13.0 cm (5.1 in), C5=0.0 cm (0.0 in), C6=2.0 cm (5.5 in). Six crush measurements were documented along the radiator support as follows: C1= 37.0 cm (14.6 in), C2=17.0 cm (6.7 in), C3=8.0 cm (3.1 in), C4=2.0 cm (0.8 in), C5=2.0 cm (0.8 in), C6=0.0 cm (0.0 in).

The maximum bumper crush was located 17.0 cm (6.7 in) left of the centerpoint and measured 33.0 cm (13.0 in).

The Collision Deformation Classification (CDC) for this event was 12FYEW2.

Figure 8. Front crush profile - bumper level

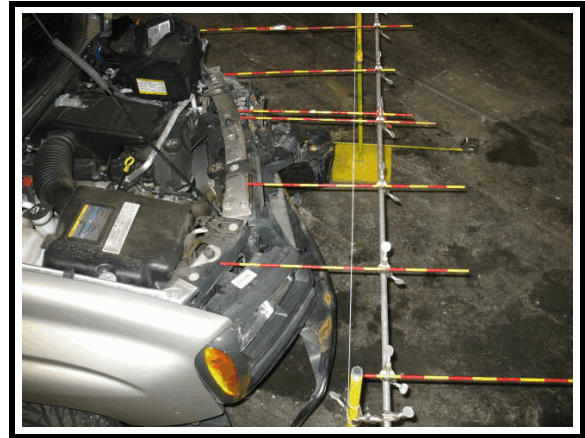
At C1 and C2, there was above bumper crush that exceeded the bumper crush by more than 13.0 cm (5.1 in) and those crush measurements were averaged. The resultant crush profile was as follows: C1 = 30.0 cm (11.8 in), C2=7.0 cm (2.8 in), C3=32.0 cm (12.6 in), C4=13.0 cm (5.1 in), C5=0.0 cm (0.0 in), C6=2.0 cm (5.5 in).

Figure 10. Above bumper crush profile - view from right

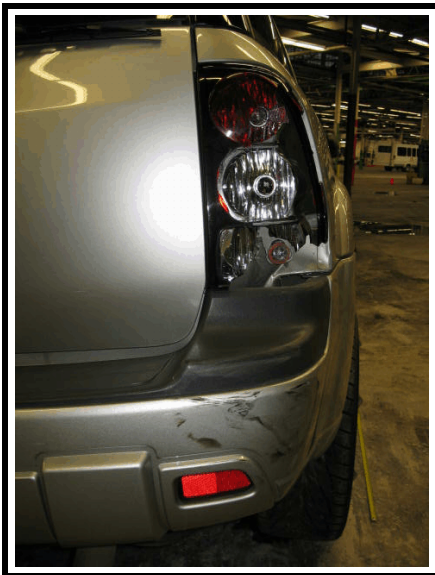
Figure 11. Back/right damage from secondary impact

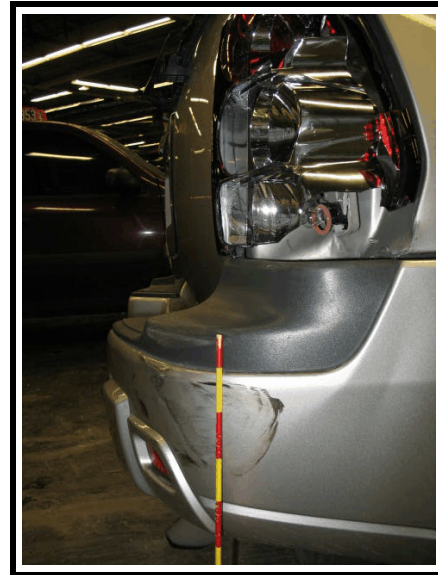
Figure 12. Right rear bumper corner/taillight damage

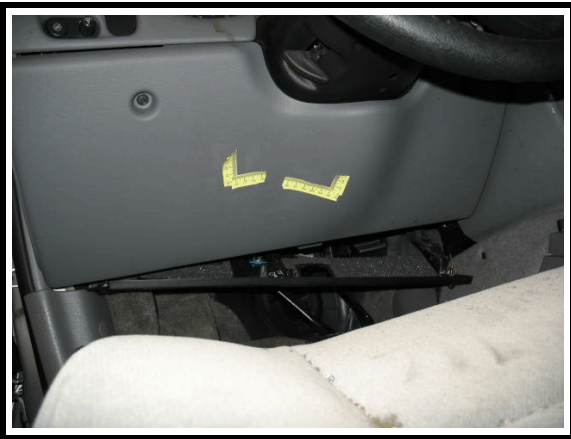
There were scuffs to the lower left instrument panel, likely due to contact from the driver's left knee. There was a faint scuff to the center of the left A pillar, which may have been a result of contact from the driver's left arm or hand.

Figure 13. Scuffs below steering column

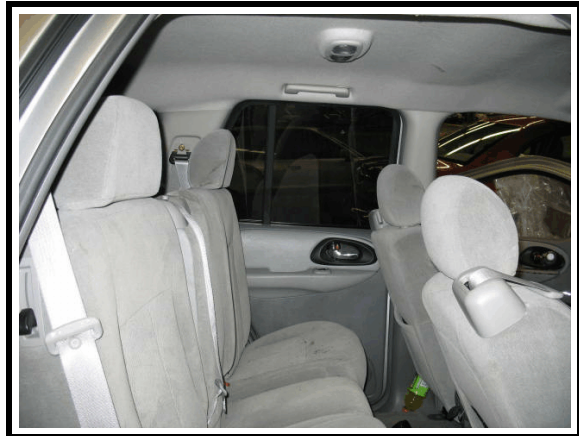
The second row seatback was damaged and had intruded longitudinally into the second row seating area. The damage was caused by contact from subwoofers that had been installed behind the seat backs.

Figure 14. Damage to 2nd row seatbacks

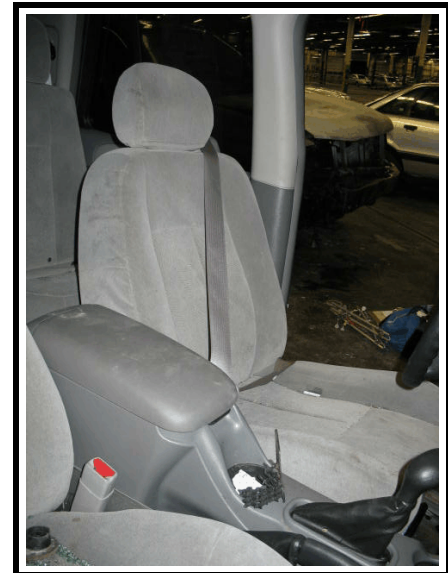
Both front row seats and the second row center seat were equipped with integral seat belts. The driver's safety belt was configured with a sliding latch plate and an emergency locking retractor (ELR). There were scuffs and discolorations on the driver's seat belt webbing, but they were in areas that had been wrapped around the left front door. This belt was used to secure the left front door to the vehicle. There were no signs of occupant loading to the driver's seat belt.

Figure 16. Driver's seat belt

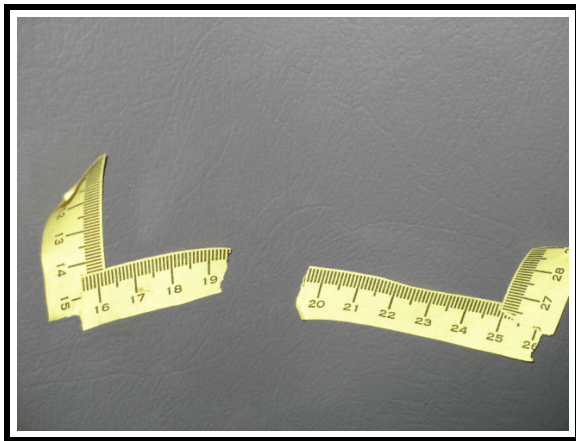
Figure 18. Close-up – scuffs below steering wheel

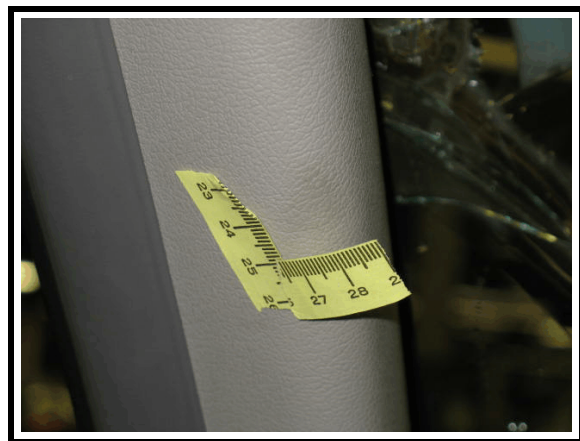
Figure 19. Possible occupant contact to left A pillar

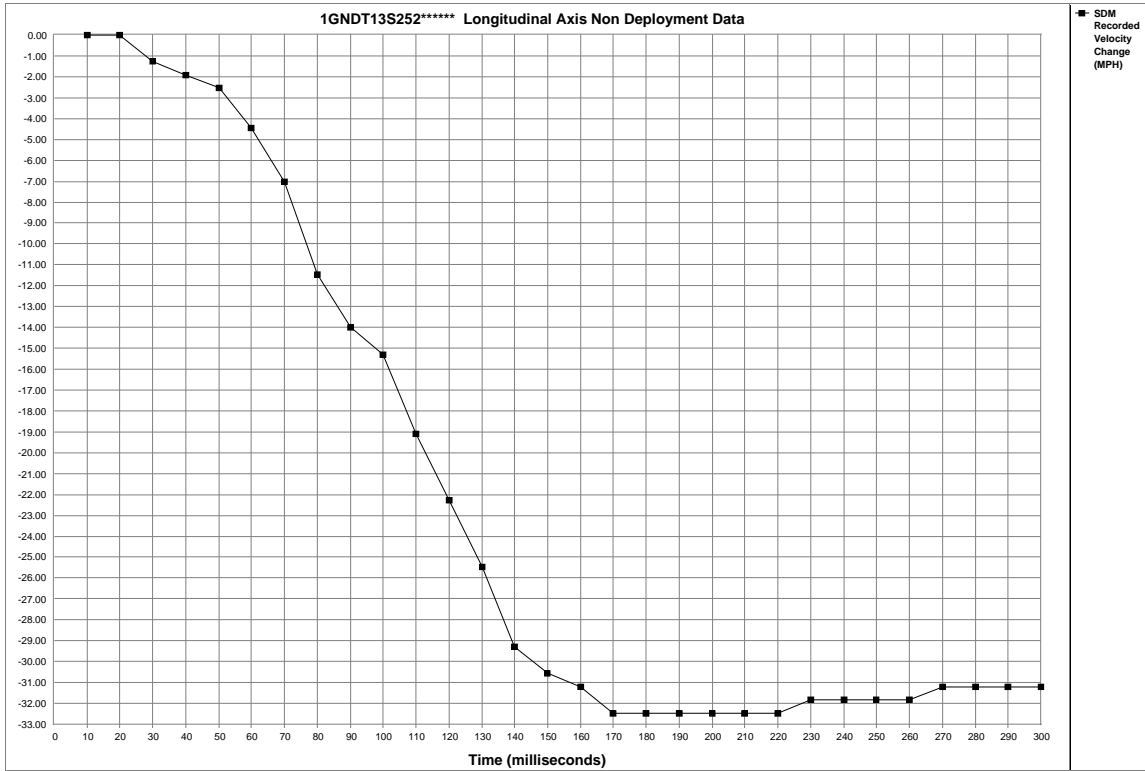
Generally, the deployment criteria must be met within the first 40ms of AE. According to the data downloaded from the case vehicle’s EDR, the longitudinal delta V at 40ms was reported to be -3.1 kmph (-1.91 mph).

Time (milliseconds)	10	20	30	40	50	60	70	80	90	100	110	120	130	140	150
Longitudinal Axis Recorded Velocity	0.00	0.00	-1.27	-1.91	-2.55	-4.46	-7.00	-11.46	-14.01	-15.28	-19.10	-22.29	-25.47	-29.29	-30.56
Time (milliseconds)	160	170	180	190	200	210	220	230	240	250	260	270	280	290	300
Longitudinal Axis Recorded Velocity	-31.20	-32.47	-32.47	-32.47	-32.47	-32.47	-32.47	-32.47	-31.84	-31.84	-31.84	-31.84	-31.20	-31.20	-31.20
