**NOT-IN-TRAFFIC SURVEILLANCE
CALSPAN ON-SITE BACKOVER FATALITY INVESTIGATION**

CASE NO: CA06-028

VEHICLE: 2005 CADILLAC ESCALADE ESV

CRASH DATE: NOVEMBER 2006

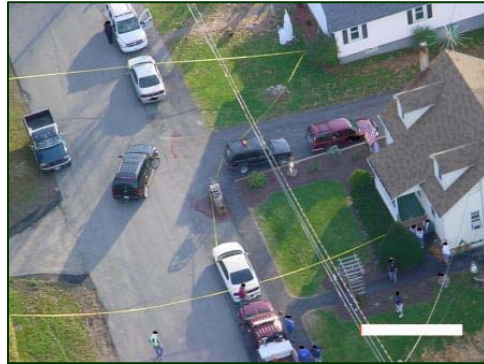
Figure 1. Aerial view of the crash site and the stopped position of the Cadillac Escalade.

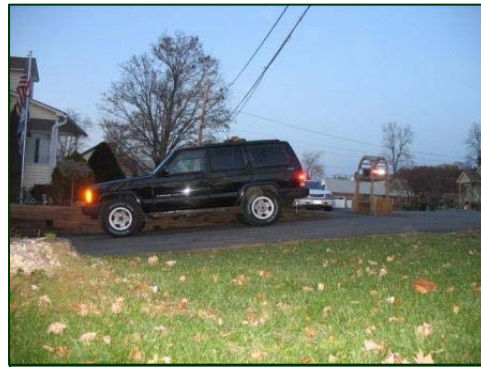
Figure 3. Lateral view of the driveway positive 13.5 percent slope.

Although the above measurements reflect a level surface, the rear visibility site distance was greatly affected by the 13.5 percent (7.7 degrees) positive slope of the subject driveway. On this slope, the sight distance would have gone to infinity as the ground behind the vehicle would not have been visible to the driver. Her line of sight while backing would have been limited to the sky and the upper level of the neighboring houses.

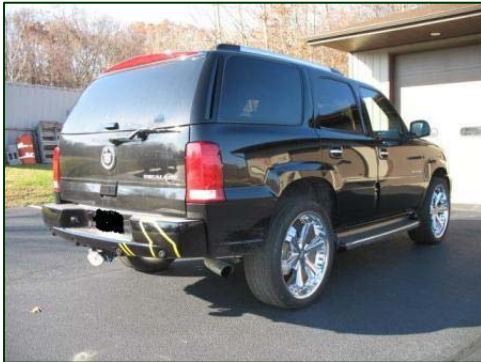
Figure 4. Right rear view of the Cadillac Escalade and OEM window tint.

The laminated windshield and the front door glazing were standard SolarRay glass with minimal OEM tint. The rear door glass, rear quarter windows, and the backlight glass were OEM deep-tinted AS3. The transparency rating of the backlight glass was labeled at 13 percent. All windows were fully closed at the time of this incident.

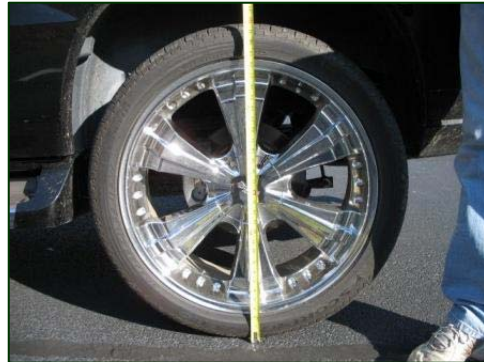
The involved vehicle was a 2005 Cadillac Escalade ESV (**Figure 4**) Sport Utility Vehicle (SUV) that was purchased used by the driver's husband at an auto auction. He stated that he owned the vehicle for approximately three months. The Cadillac was manufactured on 9/04 and was identified by Vehicle Identification Number (VIN) 1GYEK63N55R (production number deleted). The odometer reading was 57,619 km (35,804 miles) at the time of the SCI inspection. The Cadillac was a four-door SUV that was configured with eight-passenger seating (2-3-3). The Escalade was a full-time all-wheel drive vehicle that was equipped with power-assisted four-wheel disc brakes with anti-lock (ABS), traction control, and Stabili-Trac electronic stability control. The Escalade was powered by a 6.0 liter conventionally mounted V-8 engine linked to a four-speed automatic transmission with a column mounted transmission selector lever. The OEM 265/70R17 tires and wheels were replaced prior to the auction purchase with aftermarket 305/35ZR/24 Pirelli Scorpion Zero tires on chrome surfaced six-spoke alloy wheels. These tires (**Figure 5**) had a diameter of 82 cm (32.4") with a tread width of 28 cm (11"). The OEM spec tire

had a diameter of 80 cm (31.6”). The specific tire data at the time of the SCI inspection was as follows:

Figure 5. Aftermarket tire/wheel diameter.

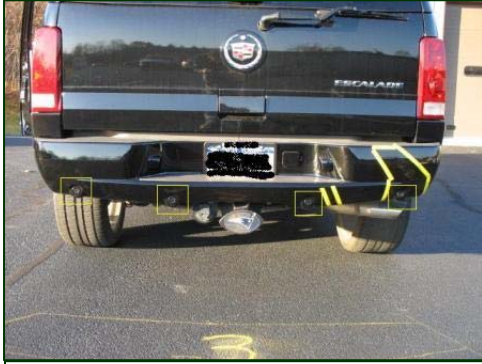
Figure 6 is a view of the rear bumper ultrasonic sensors. The sensors were flush mounted within the fascia at an average elevation of 53 cm (21") above the ground. The outboard sensors were located 94 cm (37") right and left of the vehicle's centerline respectively. The respective inboard sensor locations measured 28 cm (11") from the centerline. The width of the bumper measured 166 cm (65.5").

Figure 6. Rear bumper ultrasonic sensors.

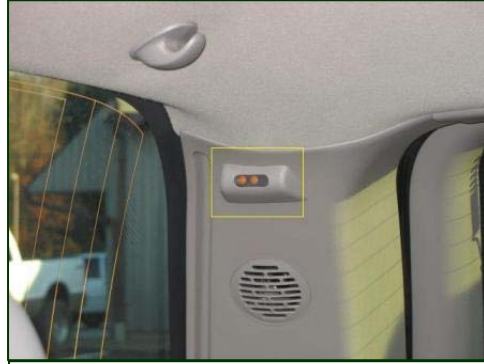
Figure 7. URPA display on the right D-pillar.

Figure 7 is an interior view of the right D-pillar and the URPA display. The display utilized three colored-coded lights to provide distance and system information to the driver. When the vehicle’s transmission was shifted to reverse the display’s three lights illuminated for 1.5 seconds to inform the driver the system was operational. Then if an object was detected at a reverse speed less than 5 km/h (3 mph), one of the following occurred:

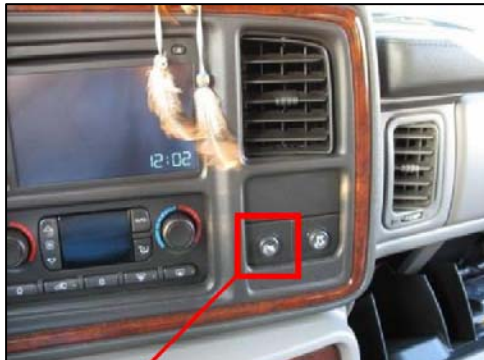
Figure 8 is a view of the mid instrument panel mounted On/Off switch used to disable the system. A small diameter amber indicator light was located immediately left of the switch and provided visual information to the driver of the system status. If the URPA system was turned OFF, the instrument panel indicator light was illuminated and the D-pillar mounted display was dark with no lights illuminated.

Figure 8. URPA On/Off switch.

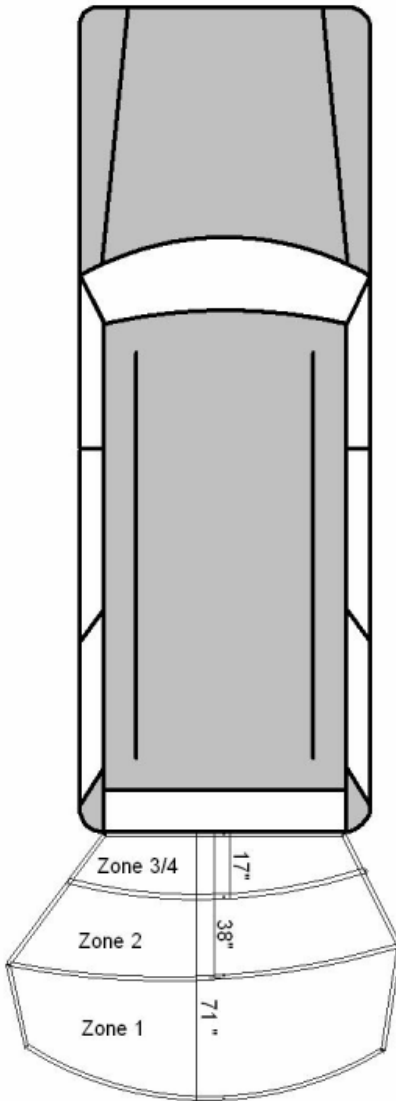
The sensor array pattern was measured at the time of the SCI inspection and is included as **Figure 9** on the following page. The measured object detection for Zone 1 on the vehicle’s centerline extended to 180 cm (71’). The transition from Zone 1 to Zone 2 detection measured 97 cm (38’). The distance to Zone 3 detection measured 43 cm (17’). The maximum width of the conical pattern in Zone 2 measured 267 cm (105’).

Figure 9. Measured URPA sensor array pattern.

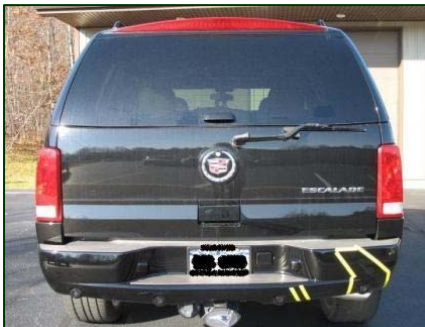
Figure 12. Rear contact plane of the Cadillac Escalade.

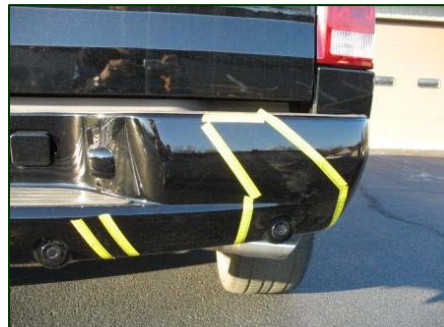
The pedestrian's contact with the face of the back right bumper fascia did not result in damage to the vehicle. Two scuff marks were noted to the rear bumper that collected dust which evidenced the contact area (**Figure 12**). A small diagonally oriented mark was noted 37 cm (14.5") right of center and extended 6 cm (2.5") vertically on the face of the bumper. A larger mark was noted outboard of the previously identified mark and was located 62-79 cm (24.5-31") right of center and was 28 cm (11") in height extending the full height of the bumper fascia (**Figure 13**). This contact area surrounded the right outboard backing sensor. At the lower right aspect of this contact point was a vertically oriented patterned mark that resembled a fabric impression. There was no abrasion to the polished surface of the fascia. It should be noted that the investigating officer indicated that the outboard contact point resembled a hand print immediately following the crash. The hand print was not apparent at the time of this SCI inspection which occurred five days post-event. An aftermarket cover/plug was positioned in the receiver trailer hitch of the Escalade. This cover was gouged and fractured from a previous event. There was no other contact evidence to the back plane of the Escalade.

Figure 13. Pedestrian contact evidence to the rear bumper fascia.

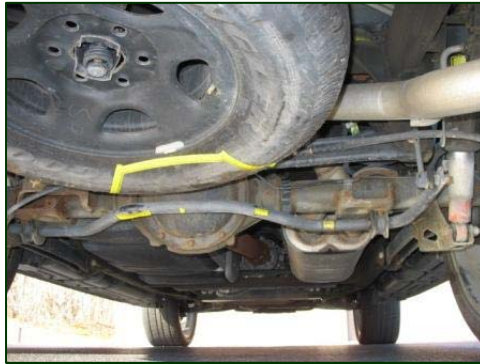
Figure 14. Undercarriage contact evidence to the spare tire and rear sway bar.

The undercarriage of the Escalade yielded several contact points as the vehicle overrode the child pedestrian. The forward aspect of the spare tire sidewall contained a wipe mark (area where the road film had been removed) that was longitudinally oriented. The wipe mark was 33 cm (13") in width at the tread area and tapered to 20 cm (8") in width, terminating 10 cm (4") rearward of the tread area. The contact originated 10 cm (4") left of center, extending 23 cm (9") to the right of the vehicle. This contact point was located 85-95 cm (33.5-37.5") forward of the rear bumper face.

The aft surface of the rear sway bar contained two wipe marks from pedestrian contact. The first wipe mark was located 8-18 cm (3.25-7") left of center and was located 99 cm (39") forward of the rear bumper face. The second wipe mark was located 16-19 cm (6.25-7.5") right of center and located 100 cm (39.5") forward of the bumper face. **Figures 14 and 15** are images of the undercarriage contact points. There was no other contact evidence to the undercarriage components. The police investigator did note that body fluid was present on the tread of the front right tire at the time of the crash. The vehicle was towed directly from the crash scene to the impound lot and stored outdoors uncovered prior to this investigation.

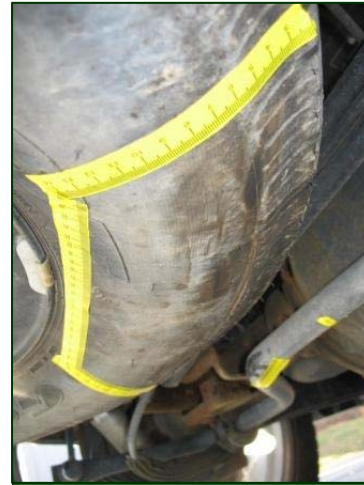
Figure 15. Right lateral view of the spare tire wipe mark.

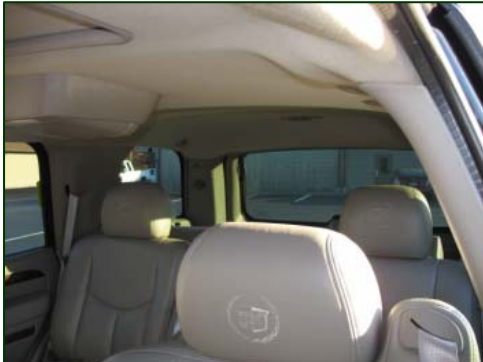
The rear visibility from the driver's position of the Escalade was affected by the width of the C- and D-pillars, as well as by the second row head restraints. The seats in the third row of the subject vehicle were folded down at the time of the crash and did not affect the visibility. **Figures 16 and 17** are views looking to the right rear along the approximate driver's line of sight. A large blind spot was created by the wide C-pillar and second row right head restraint. This blind spot was directly along the child's travel path. For reference, a 183 cm/100 kg (72"/200 lb) male was not visible to the driver at a location 2.6 m (8.5') right and 1.1 m (3.6') behind the right rear corner of the Escalade. These visibility measurements are depicted graphically in **Figure 18** at the end of this report.

Figure 16. Driver's view to the blind spot at the right C-pillar.

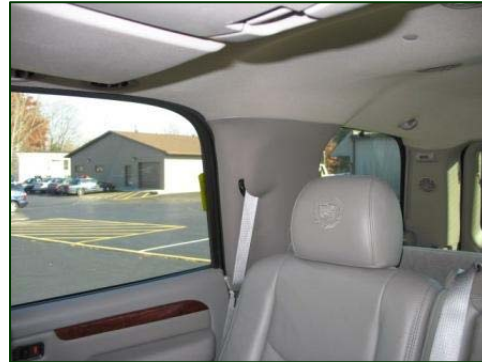
Figure 17. Additional view of the C-pillar blind spot.
