**CALSPAN ON-SITE ADVANCED OCCUPANT PROTECTION SYSTEM
CRASH INVESTIGATION**

SCI CASE NO.: CA06-030

VEHICLE: 2006 LEXUS IS250

CRASH DATE: DECEMBER 2006

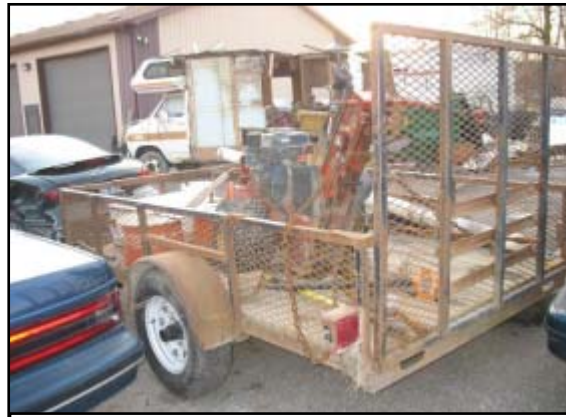
The Ford was towing a single axle trailer (**Figure 2**) that was home-built by the owner of the vehicle. The trailer was connected to the Ford using a receiver hitch with a pintle hook hitch system. The receiver hitch had a maximum tongue weight of 136 kg (300 lbs). The trailer was constructed of square steel box beam. The sides and the ramp were skirted with steel grating and the floor consisted of wood planks. The trailer's contents included landscaping tools, wire spools, and a trenching machine. The police investigators weighed the trailer and its contents which yielded a total weight of 1,134 kgs (2,500 lbs).

Figure 2. Left rear oblique view of the trailer.

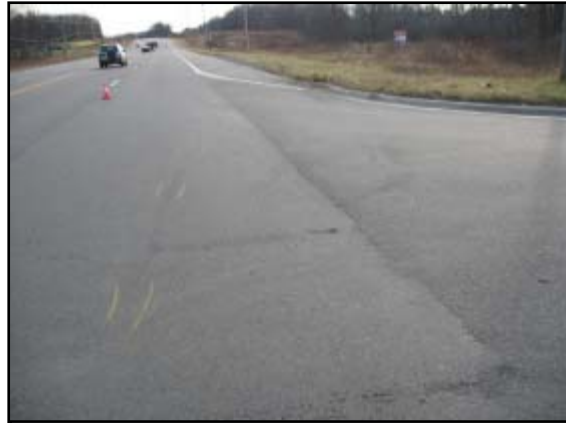
The front left corner of the Ford initially impacted the right front side area of the Lexus within the southwest quadrant of the intersection (**Figure 4**). The initial impact resulted in a 1 o'clock direction of force to the Lexus. This longitudinal direction of force and the predicted crash severity by the vehicle's air bag control module deployed the frontal air bag system, inclusive of the knee bolster air bags, and fired the front and rear safety belt pretensioners. As the vehicles continued to crush, the Lexus rotated counterclockwise. At maximum engagement, the full frontal aspect of the Ford was in contact with the right front and center sections of the Lexus.

Figure 4. Area of impact and post-impact physical evidence.

The vehicles disengaged from the impact and began to travel in a southwesterly direction. A secondary impact occurred during the post-crash travel as the front of the Ford contacted the right quarter panel of the Lexus. This contact resulted in minor damage to the Lexus. Numerous gouges from the undercarriage of the Lexus and a locked left front tire scuff from the Ford evidenced the area of impact and post-impact travel of the vehicles across the intersection.

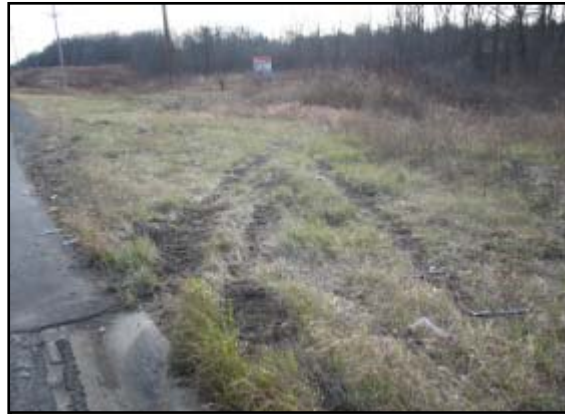
Figure 5. Post-impact off-road travel of the Lexus.

The Ford and Lexus departed the southwest corner of the roadway and entered the shoulder area. A fluid spill and scuffmarks from the front right tire of the Lexus and the left rear wheel of the trailer were documented on the shoulder. Two rotating tire marks (front tires) from the Lexus continued onto the grass roadside and extended in a southwest trajectory to final rest (**Figure 5**). The left front tire mark

measured 30.4 meters (99.7 feet) and the right front tire mark measured 36.1 meters (118.4 feet). The post-impact travel distance for the Lexus was 49 meters (160 feet).

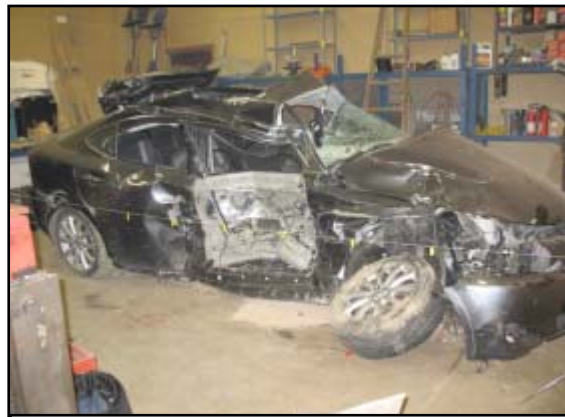
The 2006 Lexus IS250 sustained severe right side damage as a result of the initial impact with the Ford (**Figure 6**). The direct contact damage began at the leading edge of the right fender and measured 212 cm (83.5"), terminating 71 cm (28") forward of the right rear axle. The damage consisted of severe lateral deformation of the right fender, doors, sill, and roof side rail. Maximum crush was located 8 cm (3") forward of the center aspect of the right front door and measured 64 cm (25.2"). Six crush measurements were documented at the mid-door level using a combined direct and induced damage width of 224 cm (88") and were as follows: C1 = 11 cm (4.3"), C2 = 13.8 cm (14.6"), C3 = 64 cm (25.2"), C4 = 32 cm (12.6"), C5 = 35 cm (13.8"), C6 = 19 cm (7.5"). The Collision Deformation Classification (CDC) for this impact was 01-RYAW-4.

Figure 6. Resultant right side damage from the impact with the Ford.

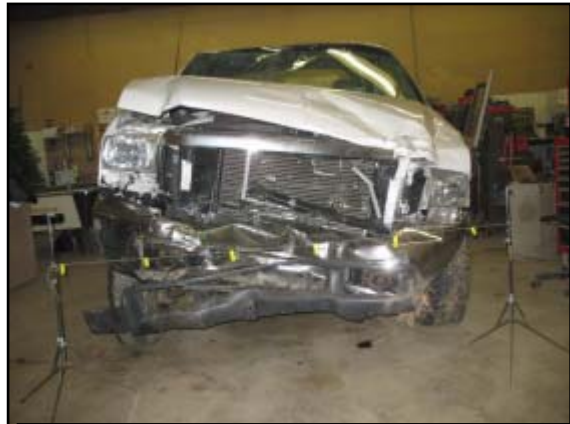
The Ford sustained moderate severity damage as a result of the impact with the Lexus (**Figure 7**). The direct contact damage measured 178 cm (70") and extended the full width of the front bumper. The maximum crush measured 20 cm (7.9") and was located at the front right bumper corner. A crush profile was documented along the bumper and the crush was as follows: C1 = 0 cm, C2 = 0 cm, C3 = 19 cm (7.5"), C4 = 20 cm (7.9"), C5 = 4 cm (1.6"), C6 = 20 cm (7.9"). The CDC for this impact was 12-FDEW-1.

Figure 7. Frontal damage to the 1993 Ford F-350.

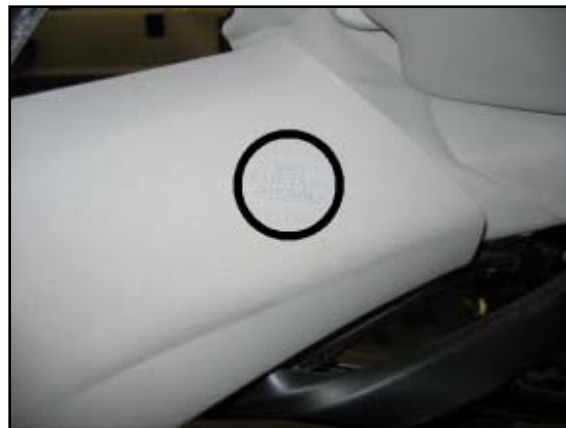
The 2006 Lexus IS250 was equipped with seatback mounted side impact air bags for the front seats and curtain air bags for the left and right outboard seating positions (**Figure 8**). The manufacturer's safety systems data indicated that the air bag system was designed to deploy in certain types of severe side impacts. The right side impact air bag system did not deploy in this crash

Figure 8. Right A-pillar curtain air bag label.

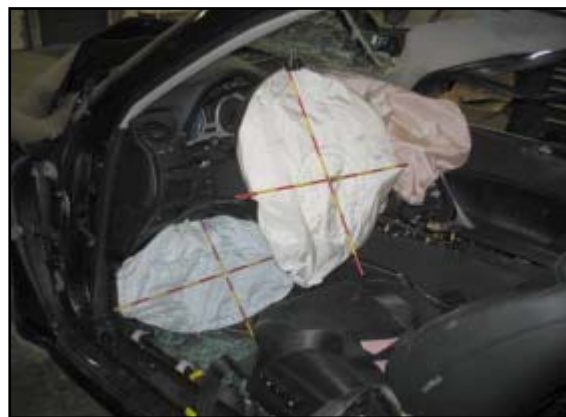
Figure 9. Deployed driver's frontal air bag system.

membrane was tethered by two wide band tethers at the 3 and 9 o'clock positions and was vented by two unconventionally shaped ports on the rear panel at the 11 and 1 o'clock sectors. The vent ports measured 2 cm (0.75") in height and 0.6 cm (0.25") in width. The air bag membrane measured 56 cm (22") in diameter in its deflated state and was free of damage and occupant contacts. Spattered body fluid was noted on the face of the membrane extending across the 6 and 9 o'clock sectors. **Figure 9** is a view of the deployed driver's frontal air bag system.

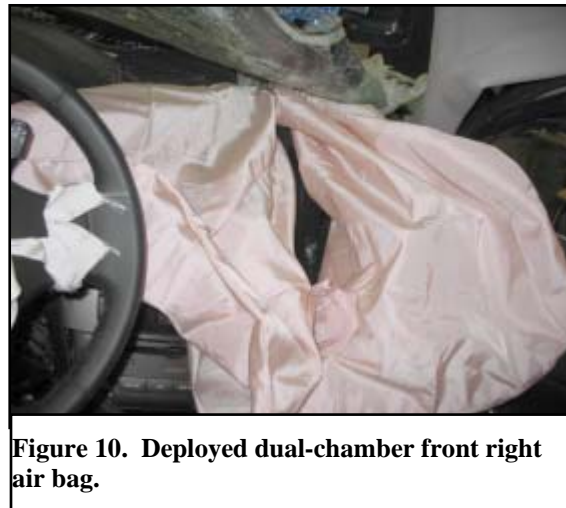
The front right air bag was located in the top instrument panel and deployed as a result of the crash sequence with the Ford (**Figure 10**). The cover flaps were concealed by the gross intrusion of the right A-pillar and door and were not inspected. The air bag membrane was a unique design which contained two separate membranes that formed dual-chambers. The membranes were stitched together at the deployed face using a 13 cm (5") semi-circle fabric section. The chambers were independently vented by a single vent port on the side panels at the 9 and 3 o'clock sectors. The vent ports were located 18 cm (7") rear of the forward seam and were 5 cm (2") in diameter. Both chambers were tethered by oval shaped tethers that measured 7 cm (2.75") in width and 10 cm (4") in height and were sewn to the side panels of the air bag. The air bag was free of damage and occupant contact points.

Figure 10. Deployed dual-chamber front right air bag.

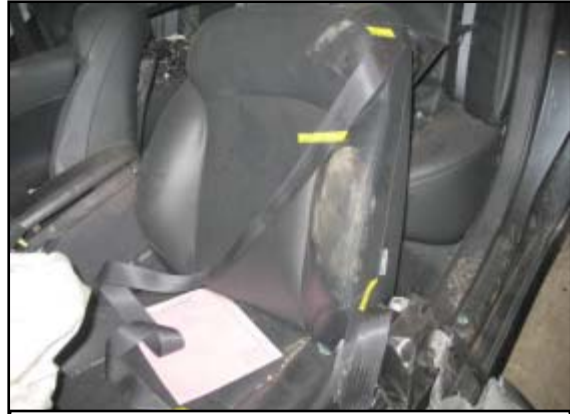
The Lexus IS250 was equipped with manual 3-point lap and shoulder safety belts for all five seating positions. The driver's safety belt (**Figure 11**) consisted of a sliding latch plate, Emergency Locking Retractor (ELR), height adjustable D-ring, and a retractor mounted pretensioner that fired during the crash. The safety belt was cut at three locations by fire department personnel. The lap portion of the webbing was cut 37 cm (14.5") above the floor anchor. This webbing section was free of crash related evidence. The central section of the webbing measured 155 cm (61") and would have been

positioned across the driver's torso and lap. Examination of the webbing revealed occupant loading evidence in the form of waffling throughout this section. The upper section measured 79 cm (31"). Rescue personnel cut the B-pillar and deflected it downward exposing the retractor. The upper section of the cut belt was measured from the exposed retractor. This section of webbing contained possible loading evidence that appeared to be transferred plastic from the interior trim panel. The latch plate was found fastened in the buckle. A full width frictional abrasion to the plastic surface was identified.

Figure 11. Driver's safety belt.
