ON-SITE CHILD SAFETY SEAT INVESTIGATION

CASE NUMBER - IN-06-034

VEHICLE - 2003 HYUNDAI ELANTRA XD

CRASH DATE - November 2006

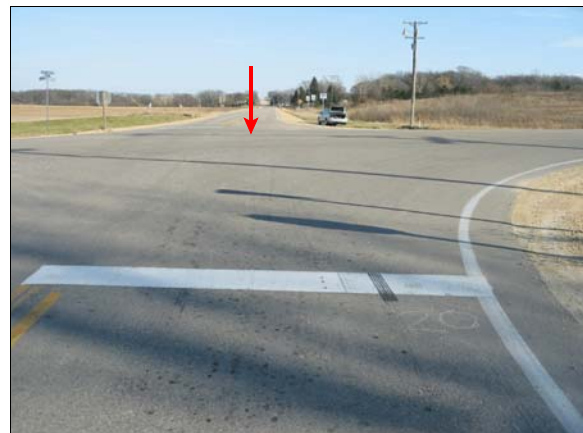
Figure 1: Case vehicle eastbound approach to impact area (denoted by arrow)

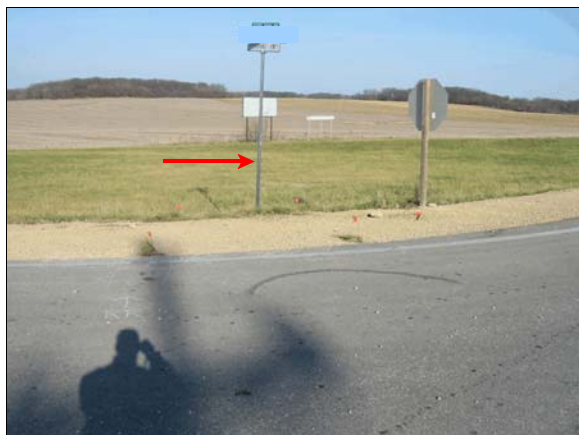
Figure 6: Case vehicle's roadway departure, arrow shows location of impacted street sign

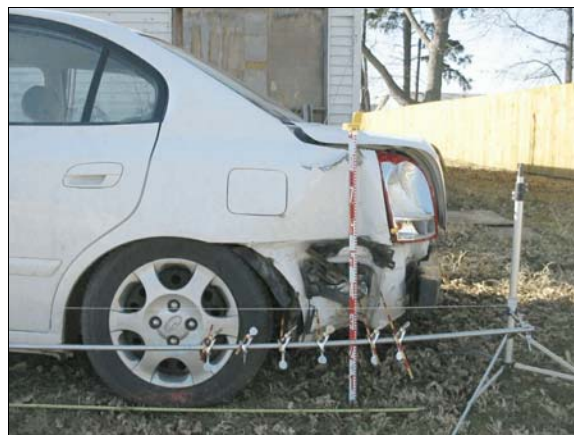
Figure 7: Overview of left quarter panel damage from impact with street sign

The case vehicle's impact with the street sign involved the left quarter panel. Direct damage was limited to the left quarter panel and the back bumper fascia that wrapped around the back left corner. Direct damage began 338 centimeters (133 inches) rear of the left front axle and extended 13 centimeters (5.1 inches) rearward along the left quarter panel. Crush measurements were taken at the middle door level of the left quarter panel. The residual maximum crush was measured as 13 centimeters (5.1 inches) at C₂ (**Figure 11**). The table below shows the case vehicle's left side crush profile.

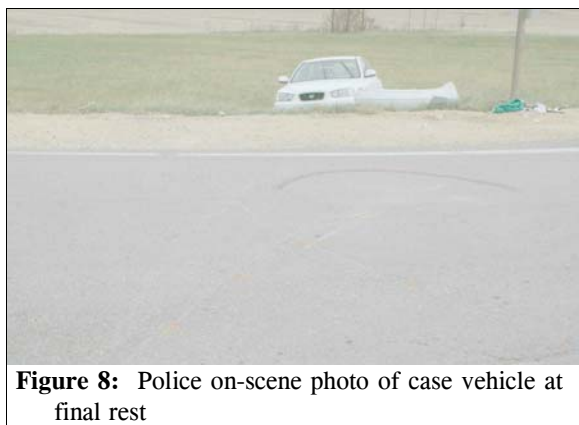
Figure 8: Police on-scene photo of case vehicle at final rest

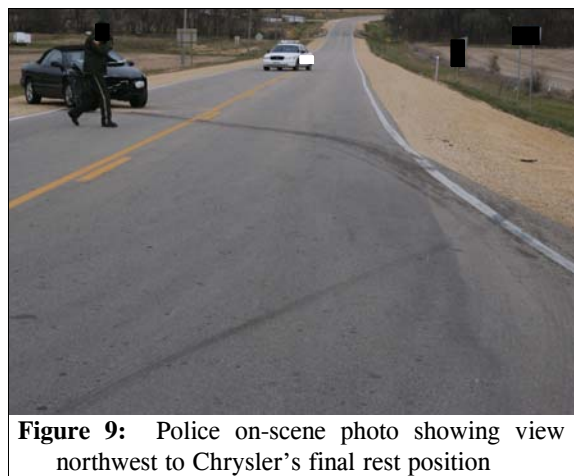
Figure 9: Police on-scene photo showing view northwest to Chrysler's final rest position

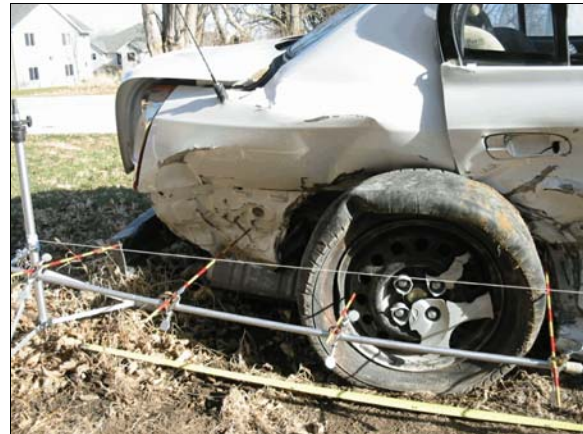
Exterior Damage: The case vehicle's impact with the Chrysler involved the rear half of the right side. The right rear door, right rear wheel, right quarter panel, rear bumper, and rear bumper fascia were directly damaged and crushed inward. In addition, the rear bumper was slightly displaced rearward. Direct damage began 184 centimeters (72.4 inches) rear of the right front axle and extended 166 centimeters (65.3 inches) rearward to the right rear bumper corner. Crush measurements were taken along the lower door level and the residual maximum crush was measured as 32 centimeters (12.6 inches) occurring at C₂ (**Figure 10**). The table below shows the case vehicle's right side crush profile.

Figure 10 Damage to right rear wheel, right rear door and quarter panel

The case vehicle's left side wheelbase was extended 9 centimeters (3.5 inches) while the right side wheelbase was reduced 1 centimeter (0.4 inches). Induced damage from the impact with the Chrysler involved the lower right C-pillar and the right rear window, which disintegrated as a result of the impact. Induced damage from the street sign impact involved the left rear taillight assembly. No other induced damage was noted on the remainder of the case vehicle.

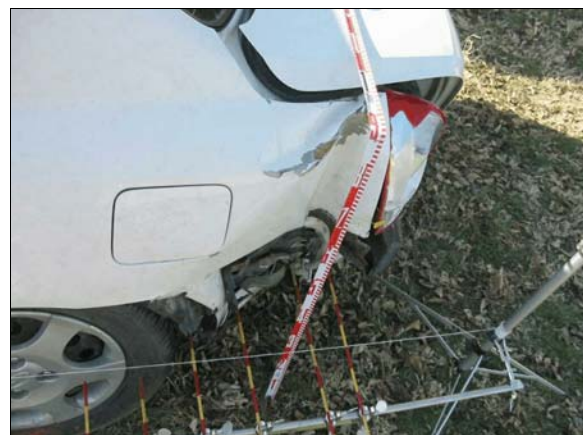
Figure 11: Left quarter panel damage from sign impact, vertical scale in tenths of meter, each increment on rods is 5 cm (2 in)

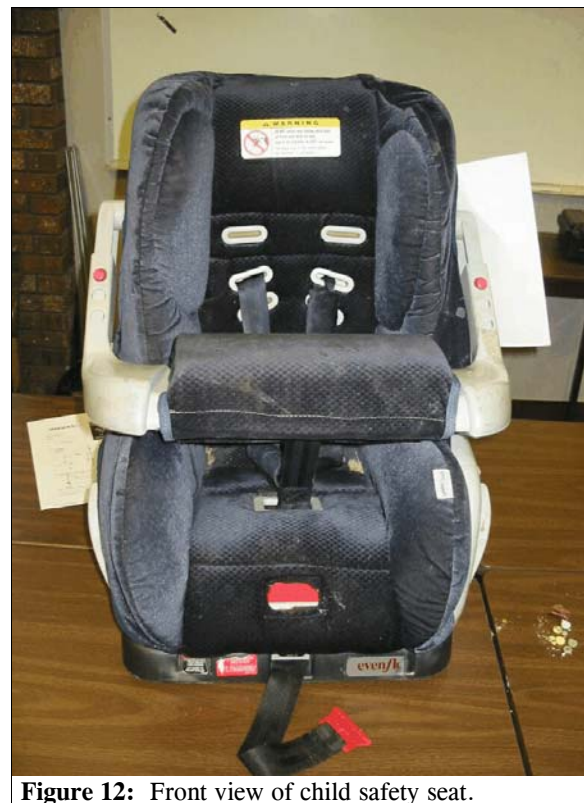
Figure 12: Front view of child safety seat.

Inspection of the child safety seat showed a few stress marks in the plastic on the left edge of the plastic shell and the front right portion of the child seat base. There was no evidence of stress or damage to the remainder of the child safety seat, including the harness webbing, buckle, and latch plate. Discussions with the sheriff's deputies indicated that the case vehicle's safety belt was not used to secure the child safety seat during the crash. The child safety seat was found secured only by the tether strap. In addition, the right harness strap was found detached from the harness retainer clip. Furthermore, through conversations with the child's father, it was learned that the child would frequently undo the harness retainer clip. The child's medical records also indicated that the child's mother reported the child would commonly work her way out of the child safety seat. Given the position of the harness straps in the middle slots, this may indicate that the straps were not properly adjusted for the size of the child and were uncomfortable. It is possible that the child unhooked the harness retainer clip and may have pushed the harness straps aside at some point prior to the crash, which contributed to the child being ejected from the child safety seat and through the right rear window as discussed in the following section.

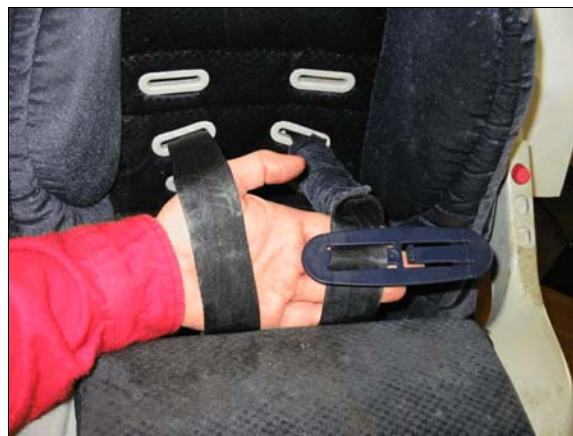
Figure 13: Child safety seat's harness straps and harness retainer clip

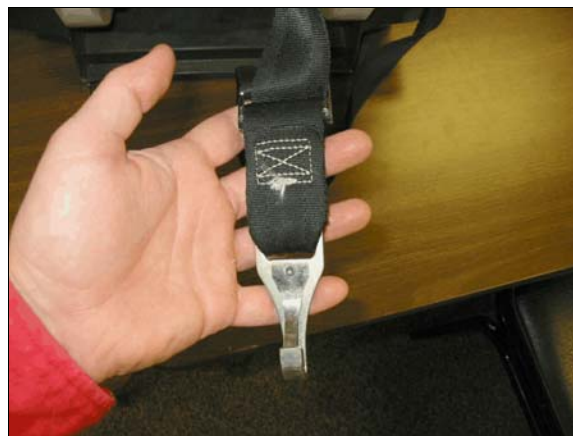
The back right passenger was most likely not secured in her child safety seat. In addition, the child safety seat was improperly secured in the case vehicle. As mentioned previously, it was reported by the child's mother and father that the back right passenger would frequently unclip the harness retainer clip. The harness straps would not be secure on the child in this condition and could possibly come off the child's shoulders during the crash. In addition, with the tray shield adjusted to it furthest from the child position, it is also possible that the child had additional room to move around in the seat and may have pushed the harness straps aside and off her shoulders at some point prior to the crash. It is also possible the harness straps were not properly secured when the child was placed in the child safety seat. In any case, it is unlikely the child would have been ejected from the child safety seat during the crash had the harness straps and harness retainer clip been securely fastened. In addition, the case vehicle's back right safety belt was not used to secure the child safety seat in the vehicle. According to the investigating sheriff's deputies, only the top tether strap was used to secure the child safety seat in the vehicle (**Figures 14 and 15**). This condition would allow the bottom of the child safety seat to move off the case vehicle's seat during the crash and allow the child safety seat to roll to the right and upward against the door. This would set up the condition for the subsequent ejection of the improperly restrained back right passenger as described in the following paragraph.

Figure 14: Top tether strap and fastener

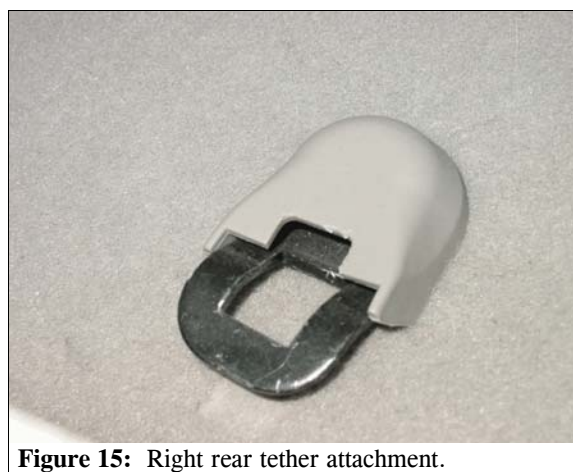
Figure 15: Right rear tether attachment.

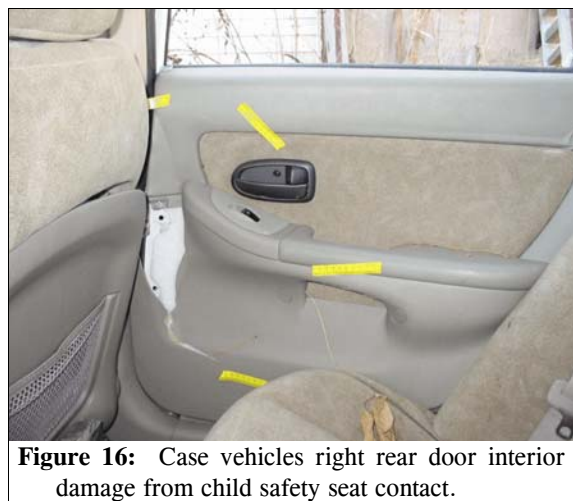
Figure 16: Case vehicles right rear door interior damage from child safety seat contact.

femur. The base of the child safety seat most likely moved off the seat and the child safety seat rolled to the right and upward against the right rear door. As the child seat moved upward and rolled right, the lateral force of the crash caused the back right passenger to come out of the harness straps, and she was ejected through the broken right rear window. The back right passenger landed on her face causing several brain injuries and facial fractures. She came to final rest in the field on the northeast corner of the intersection near the right rear corner of the case vehicle.

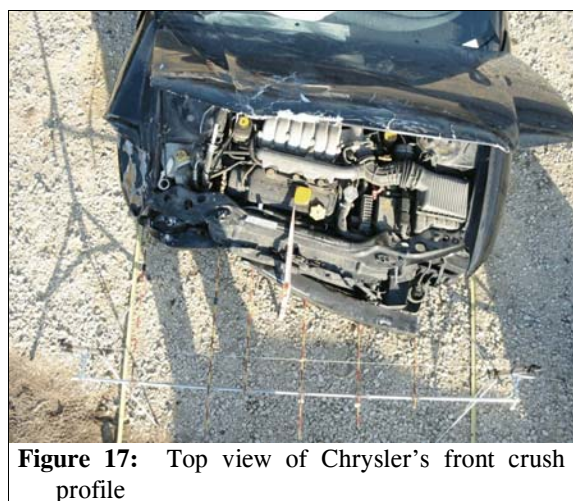
Figure 17: Top view of Chrysler’s front crush profile

Exterior Damage: The Chrysler’s impact with the case vehicle involved the front plane. The front bumper, bumper fascia, hood, grille, radiator, both turn signal and headlamp assemblies, and the right fender were directly damaged and crushed rearward. Though the bumper fascia was not found, it appeared the direct damage extended across the entire front bumper. The direct damage length was determined to be 138 centimeters (54.3 inches). The crush measurements were taken at the bumper level, and the residual maximum crush was measured as 44 centimeters (17.3 inches) occurring at C₆ (Figure 17). The table below shows the Chrysler’s front crush profile.

The Chrysler’s left side wheelbase was extended 1 centimeter (0.4 inches) while the right side wheelbase was reduced by 6 centimeters (2.4 inches). Induced damage involved only the right fender and windshield.
