**CALSPAN ON-SITE SIDE IMPACT INFLATABLE OCCUPANT PROTECTION  
INVESTIGATION**

**NASS/SCI COMBO CASE NO.: 2007-11-113E**

**LOCATION: MICHIGAN**

**VEHICLE: 2007 FORD ESCAPE**

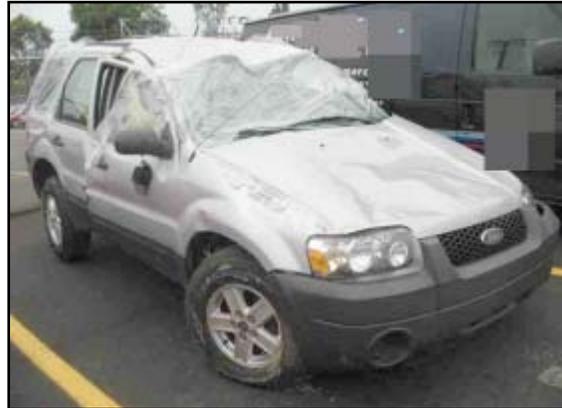
**Figure 1. Rollover damage to the 2007 Ford Escape.**

The 2007 Ford Escape sustained moderate severity damage as a result of the rollover crash. Damage was noted to all planes; however, the crush was localized to the front roof area. The direct contact damage consisted of laterally oriented abrasions that began at the right roof side rail and extended left 38 cm (15"). Vertically oriented abrasions were present on the right plane. On the right fender, the abrasions began at the leading edge and extended rearward 99 cm (39"). In addition to the abrasions, the top surface of the fender was crushed down approximately 5 cm (2"). Abrasions were present on the full height of the 64 cm (25") right A-pillar and extended 65 cm (25.5") rearward onto the right roof side rail. Abrasions were noted on the rear aspect of the right roof rail, right quarter panel, and localized abrasions on the right doors at the B-pillar area.

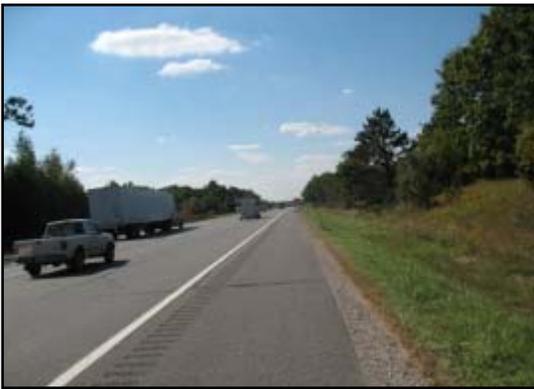
The Ford rotated approximately 110 degrees from its initial travel direction where the left side tires folded under the alloy wheels exposing the rims to the asphalt road surface. The left side rims contacted the asphalt surface of the outboard merge lane and the vehicle tripped into a left side leading rollover event (**Figure 2**). The road contact was confirmed by abrasions that were present on the outer edge of the rims. The rollover event triggered the deployment of the left and right side curtain air bags. The Ford rolled three quarter turns across the merge lanes and shoulder and entered the roadside. The vehicle rolled an additional two-quarter turns off-road coming to final rest on its left side on the roadside (**Figure 3**). The RCM data recorded the rollover angle at the time of the curtain air bag deployment. The accumulated roll angle at the time of deployment was -39 degrees (left). The angular roll rate was -133.6 degrees per second with a maximum angular rate of -208.3 degrees per second.

**Figure 2. Approximate area of rollover.**

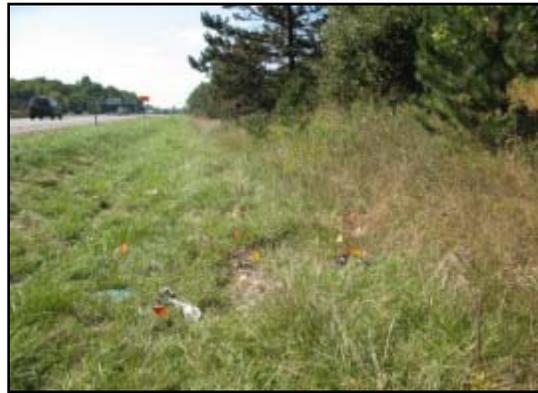
**Figure 3. Area of final rest position.**

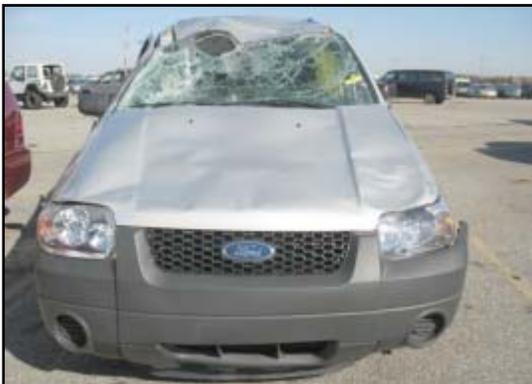
The crush was localized to the windshield header area with the maximum crush measuring 8 cm (3.3") at the junction of the right A-pillar and the roof. The direct contact damage on the roof measured 38 cm (15") and began on the roof side rail and extended to the center of the roof. A crush profile was documented along the 101 cm (40") wide windshield header (**Figure 4**). The maximum vertical and lateral crush were located at the right A-pillar and were: 8 cm (3.3") and 0 cm, respectively (**Figure 5**). The Collision Deformation Classification (CDC) for this impact was 00-TDDO-3.

**Figure 4. Roof crush profile**

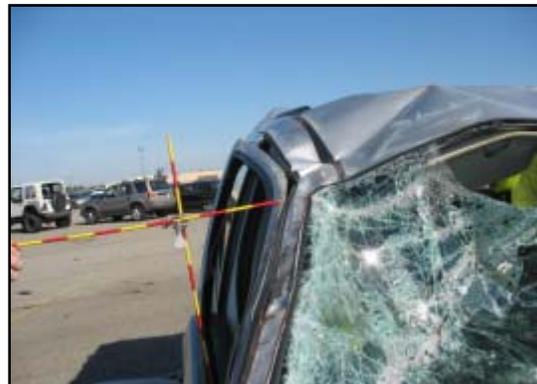
**Figure 5. Maximum vertical and lateral crush.**

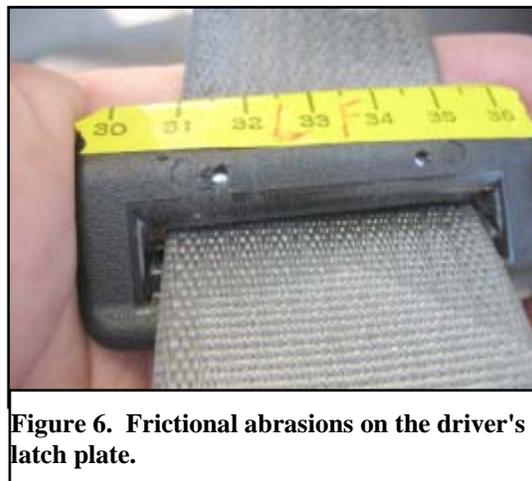
The driver's belt was configured with continuous loop webbing, sliding latch plate, height adjustable D-ring that was located 3 cm (1") above the full-down position at the time of the SCI inspection, and a buckle mounted pretensioner that actuated during the crash. The buckle stalk was compressed 5 cm (2") by the actuated pretensioner. The driver's safety belt retracted onto an Emergency Locking Retractor (ELR). The driver used the safety belt in the crash which was supported by frictional abrasions on the latch plate (**Figure 6**) and D-ring.

**Figure 6. Frictional abrasions on the driver's latch plate.**

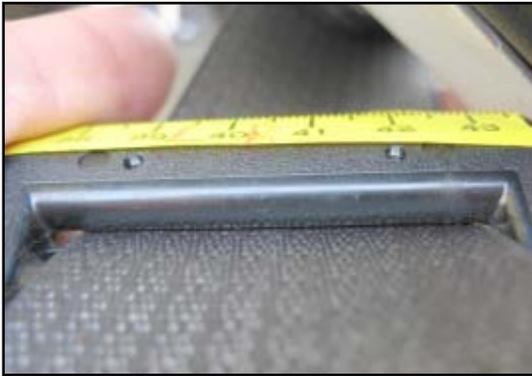
The second row safety belts were equipped with switchable ELR/ALR and sliding latch plates. The outboard safety belts were used by the 5-year-old male passengers. This was supported by the frictional abrasions on the latch plates and D-rings (**Figures 7 and 8**).

**Figure 7. Left rear latch plate frictional abrasions.**

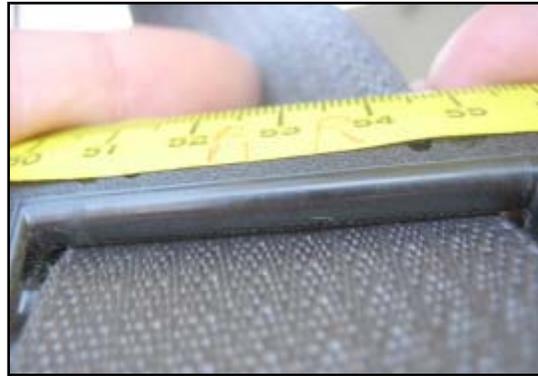
**Figure 8. Frictional abrasions on the rear right latch plate.**

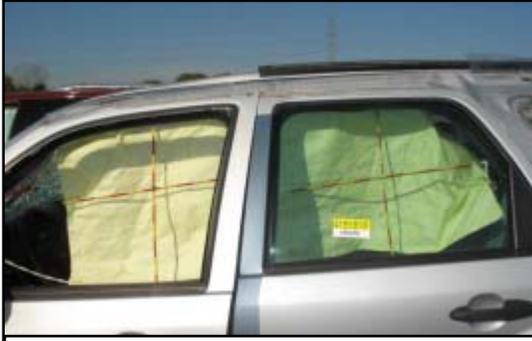
The 2007 Ford Escape was equipped with curtain air bags for the left and right outboard seating positions. The system consisted of curtain-type air bags that deployed from the roof side rails. The curtain air bags were designed to deploy in the event of a side impact or rollover crash. The left and right curtain air bags deployed as a result of the rollover event (**Figures 9 and 10**). The left and right air bags were rectangular in shape and measured 55 cm (21.5”) vertically from the roof side rail and 145 cm (57”) in length providing protection to the four outboard seating positions. The air bags were tethered by rope-type tethers at the A- and C-pillars. The A-pillar tether measured 40 cm (15.8”) in length and the C-pillar tether measured 8 cm (3.3”) in length. There were no occupant contact points present on the air bags. No damage or malfunctions were noted to the air bags. The following nomenclature was located on the center aspect of the air bag membranes:

**Figure 9. Deployed left side curtain air bag.**

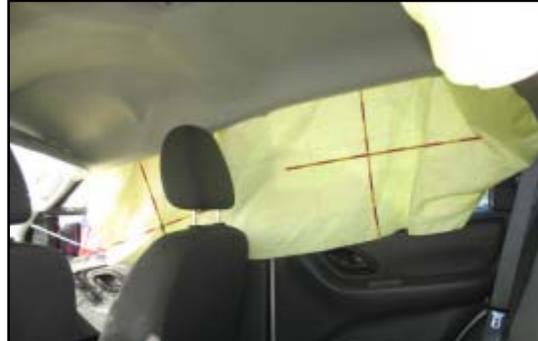
**Figure 10. Interior view of the deployed right side curtain air bag.**

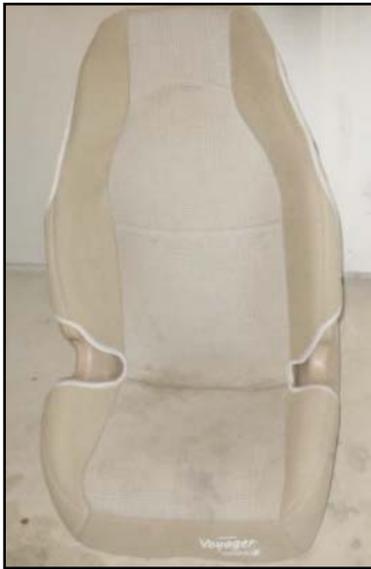
the vehicle's manual 3-point lap and shoulder belt systems. The rear left passenger was seated in a Cosco Complete Voyager high back belt positioning booster seat (**Figure 11**). A partial model number was visible on the torn placard and was 22-2- - -TIM. The seat was manufactured on 3/5/2003. This safety seat was designed to be used by children that weigh between 14 and 36 kgs (30 and 80 lbs) and up to a maximum height of 132 cm (52"). The child that utilized this seat weighed 19 kgs (42 lbs) and was 109 cm (43") in height. The safety seat was equipped with three shoulder belt positioning slots. The driver stated that the middle slot was used at the time of crash and the belt system was snug against the shoulder and across the hips of the child passenger. **Figure 12** is a side view of the booster seat. There was no damage present on the safety seat.

**Figure 11. Belt positioning booster seat used by the 5-year-old male rear left passenger.**

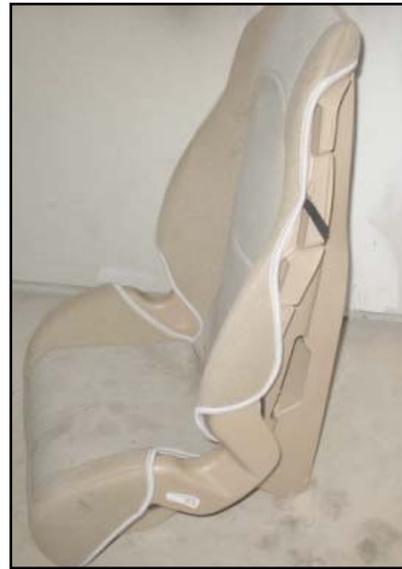
**Figure 12. Left side of the booster seat.**
