Remote Combination ODI Passenger Air Bag Deployment Investigation  
Dynamic Science, Inc. (DSI), Case Number 2007-75-135J  
2007 Dodge Charger  
Colorado  
November 2007

1. Report No. 2007-75-135J	2. Government Accession No.		3. Recipient Catalog No.	
4. Title and Subtitle  Remote Combination ODI Passenger Air Bag Deployment Investigation			5. Report Date November 12, 2008

**Dynamic Science, Inc.**  
**Crash Investigation**  
**Case Number: 2007-75-135J**

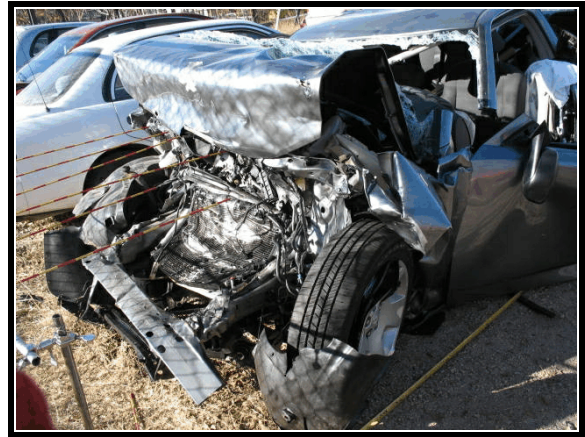
This Remote Combination Office of Defects Investigation (ODI) Passenger Air Bag Deployment Investigation focused on the frontal air bags installed in a 2007 Dodge Charger (**Figure 1**). The Charger was involved in a two vehicle crash that occurred in November 2007 at night. The subject vehicle was being driven by a restrained 24-year-old male. The other vehicle was a 2000 Ontario Orion V city bus. The Dodge Charger was traveling eastbound in the outboard lane of a four-lane divided roadway. The Ontario bus was stopped in front of the Charger in the same lane. The driver of Dodge Charger failed to stop and rear-ended the bus. Both frontal air bags in the Dodge Charger deployed. The driver of the Dodge Charger sustained serious injuries and was hospitalized for 16 days.

**Figure 1.** 2007 Dodge Charger

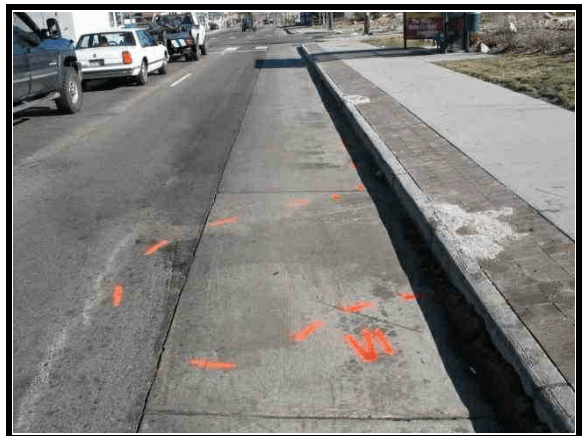
The front of the Dodge Charger struck the rear of the Ontario Orion bus (**Figure 4**). The impact was severe, and resulted in the deployment of the frontal air bag system in the Charger. The Barrier algorithm of the WinSmash program computed a total delta V of 51 km/h (31.6 mph), based on the Charger's front end crush profile. The Charger came to rest at approximately the same location as the impact.

**Figure 4.** Area of impact/final rest

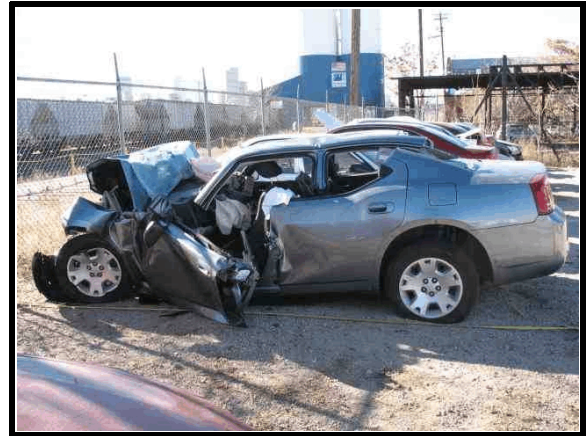
The 2007 Dodge Charger sustained severe front end damage as a result of the impact with the bus (**Figure 5**). The direct damage extended from bumper corner to bumper corner. The direct damage width measured 144 cm (56.7 in). The Charger sustained substantial underride damage. The hood deformed upward and rearward, and both fenders were deformed. The windshield was fractured and all four doors were jammed shut. The vehicle wheelbase was shortened by 19 cm (7.5 in) on the left and 15 cm (5.9 in) on the right. Both front tire rims were fractured and all four tires were flattened at the time of the vehicle inspection. Two sets of crush measurements were taken, one at the bumper level and one at the upper radiator support level. Per NASS protocol, the two crush profiles were averaged. The resultant crush measurements were documented as follows: C1 = 52 cm (20.5 in), C2 = 54 cm (21.2 in), C3 = 59 cm (23.2 in), C4 = 62 cm (24.4 in), C5 = 61 cm (24.0 in), C6 = 56 cm (22.0 in). The Collision Deformation Classification (CDC) for the impact with the bus was 12FDEW3.

**Figure 5.** Lateral view of frontal crush

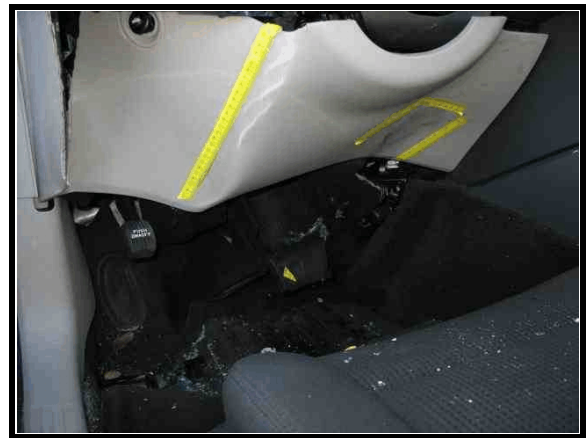
The left lower instrument panel exhibited scuffing and deformation from the driver's knees and lower legs (**Figure 6**). The steering wheel rim was deformed and fully collapsed with 10 cm (3.9 in) of forward movement. Blood was located on the driver's air bag. The driver's seat back was deformed and there was also deformation of the brake pedal.

**Figure 6.** View of lower instrument panel contacts/damage

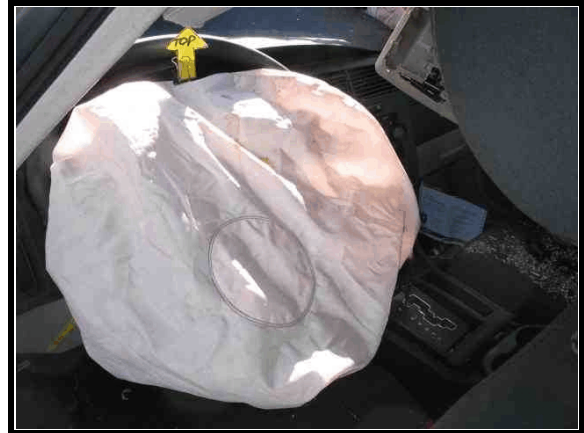
The driver's air bag deployed from the center of the steering wheel hub through H-configuration module cover flaps (**Figure 7**). There were patches of blood found on the right upper quadrant of the air bag face. There were no reports of any damage to the air bag or the air bag module flaps.

**Figure 7.** Deployed driver's air bag

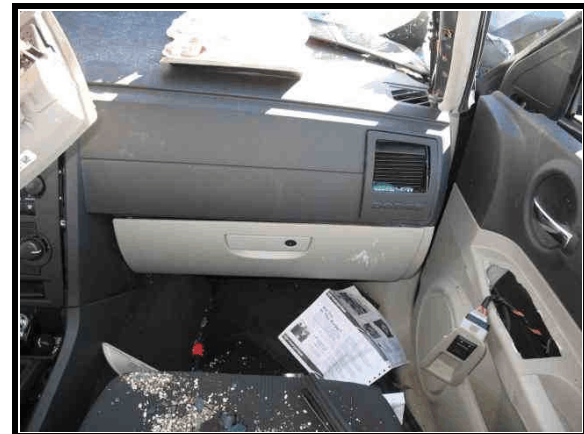
The front right passenger's air bag deployed from a top mount module with a rectangular cover flap (**Figure 8**). Based on the system configuration and the absence of a passenger in the front row right

**Figure 8.** Deployed front right passenger air bag

seat, the passenger air bag was not designed to deploy. There were no reports of any damage or occupant contact to the air bag or the air bag module flap.

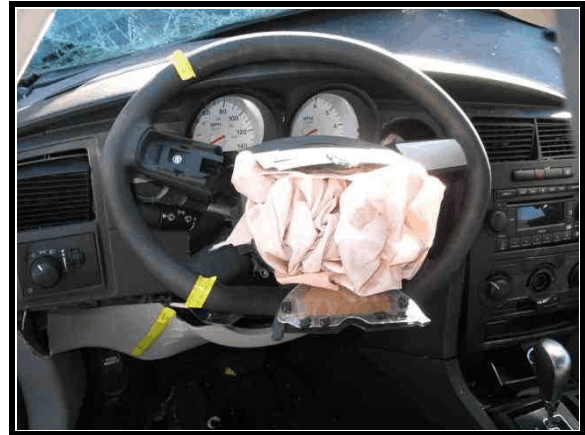
The 24-year-old male driver was seated in an upright posture and was restrained by the 3-point manual lap and shoulder belt. The seat was positioned between the middle and rear most track positions. The driver was braking just prior to impact. At impact, the frontal air bags deployed. It is not known if the pretensioner actuated. The driver initiated a forward trajectory. He loaded the safety belt and engaged the deployed driver's air bag. His lower legs engaged the steering column and lower instrument panel, causing tibia, fibula, and patella fractures. The driver engaged and loaded the steering wheel rim, causing ulna and radius fractures, internal injuries, facial injuries, and a concussive head injury (**Figure 9**). He was

**Figure 9.** Steering wheel rim loading
