**CALSPAN ON-SITE ADULT AIR BAG RELATED FATALITY
CRASH INVESTIGATION**

CASE NO: CA07-001

VEHICLE: 1995 FORD ESCORT

CRASH DATE: DECEMBER 2006

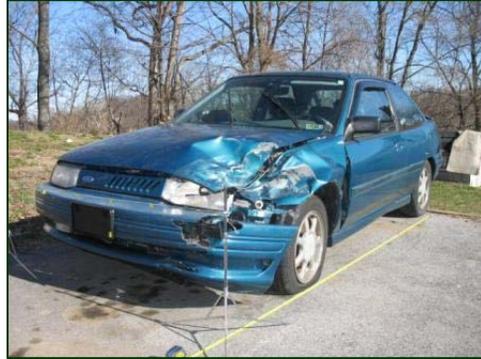
Figure 1. 1995 Ford Escort.

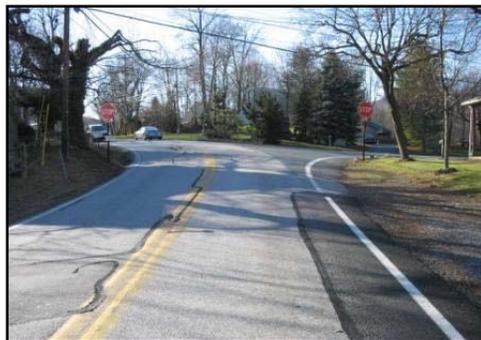
Figure 2. Overall view of the crash site.

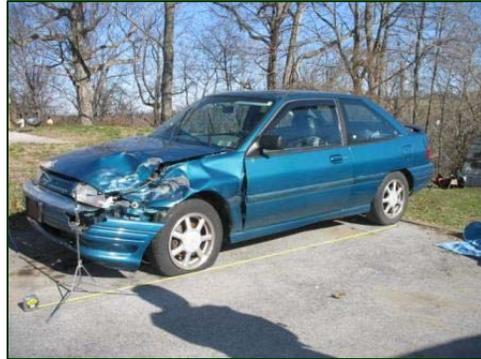
Figure 3. Left side view of the Ford Escort.

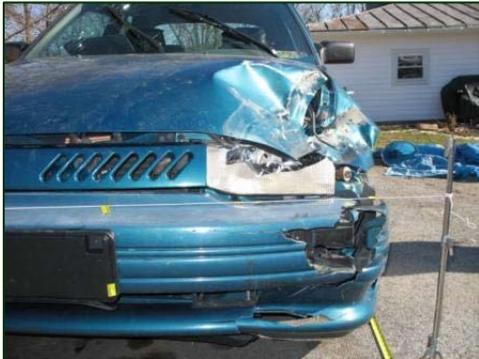
The Ford Escort sustained minor severity damage as a result of the front-to-rear crash sequence with the back of the stopped Jeep Cherokee. Maximum crush was 10 cm (4") located at the left corner of the upper radiator support. The direct contact damage on the bumper fascia began 15 cm (6") left of the vehicle's centerline and extended 55 cm (21.5") to the left corner (**Figure 4**). Although the bumper engaged the back of the Jeep, there was no residual crush at bumper level. The left aspect of the bumper was pulled forward as a result of separation from the Jeep.

Figure 4. Direct contact damage on the frontal plane.

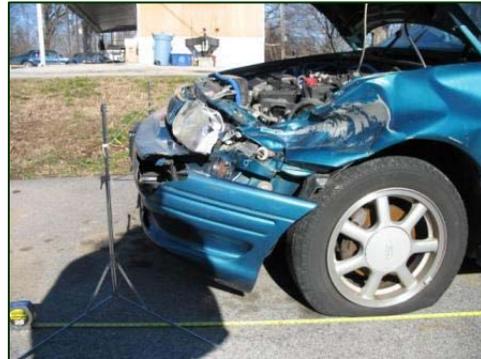
The Escort partially underrode the back right corner area of the Jeep resulting in crush and contact damage to the hood face and the left front fender. A residual crush profile was documented at the face of the upper radiator support (**Figure 5**). The six equidistant crush profiles were as follows: C1 = 10 cm (4"), C2 = 4 cm (1.75"), C3 = 1 cm (0.25"), C4 = 0 cm, C5 = 0 cm, C6 = 0 cm. The contact damage of the left front fender extended 70 cm (27.5") rearward. The rearward crush was limited to the 10 cm (4") at the leading edge. The Collision Deformation Classification (CDC) for this impact was 12-FYEW-1.

Figure 5. Extent of crush at the radiator support level.

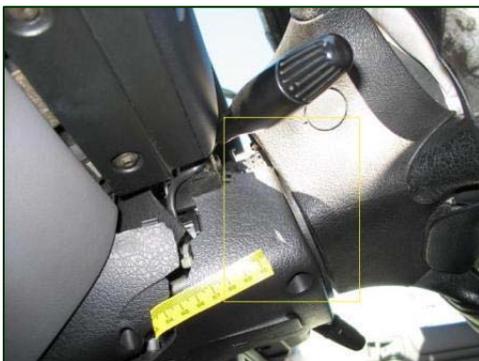
The driver was positioned forward within the deployment path of the driver's air bag. The expanding air bag engaged the chest of the driver as she responded to the frontal crash forces. Her loading force was transmitted into the steering wheel and the energy absorbing steering column. The steering wheel flange was deformed which resulted in a closure of the gap between the forward aspect of the wheel hub and the steering column (**Figure 6**). The bottom gap was widened to 1 cm (0.25").

Figure 6. Steering wheel flange deformation.

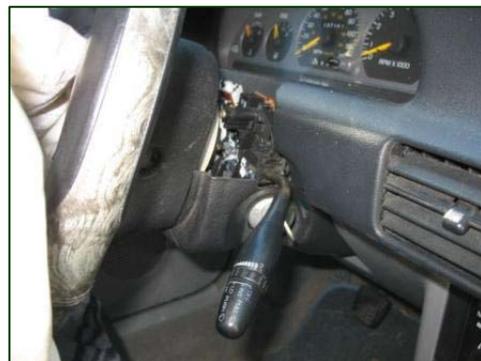
Figure 7. Wiper stalk deformed and fractured from column compression.

The driver compressed the energy absorbing steering column approximately 5 cm (2"). This column did not utilize a conventional shear bracket system. The column was an extrusion-type column that compressed through a sleeve. The plastic steering column cover fractured from column compression. The column compression resulted in bending and fracturing of the turn signal stalk and the wiper stalk (**Figure 7**) as they engaged the mid instrument panel.

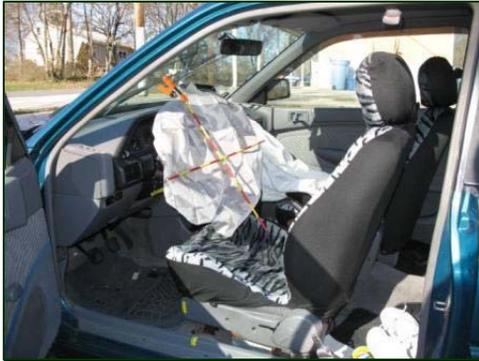
The Ford Escort was equipped with first generation frontal air bags for the driver and front right passenger positions. **Figure 8** is a view of the deployed air bags. The system utilized two ball-in-tube external crash sensors that were located on the forward aspect of the upper radiator support panel. Both sensors remained intact and were free of damage from the crash. The sensors were bar coded with the following:

Figure 8. Deployed frontal air bag system.

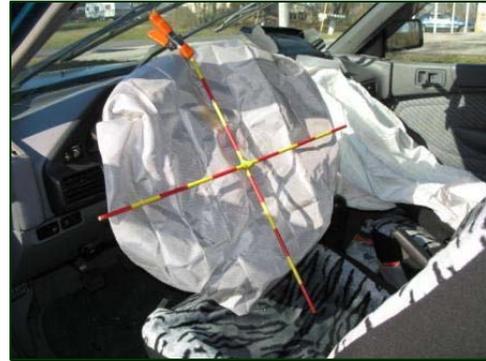
state was 62 cm (24.5"). The maximum excursion of the driver's air bag was 25 cm (10") at the tether location. There was no damage or occupant contact evidence on the deployed driver's air bag (**Figure 9**).

Figure 9. Deployed driver's air bag.
