ON-SITE CHILD AIR BAG-RELATED FATALITY INVESTIGATION

CASE NUMBER - IN-07-001

VEHICLE - 1995 FORD MUSTANG

CRASH DATE - April 2006

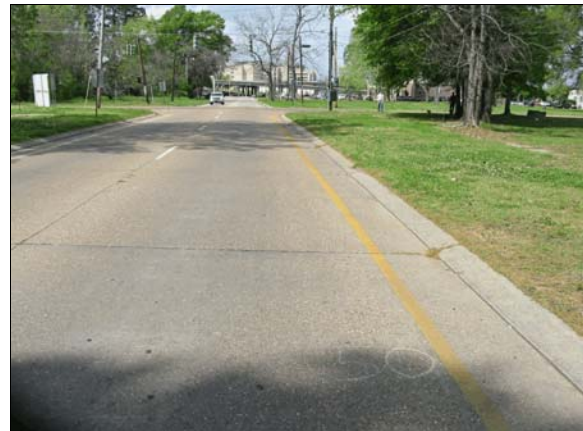
Pre-Crash: The case vehicle was traveling northbound in the right lane of the one-way southbound street (**Figure 1**) approaching the intersection. The case vehicle's driver had just turned left (i.e., the wrong way) onto the one-way street from an intersecting city street (**Figure 2** below). The case vehicle's driver stated she was a little "bewildered" and wondering where she was, but was intending to continue northbound through the approaching intersection. The Five Hundred was traveling eastbound in the eastbound lane, also approaching the intersection (**Figure 3** below). The police crash report indicated that the case vehicle's driver applied the brakes in an attempt to avoid the crash. The driver also stated that she applied hard braking in an attempt to avoid the crash with the approaching Five Hundred. The crash occurred in the intersection of the two trafficways (**Figures 3 and 6** below).

Figure 1: Approach of case vehicle to intersection, northbound on southbound one-way street, number on pavement shows meters to intersection

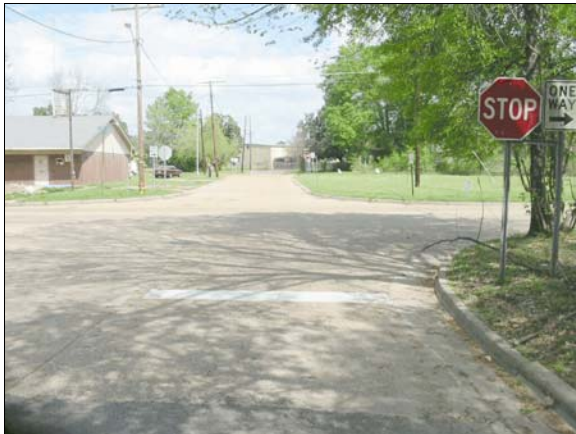
Figure 2: Intersection where case vehicle driver turned left onto one-way city street

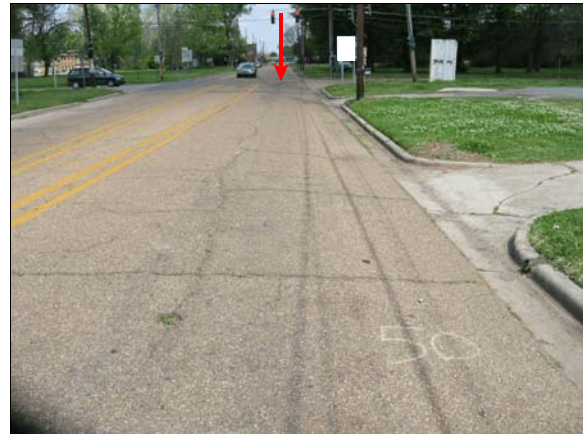
Figure 3: Approach of Five Hundred eastbound to intersection, arrow shows area of impact

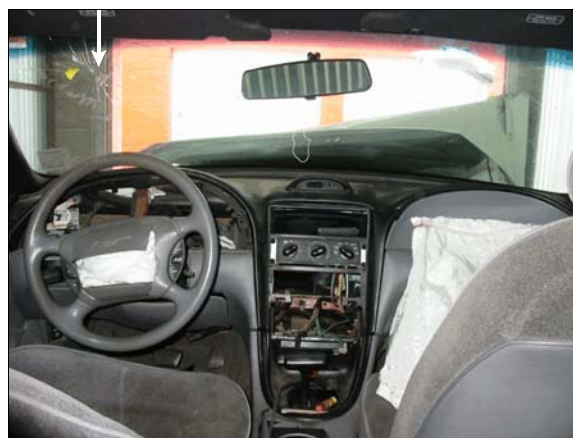
Vehicle Interior: Inspection of the case vehicle's interior revealed a "star burst" type fracture to the windshield left of the centerline of the steering wheel due to driver head contact (**Figure 7**). A few possible fluid spots were observed on the front right passenger's air bag. No other evidence of possible occupant contact was noted in the case vehicle's interior. Finally, there was no passenger compartment intrusion, and no evidence of compression of the energy absorbing steering column or deformation of the steering wheel.

Figure 7: Overview of case vehicle's front seat area, arrow shows "star burst" type fracture to windshield from driver's head contact
