Rollover Investigation
Dynamic Science, Inc. / Case Number: DS07003
2006 Honda CR-V
California
November 2006

1. Report No. DS07003	2. Government Accession No.		3. Recipient Catalog No.	
4. Title and Subtitle Rollover Investigation		5. Report Date October 10, 2007

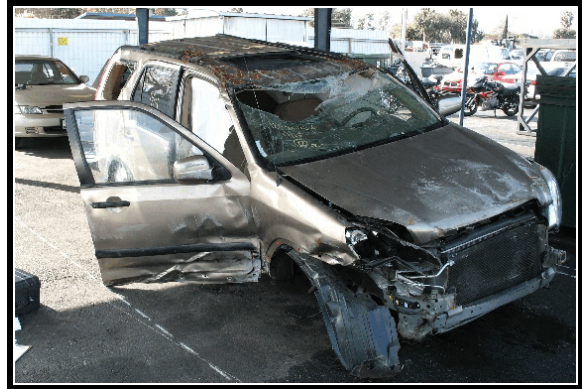
Figure 1. 2006 Honda CR-V

This single vehicle rollover crash occurred in November 2006 at 0122 hours. The crash occurred in the eastbound lanes of a five lane divided interstate highway. The vehicle was a 2006 Honda CR-V sport utility vehicle that was being driven by a restrained 37-year-old (**Figures 1-2**). The driver had been drinking. The case vehicle was traveling eastbound in middle lane at an unknown speed. The driver failed to negotiate the turn and the Honda crossed the two adjacent travel lanes and departed the roadway to the south. The Honda crossed the roadway shoulder and struck a metal/wood guardrail with its front end. The vehicle was re-directed to the left and began a counter-clockwise rotation as it reentered the roadway and overturned with its right side leading. The Honda came to rest on its roof in the second lane. The driver sustained a contusion and a sprain to his left thumb and was able to exit the vehicle under his own power.

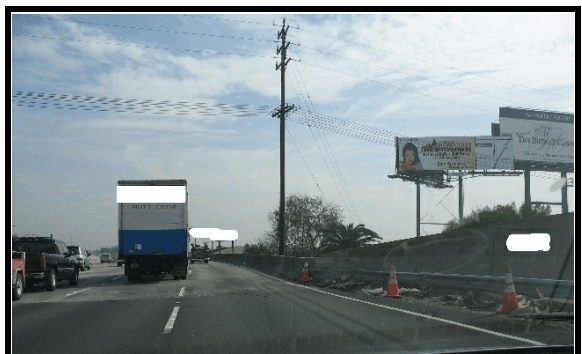
This single vehicle crash occurred in November 2006 at 0122 hours. The crash occurred on a north/southbound interstate highway (**Figure 3**). At the crash location; however, the roadway actually travels east/west. The crash occurred in the eastbound lanes of the five lane divided interstate highway. The road surface was composed of asphalt and was dry at the time of the crash.

Figure 3. Area of impact (east)

The crash took place in a left hand curve. The speed limit at this location was 89 km/h (55 mph).

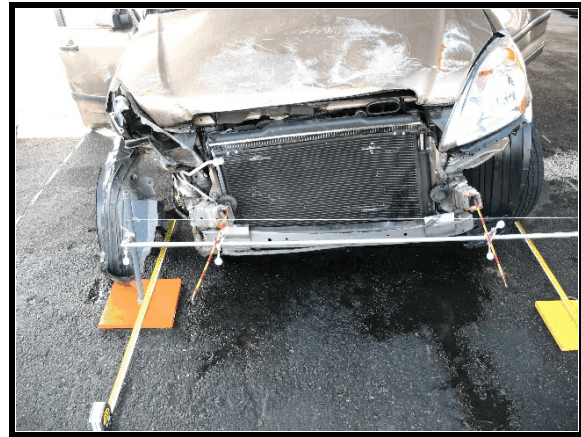
The 2006 Honda CR-V sustained moderate front end damage as a result of the impact with the guardrail. The direct damage began at the front right corner and extended 62 cm (24.4 in) to the right. The bumper fascia and backing bar were dislodged during the crash and were no longer with the vehicle. It appears likely that the direct contact was outboard of the right bumper mounting bracket. The direct damage extended longitudinally down the right side and terminated at the mid point of front right door—near the sill. The right front tire was damaged and separated from the vehicle. Both front mounting brackets were shifted to the left, with the right bracket shifted 21 cm (8.3 in) and left shifted 5 cm (2.0 in). Two crush measurements (**Figures 4-5**) were documented at the mounting bracket as follows: C1 = 0 cm, C2 = 2 cm (0.8 in). The Collision Deformation Classification (CDC) for the impact with the guardrail was 01FZEW1. The EDR reported Delta V End was 9.2-10.7 km/h (5.7-6.7 mph). The barrier routine of the WinSmash program computed a total delta V of 11.0 km/h (6.8 mph), based on the CR-V's front crush profile. The longitudinal and lateral components were -10.3 km/h (-6.4 mph) and -3.8 km/h (-2.3 mph), respectively.

Figure 4. Front end damage, Honda CR-V

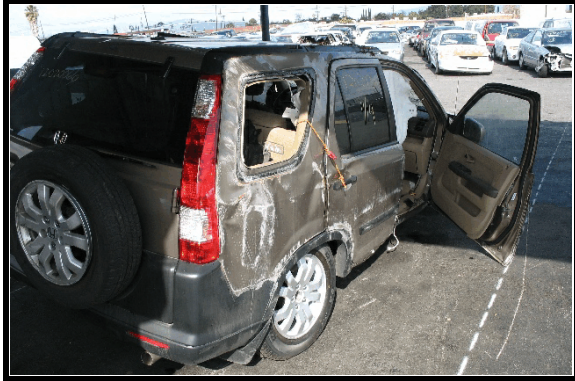
The Honda CR-V also sustained damage to the right side and roof from the rollover (**Figures 6-7**). The direct damage on the right side began at the right rear bumper corner and extended forward 304 cm (119.7 in). There was direct contact to the hood and roof. The hood contact measured 136 cm (53.5 in) wide by 55 cm (21.6 in) long. The roof damage began at the A pillars/windshield header

Figure 5. Right side damage

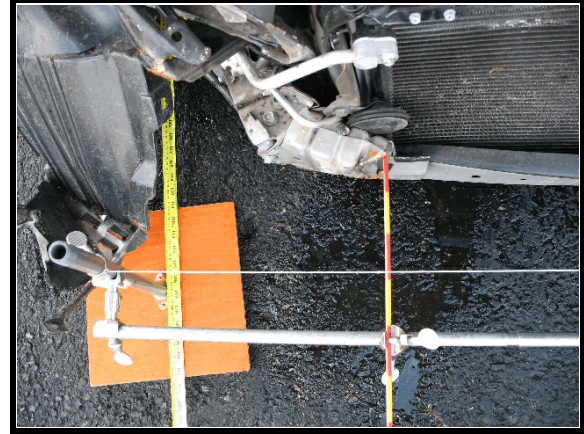
Figure 6. Shifted right bracket

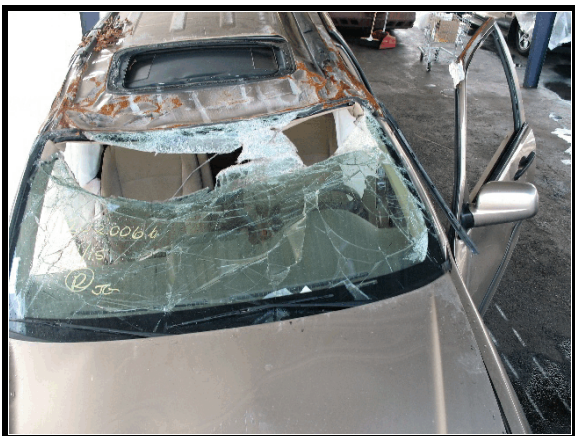
Figure 7. Roof damage

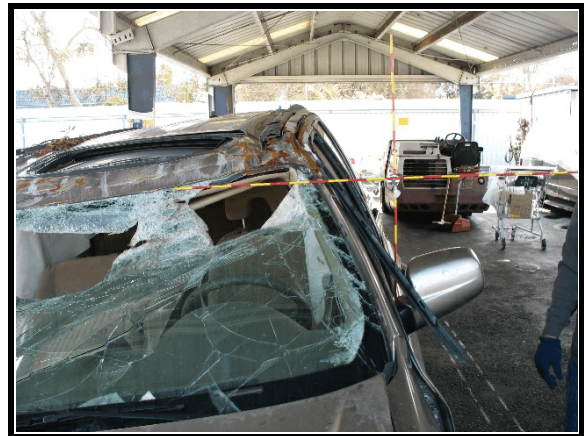
and extended rearward past the sun roof. The maximum vertical crush was located at the windshield header 35 cm (13.8 in) to the right of the A pillar (**Figure 8**). The maximum crush 9.5 cm (3.7 in). The CDC for the rollover was 00TDDO2.

Figure 8. Maximum vertical crush

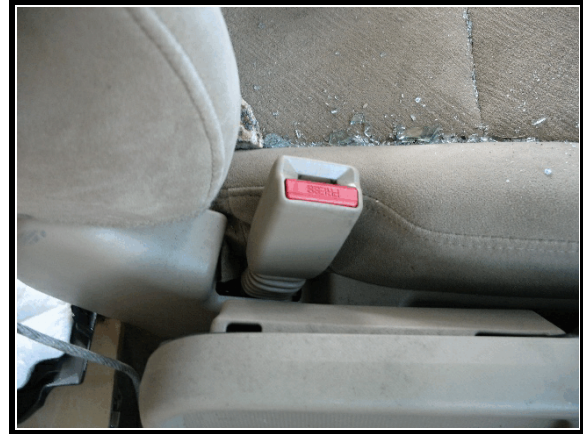
Figure 9. Driver's compressed seat belt latch

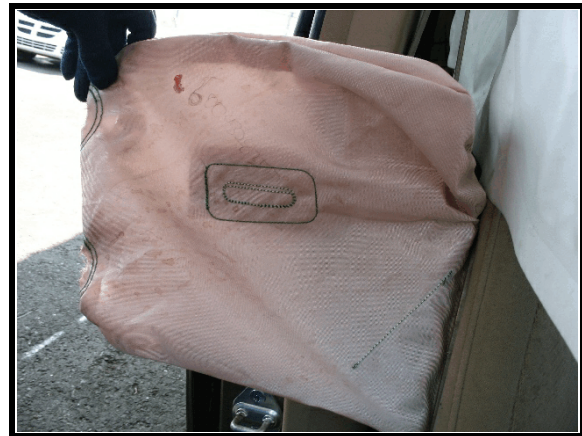
The front right passenger's seat back mounted side air bag deployed during the rollover (**Figures 10-11**). The deployed air bag measured 26 cm (10.2 in) in height by 33 cm (13.0 in) in width. Two vent ports were located at the top and bottom leading edge of the air bag in the 9 o'clock position.

Figure 10. Front right passenger side air bag

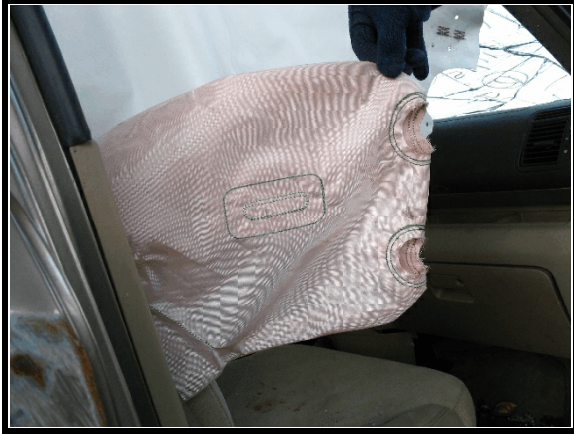
Figure 11. Front right side air bag (exterior view)

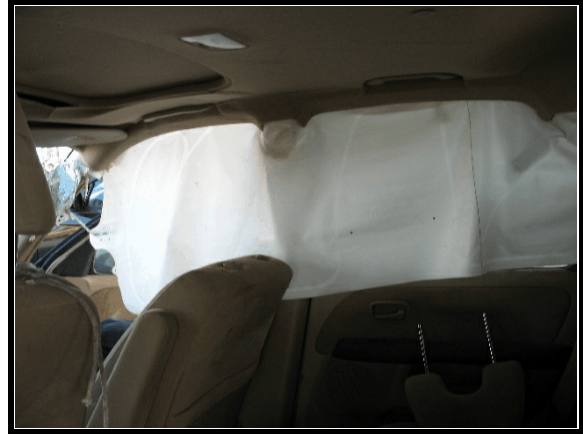
Both side air curtains deployed during the rollover (**Figures 12-14**). The deployed curtains measured 155 cm (61.0 in) in length. They extended from the A-pillar to the C-pillar longitudinally and provided protection for front and rear seat occupants. They extended vertically from the roof cladding downward to just below the side window frames. They were attached at the A-pillar by an 11 cm (4.3 in) tether and at the D-pillar by a 30 cm (11.8 in) tether.

Figure 12. Right side air curtain

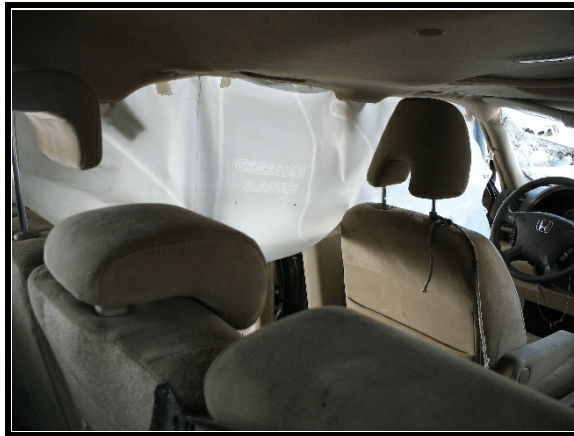
Figure 13. Left side air curtain

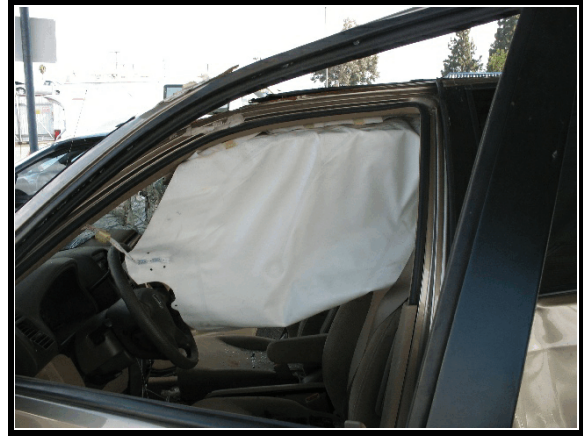
Figure 14. Left side air curtain. Outside view at driver's location.

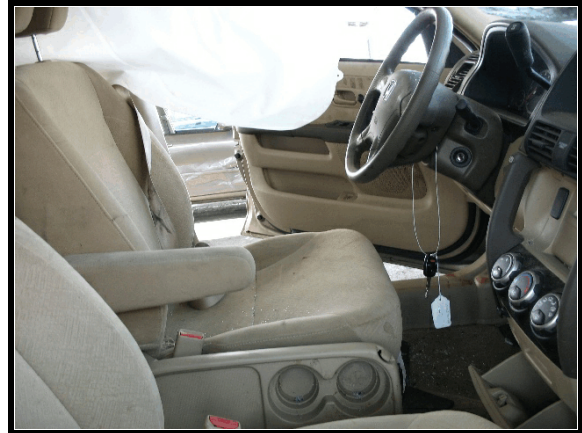
The 37-year-old male driver was likely seated in an upright posture. He was restrained by the 3-point manual lap and shoulder belt. The seat track was adjusted to the mid position. The driver's seat back angle was 17 degrees from vertical and the seat bottom angle was 11 degrees from horizontal. There were no indications of any braking. At impact with the guardrail, the driver initiated a forward and slightly left trajectory. The driver likely sprained and contused his left thumb at this time. The guardrail impact appears to have been relatively minor. As the vehicle began a counterclockwise rotation, the driver shifted to the right. As the vehicle tripped over onto its right side, the side curtain air bags deployed. The driver's safety belt pretensioner also appears to have actuated during the rollover. The driver was held in place by the belt system during the rollover. He was able to exit the vehicle under his own power. He was transported by ground ambulance to a local hospital.

Figure 15. Driver's seated position

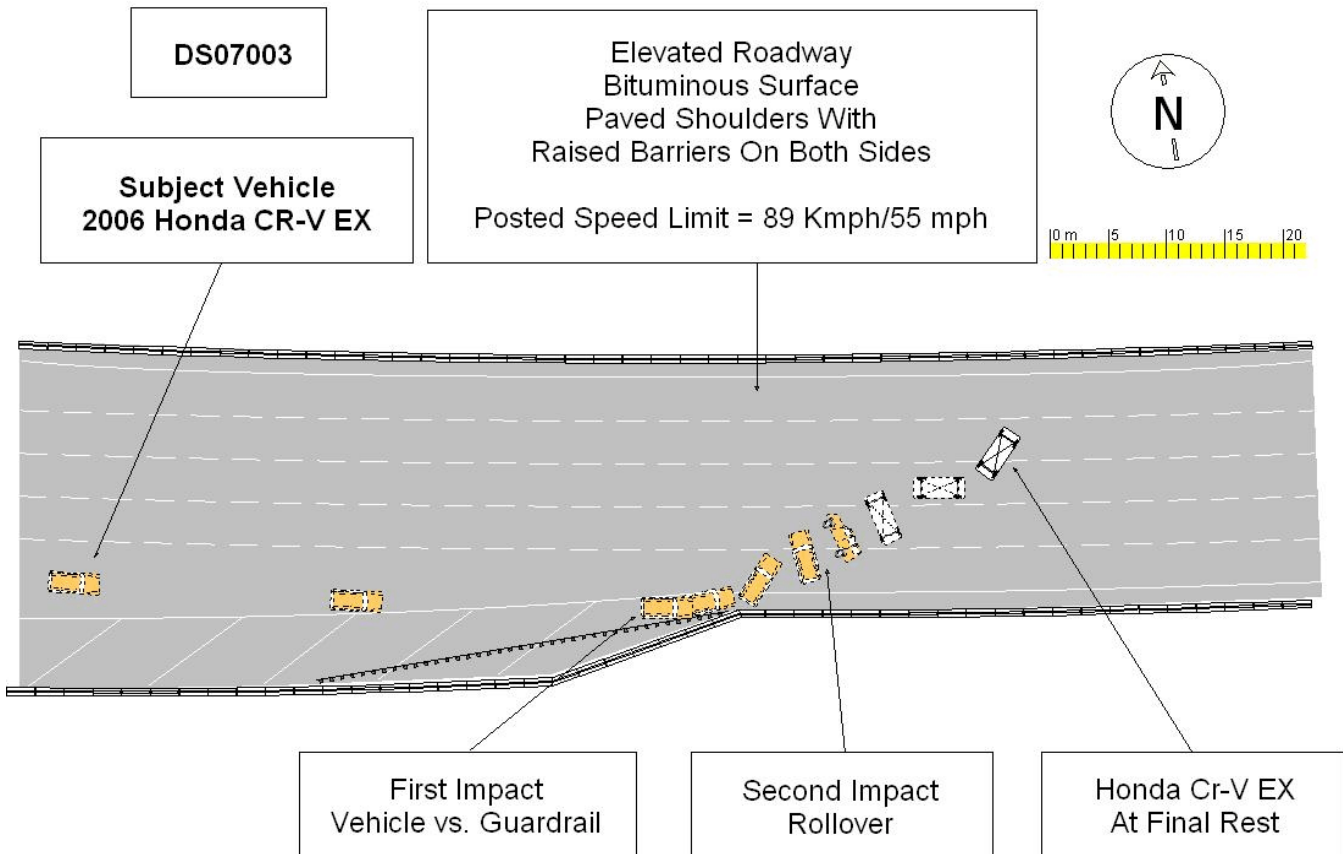
Attachment 1. Scene Diagram

The Honda crossed the roadway shoulder and struck a metal/wood guardrail with its right front end. The Honda was re-directed to the left and the vehicle began a counterclockwise rotation as it reentered the roadway and overturned with its right side leading. Both side air curtains deployed during the rollover. The vehicle rolled two quarter turns and came to rest on its roof in the fourth lane from the right.
