**CALSPAN ON-SITE CHILD SAFETY SEAT CRASH INVESTIGATION  
CALSPAN CASE NO.: CA07-007**

**LOCATION: NEW JERSEY**

**VEHICLE: 1998 NISSAN QUEST**

**CRASH DATE: JANUARY 2007**

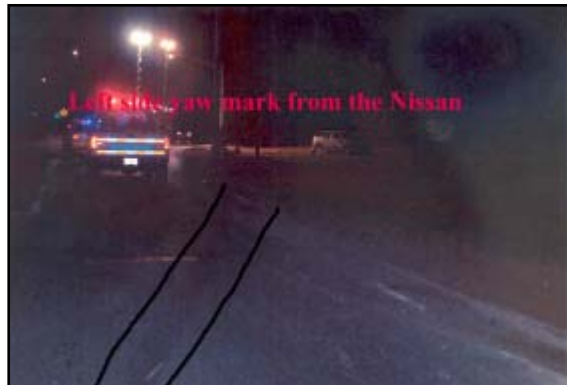
**Figure 2. On-scene image of the on-road yaw marks.**

These yaw marks extended from the roadway to the roadside in a west to east direction. **Figure 2** is an on-scene police image of the on-road evidence. The left side tires of the Nissan overrode the concrete mountable curb and the vehicle entered the roadside. No damage was noted to the left side wheels of the Nissan or the curb. The Nissan entered the grassy roadside continuing its clockwise rotation where the left side tires furrowed into the soft surface (**Figure 3**). The off-road travel was evidenced by a left front tire mark that measured 13 meters (42.6 feet) in length and a left rear tire mark which measured 9 meters (29.5 feet) in length. The Nissan rotated to an angle of 90 degrees from its original heading. The distance between the yaw marks was 285 cm (112”) at the end points.

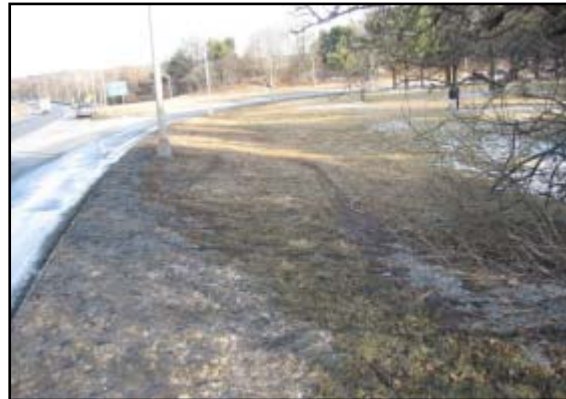
**Figure 3. Left side tire marks on roadside.**

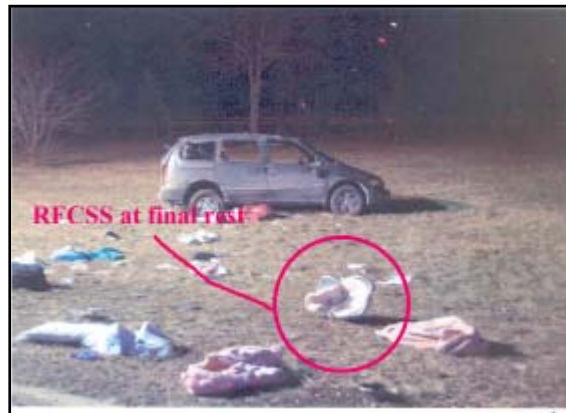
**Figure 4. On-scene impact of the final rest positions of the safety seat and the Nissan.**

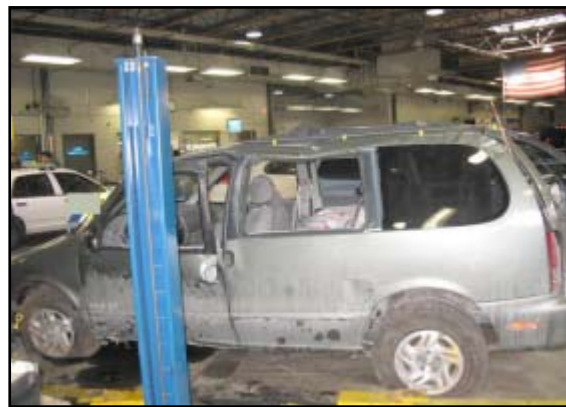
The 1998 Nissan Quest sustained moderate severity damage to the roof area as a result of the rollover crash (**Figures 5 and 6**). Isolated deformation was noted to the side, front, and rear planes of the Nissan. The left front window frame was deflected outboard of the vehicle from the ground contact during the first and second quarter turns. The roof side rails of the vehicle were deformed vertically downward. The direct contact damage on the left roof side rail began 15 cm (6") rear of the A-pillar and extended 241 cm (95") to the D-pillar. The maximum crush was centered over the second row glazing within the B-pillar area of the vehicle and measured 9 cm (3.5").

**Figure 5. Left side damage and roof side rail crush profile.**

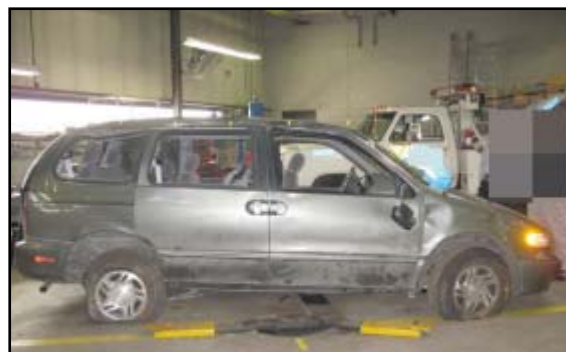
The direct contact damage on the right roof side rail extended the full length measuring a total length of 241 cm (95"). The maximum crush measured 11 cm (4.5") and was located 51 cm (20") forward of the D-pillar. The maximum vertical and lateral crush were located at the D-pillar area. These crush values were 11 cm (4.5") and 28 cm (10.5"), respectively. The Collision Deformation Classification for the rollover event was 00-TDDO-2.

**Figure 6. Right roof side rail crush documentation.**

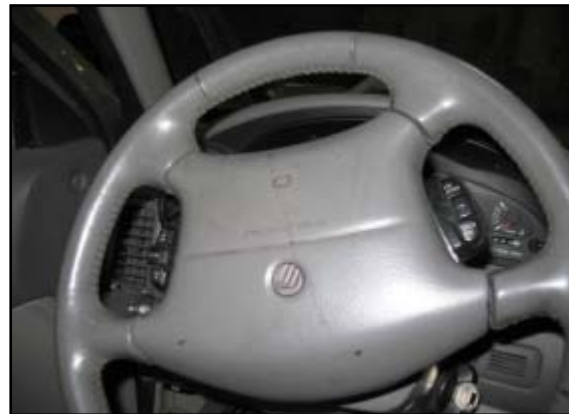
The Nissan was originally equipped with a redesigned frontal air bag system for the driver and front right passenger positions. During the inspection of the air bag system, it was determined that this vehicle was involved in a previous collision where the air bag system deployed. The determination was based on the rear right passenger's statement to the investigating officer that she was involved in a prior collision with a curb that resulted in the deployment of the frontal air bag system. Additionally, the replacement air bag modules in the vehicle were obtained from a Mercury Villager which was the peer vehicle to the Nissan Quest. **Figure 7** is a view of the replaced driver's air bag module. The frontal air bag system did not deploy in this rollover crash.

**Figure 5. Replaced driver's air bag module.**

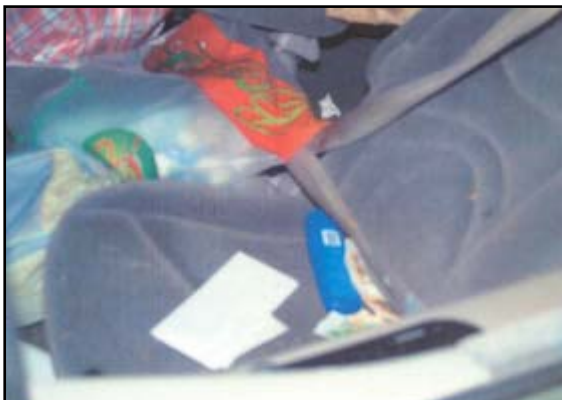
**Figure 8. On-scene image of the rear left belt system.**

inspection. This was further supported by the on-scene images of the safety belt system. **Figures 8 and 9** are of the rear left safety belt system exhibiting the same position post-crash and at the time of the SCI investigation. The recline angle of the safety seat and the tightness of the installation were unknown. The vehicle seatback was adjusted to 35 degrees rearward of vertical.

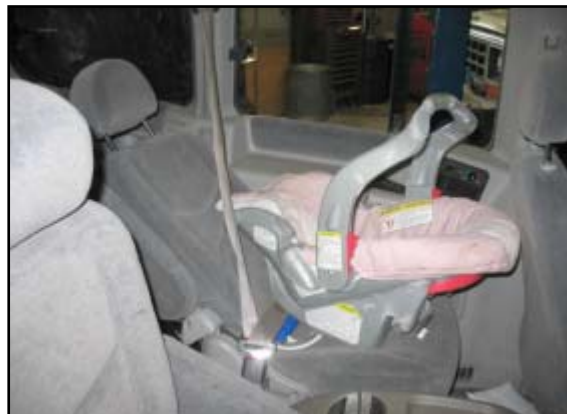
**Figure 9. Rear left safety seat position at the time of the SCI inspection.**

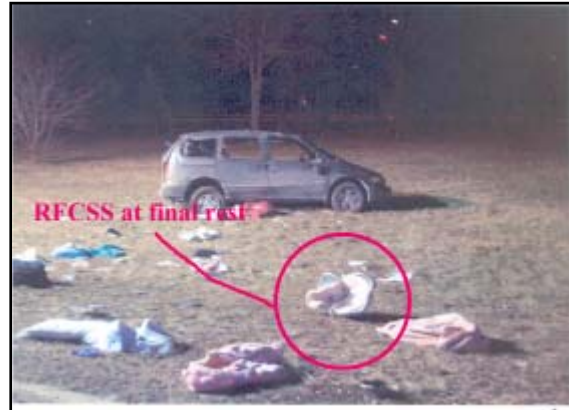
**Figure 10. Approximate position of the safety seat at final rest.**

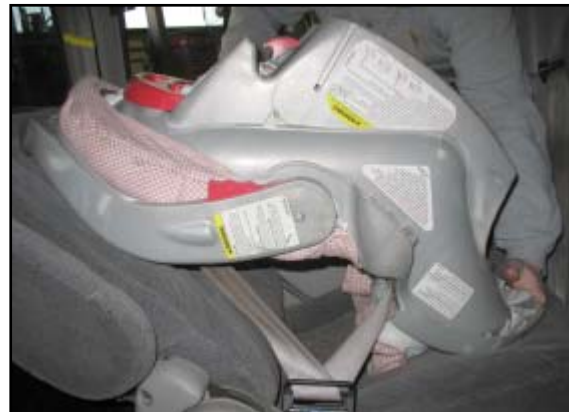
**Figure 12. Front-to-rear rotation of the safety seat. The webbing remained engaged with the belt path during this simulation.**

The safety seat was moved from side-to-side to duplicate the pre-crash steering inputs. This movement did not result in disengagement of the safety belt from the belt path. The safety seat was then rotated from front-to-rear to simulate movement during the rollover event and to achieve the ejection that occurred during the first and second quarter-turns of the rollover. During the rotation, the safety belt remained engaged with the belt path and should not have resulted in the ejection (**Figure 12**).

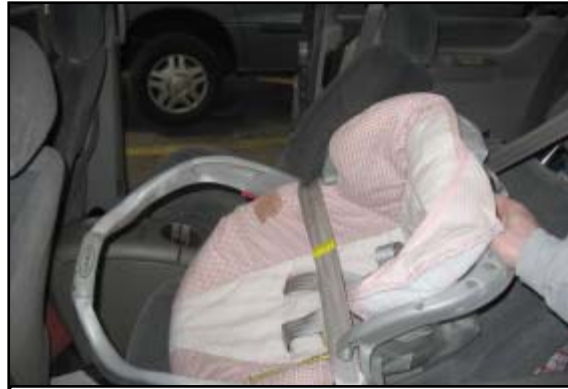
The safety seat was repositioned on the left rear seat with the lap belt routed through the belt path. The RFCSS was rotated from rear-to-front (**Figure 13**). During this movement, the safety belt webbing became restricted between the belt path and carry handle mounting point. This restriction would have prevented the ejection of the RFCSS that occurred early in the crash event.

**Figure 13. Rear to front rotation of the RFCSS.**

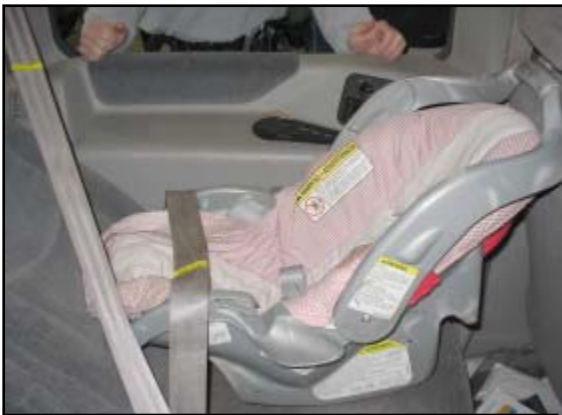
The safety seat was reinstalled using the lap belt positioned across the safety seat, rearward of the belt path (**Figure 14**). The safety seat was moved from side-to-side to duplicate the pre-crash steering inputs. This movement caused the webbing to slide slightly rearward. The safety seat was then rotated from front-to-rear resulting in disengagement from the safety belt system (**Figure 15**). At this point, the safety seat was not restrained and would have resulted in the ejection that occurred during the first and second quarter-turns of the crash phase.

Based on the lack of evidence on the safety belt system and at the belt path of the RFCSS, it was determined that the safety belt webbing was not routed through the belt path and was positioned over the rear aspect of the safety seat. This positioning resulted in the ejection of the safety seat during the first and second quarter turns of the rollover event. The SCI test concluded that with the vehicle safety belt system routed through the belt path, the RFCSS would not have disengaged, thus preventing an ejection of the RFCSS and the child.

**Figure 14. RFCSS with the lap positioned across the rear of the safety seat.**

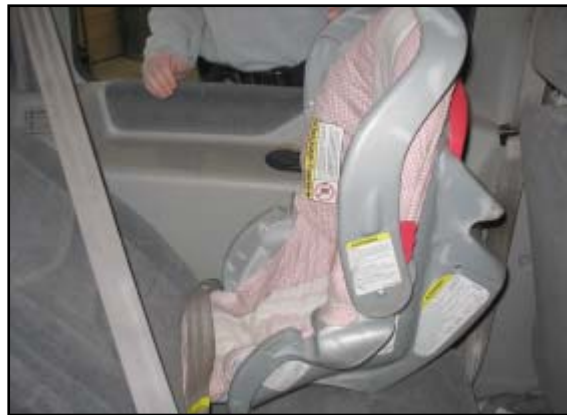
**Figure 15. Separation from the safety belt system.**

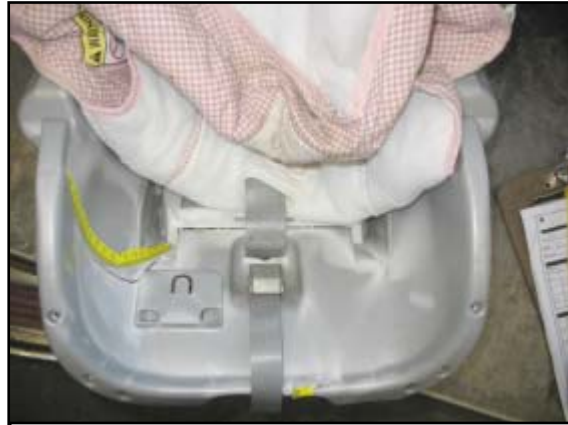
The RFCSS exhibited damage that was attributed to the ground contact during the ejection. The damage consisted of white stress marks throughout the plastic shell of the RFCSS. These stress marks were also present across the entire 42 cm (16.5") width of the carrying handle. In addition to these stress marks, two fractures were noted. The largest of these fractures measured 50 cm (19.5") and began at the rear aspect of the right belt path and wrapped around to the right left of the safety seat (**Figure 16**). A second fracture was found at the rear edge of the safety seat and measured 5 cm (2"). The harness straps were free of damage and contained body fluid and dirt. The total length of the exposed harness straps was 30 cm (12"). The cushion of the safety seat also contained body fluid and dirt from the ground contact.

**Figure 16. Stress marks and fracture at the right belt path.**
