INDIANA UNIVERSITY

ON-SITE ROLLOVER INVESTIGATION

CASE NUMBER - IN07008
LOCATION - TEXAS
VEHICLE - 2003 FORD EXPLORER SPORT TRAC
CRASH DATE - December 2006

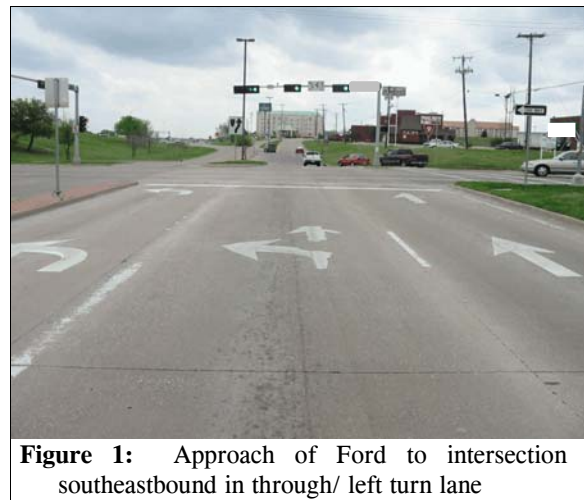
Pre-Crash: The Ford was traveling southeast in the through/left turn lane (**Figure 1**). The Ford's driver was intending to continue through the intersection. The Nissan was traveling east in the center left through lane (**Figure 2**). The Nissan's driver was also intending to continue through the intersection. It is not known if the Ford's driver made any pre-crash avoidance maneuvers. There was no indication of any avoidance maneuvers on the police crash report for either driver. The police crash schematic gave no indication of pre-crash braking. The crash occurred within the four-leg intersection.

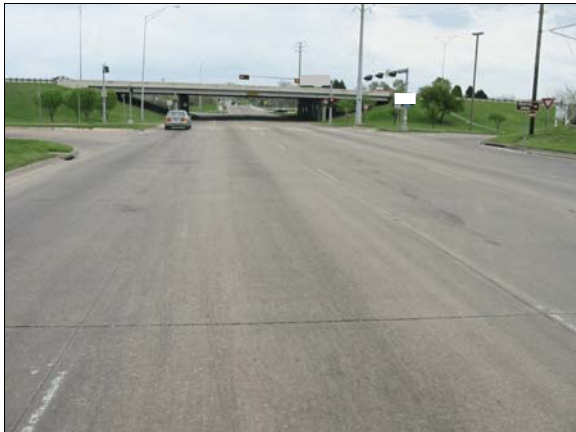
Figure 2: Approach of Nissan to the intersection eastbound in the inside center through lane

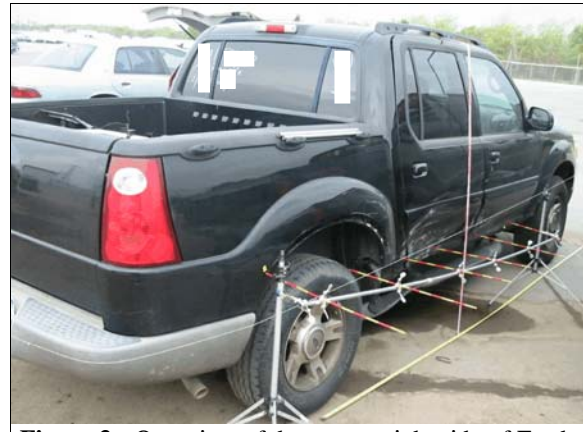
Crash: The front of the Nissan impacted the right side of the Ford (**Figure 3**). As a result of the impact, the Ford was redirected further to the southeast and began to rotate clockwise. As it rotated, the Ford rolled over one-quarter turn onto its left side (**Figure 4**). The Ford's air bags did not deploy in this crash.

Figure 3: Overview of damage to right side of Ford due to impact with the Nissan

Exterior Damage: The Ford’s impact with the Nissan involved the right side. The Ford’s right front and rear doors, nerf bar, right rear tire, and the right side of the truck bed were all directly damaged. The direct damage began 95 centimeters (37.4 inches) rear of the right front axle and extended 270 centimeters (106 inches) along the lower right door area and rearward. The residual maximum crush was measured as 4 centimeters (1.6 inches) occurring at C₃. There was minimal crush to the right side due to the Nissan’s engagement of the right rear wheel, which prevented

significant engagement with the side sheet metal. The induced damage was minimal as well with the right rear door displaced outward slightly at the top. No other induced damage or remote buckling was noted. The table below shows the 's right side crush profile.

Damage Classification: The CDCs for the Ford were **02-RZEW-01 (60 degrees)** for the impact with the Nissan and **00-LDAO-02** for the rollover. The WinSMASH reconstruction program, missing vehicle algorithm was initially used to reconstruct the Delta Vs for the right side impact with the Nissan (i.e., the highest severity impact). The Total, Longitudinal, and Lateral Delta Vs are, respectively: 5 km.p.h. (3.1 m.p.h.), -2.5 km.p.h. (-1.5 m.p.h.), and -4.3 km.p.h. (-2.3 m.p.h.). The results were considered too low and not reasonable given the vehicle's post-impact trajectory and rollover. The low WinSMASH results were due to the minor sheet metal crush

sustained by the vehicle. The crush was minor because the front of the Nissan primarily engaged the vehicle's right rear wheel. The estimated crash severity for this impact was 14-23 km.p.h. (9-14 m.p.h.). In addition, the crash severity of the rollover was considered to be minor based on minor left side crush and the fact it rolled over only one quarter turn. The Ford was towed due to damage.

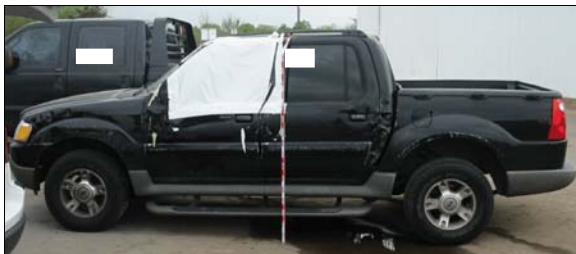
Figure 4: Overview of minor rollover damage to left side of

The rollover damage to the Ford involved the entire length of the left side. The left fender, both doors, left roof side rail, the left side view mirror, and left side of the truck bed were all directly damaged and crushed minimally. The left front window disintegrated as a result of ground impact to the door. No other induced damage or remote buckling was noted on the remainder of the left side. The vehicle's wheelbase was unaltered due to the crash.

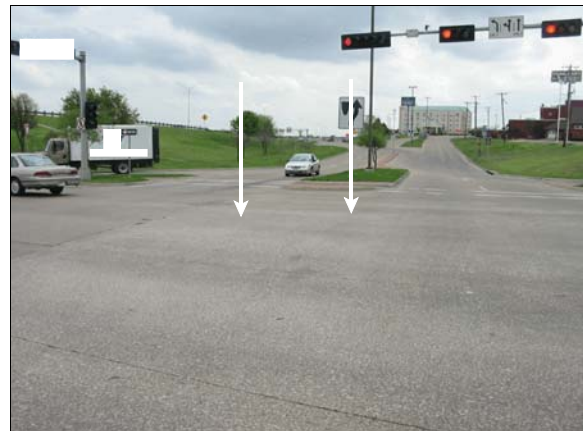
Post-Crash: The Ford came to final rest within the intersection facing southwest (**Figure 5**). The Nissan was redirected to the southeast and came to final rest within the intersection facing southeast (**Figure 5**).

Figure 5: Overview southeast to area of final rest of Ford (left arrow) and Nissan (right arrow)

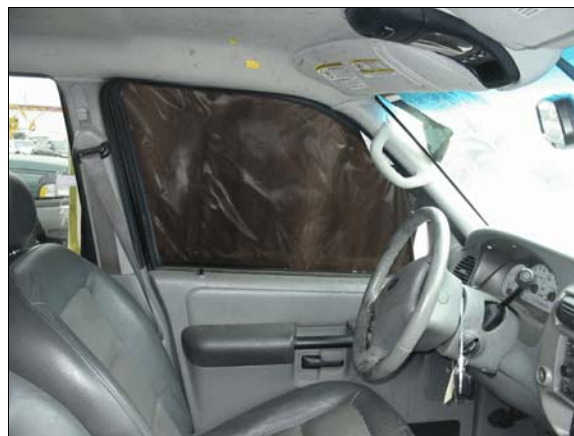
Vehicle Interior: An inspection of the Ford's interior (**Figures 6 and 7**) revealed dirt and grease smears though out the interior. The only occupant contact found was on the roof above the driver's seat and there was no passenger compartment intrusion. In addition, there was no deformation of the steering wheel or compression of the energy absorbing steering column.

Based on the vehicle inspection, the driver was not using his lap-and-shoulder safety belt. Inspection of the driver's safety belt webbing, D-ring, and latch plate revealed no evidence of loading.

Figure 6: Overview of driver's seating position, yellow tape shows hair transfer on roof

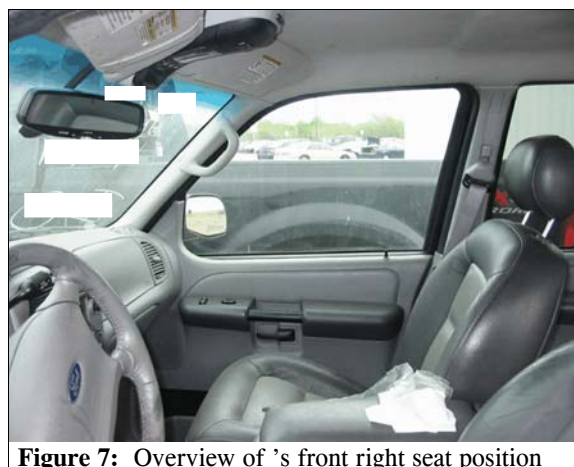
Figure 7: Overview of 's front right seat position

Based on the vehicle inspection, the vehicle's front right passenger was not using her lap-and-shoulder safety belt. No evidence of loading was found on the belt webbing or D-ring, and there was little evidence of historical usage. In addition, the police crash report indicated the front right passenger was not restrained.

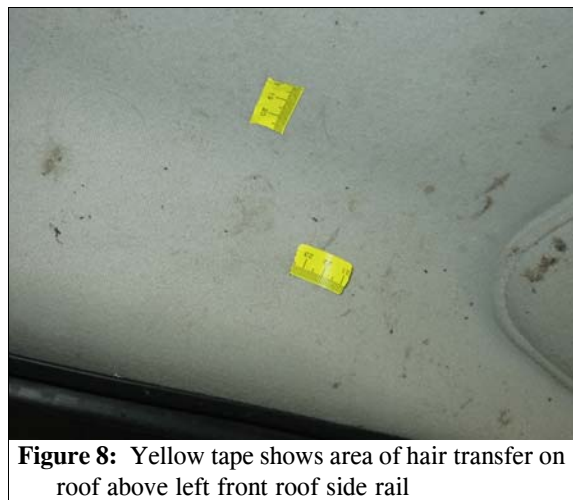
The vehicle's right side impact with the Nissan caused the driver to continue forward and to the right opposite the vehicle's 60 degree direction of principal force. Based on occupant kinematic principles, as the vehicle rotated clockwise, the driver was displaced to the left and loaded his door as the vehicle rolled over onto its left side. When the vehicle impacted the ground, the driver impacted the left front door and was displaced toward the roof. He impacted his head on the roof, just above the left roof side rail (Figure 8). The driver came to rest against the left front door. It is not known how he exited the vehicle.

Figure 8: Yellow tape shows area of hair transfer on roof above left front roof side rail
