Rollover/Child Safety Seat Investigation / Vehicle to Object  
Dynamic Science, Inc. / Case Number: DS07011  
1996 Jeep Grand Cherokee  
Utah  
February 2007

1. Report No. DS07011	2. Government Accession No.		3. Recipient Catalog No.	
4. Title and Subtitle Rollover/Child Safety Seat Investigation			5. Report Date June 10, 2007

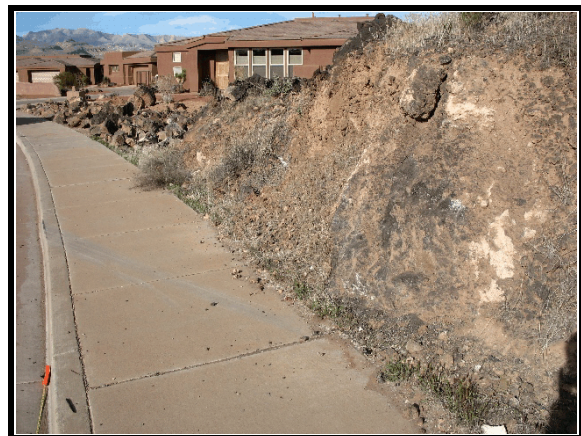
The front of the Jeep struck an outcropping of rocks with its front end (**Figure 4**). The impact severity was moderate, and resulted in the deployment of the frontal air bag system in the vehicle. The Damage Only algorithm of the WinSmash program computed a total delta V of 24.0 km/h (14.9 mph), based on the Jeep's front end crush profile. The longitudinal and lateral components were -24.0 km/h (-14.9 mph) and 0 km/h (0 mph), respectively.

**Figure 4.** Impact with rock outcropping

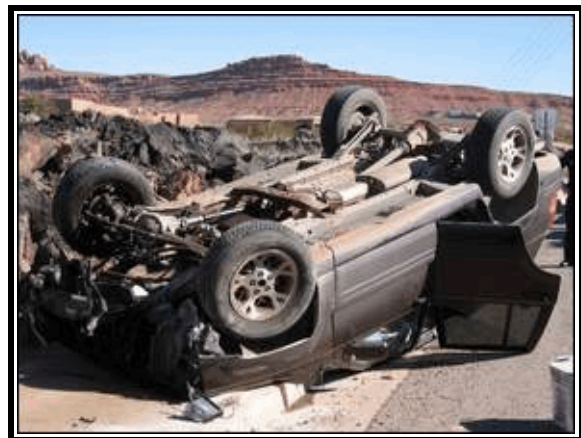
It appears that the Jeep rotated clockwise slightly as the vehicle struck the rock outcropping. As the vehicle rotated, it began a left side leading rollover. The Jeep rolled two quarter turns and came to rest on its roof facing west (**Figure 5**).

**Figure 5.** Case vehicle at final rest

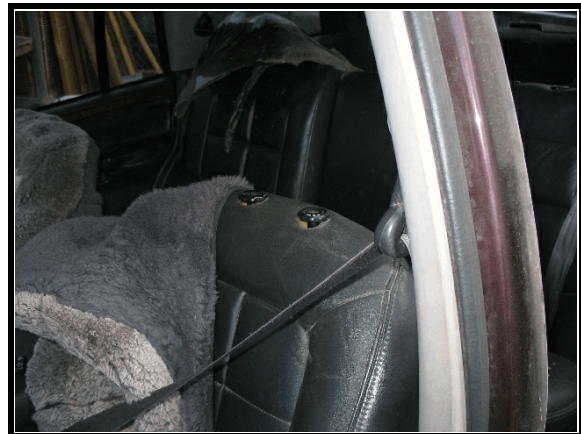
The seating in the Jeep Grand Cherokee was configured with leather covered front bucket seats with adjustable head restraints and a second row split bench back seat. The front head restraints had been removed in order to install after-market seat covers. The rear seat head restraints were missing at the time of the inspection. Both front seats were located at the rear most track position. The driver's seat back was at a 22 degree angle from the vertical; the seat bottom angle was 12 degrees from the horizontal. The front right passenger seat back was at a 22 degree angle from the vertical; the seat bottom angle was 12 degrees from the horizontal. The rear seat backs were at a 22 degree angle from the vertical; the seat bottom angles were 13 degrees from the horizontal.

**Figure 6.** Driver's seat back with after market cover removed.

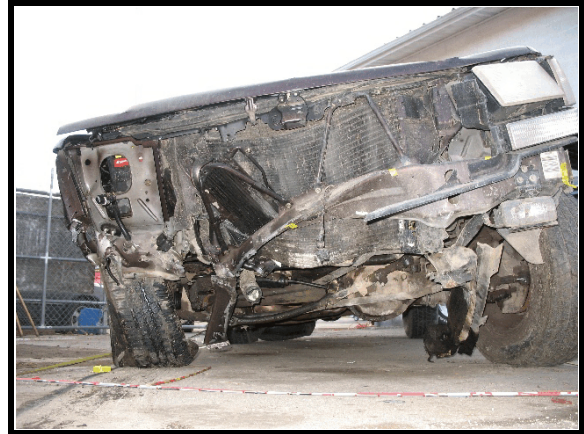
The 1996 Jeep Grand Cherokee sustained moderate front end damage as a result of the impact with rock outcropping (**Figure 7**). The direct damage began at the front right bumper corner and extended laterally 52 cm (20.5 in). The combined direct and induced damage measured 143 cm (56.3 in). The maximum longitudinal crush was located between C5 and C6 and measured 51 cm (20 in). There was damage into the radiator area and into the lower frame. The right wheelbase was shortened by 3 cm (1.2 in) and the right front tire was flattened. All the doors remained closed and operational. Six crush measurements were documented at the bumper level as follows: C1 = 3 cm (1.2 in), 6 cm (2.4 in), 9 cm (3.5 in), 21 cm (8.3 in), 28 cm (11.0 in), 28 cm (11.0 in). The Collision Deformation Classification (CDC) for the impact with the rocks was 12FREW3.

**Figure 7.** Front impact, Jeep Grand Cherokee

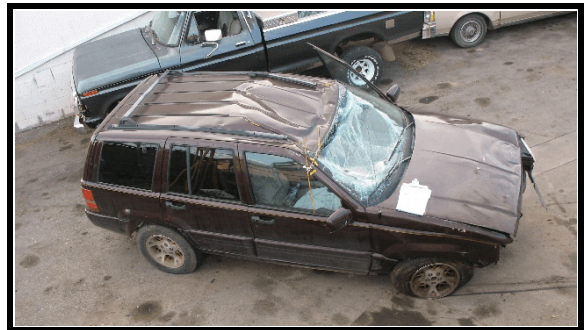
The Jeep also sustained damage during the rollover (**Figure 8**). The direct damage was 122 cm (48.0 in) wide. It began at the hood line and extended rearward 208 cm (81.9 in) to include the windshield header and the roof area above the front seats. The maximum vertical crush was to the left of the A pillar along the windshield header (**Figure 9**). It was located 34 cm (13.4 in) laterally from the side with a maximum crush of 11 cm (4.3 in). The CDC for the rollover was 00TYDO3.

**Figure 8.** Top view of roof damage

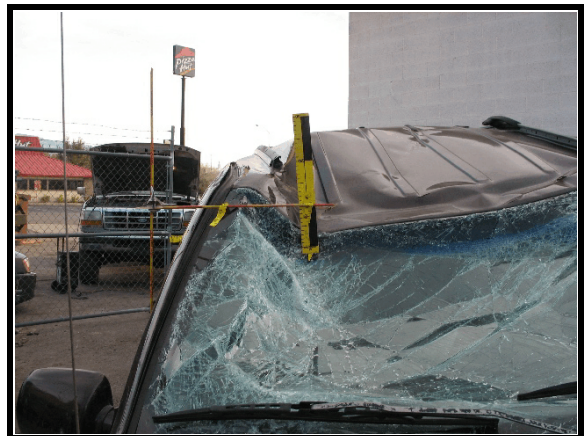
**Figure 9.** Front view of roof damage

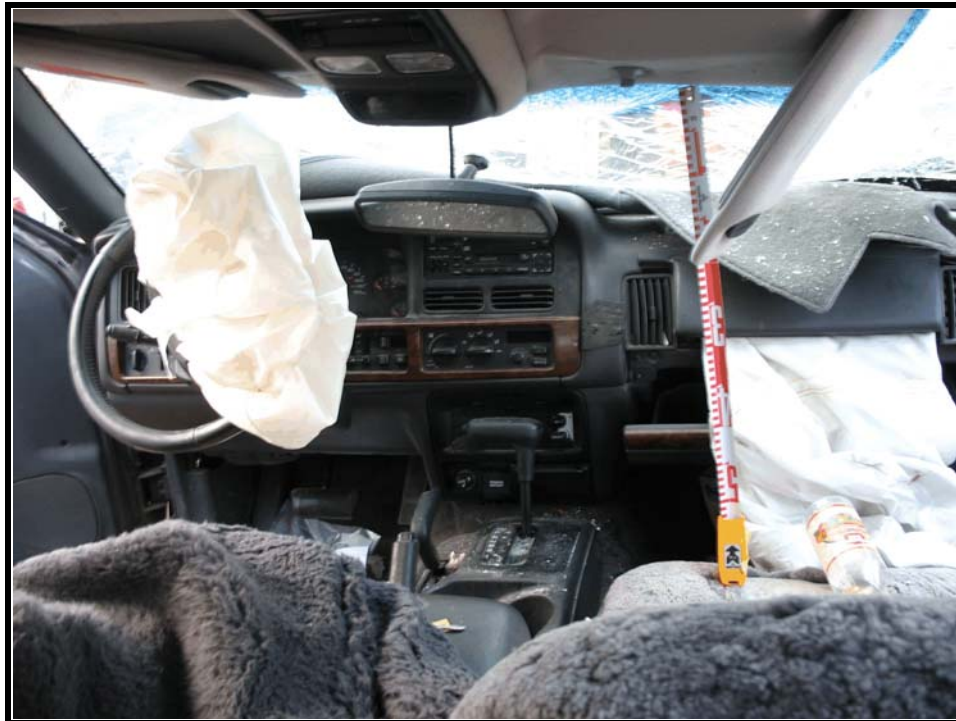
The 1996 Jeep Grand Cherokee sustained minor interior damage as a result of passenger compartment intrusion (**Figure 10**). The roof and windshield sustained vertical intrusion. The windshield was cracked from impact damage. All the doors remained closed and operational. The specific passenger compartment intrusions were documented as follows:

Position	Intruded Component	Magnitude of Intrusion	Direction
LF	Roof	9 cm (3.5 in)	Vertical
LF	Header	9 cm (3.5 in)	Vertical
RF	Roof	14 cm (5.5 in)	Vertical
RF	Header	14 cm (5.5 in)	Vertical

**Figure 10.** Overview of roof/windshield header intrusion

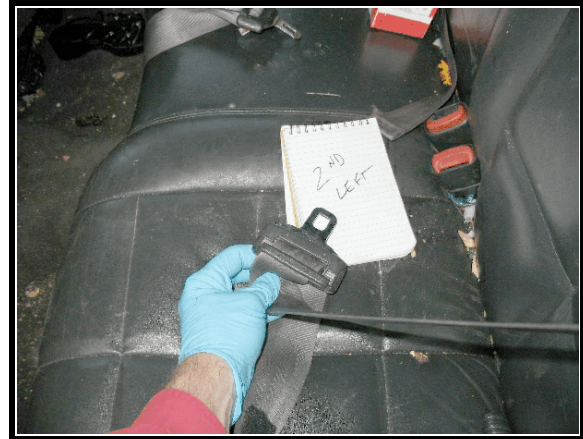
The driver's belt exhibited a 13 cm (5.1 in) area of possible loading that was located approximately 152 cm (59.8 in) from the anchor. The driver reported that she was wearing the safety belt. The second row left safety belt was used to secure a forward facing booster seat (**Figure 11**). There were no indications of seat belt loading. The second row right safety belt was used to secure a rear facing infant seat. The second row right seat belt webbing was cut in two locations by either the responding private parties or emergency personnel (**Figure 12**). The cut section measured 105 cm (41.3 in) in length.

**Figure 11.** Second row left seat belt/latch plate

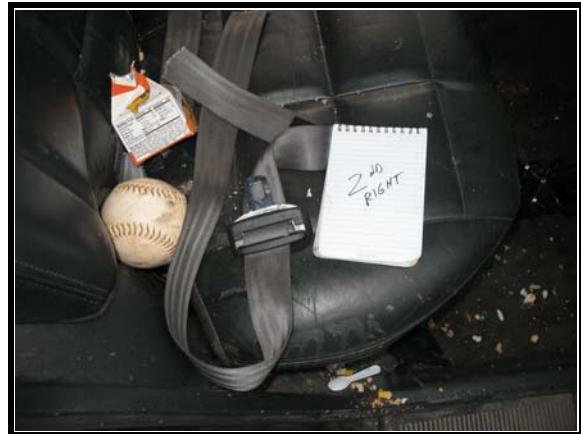
**Figure 12.** Cut section of second row right seat belt webbing

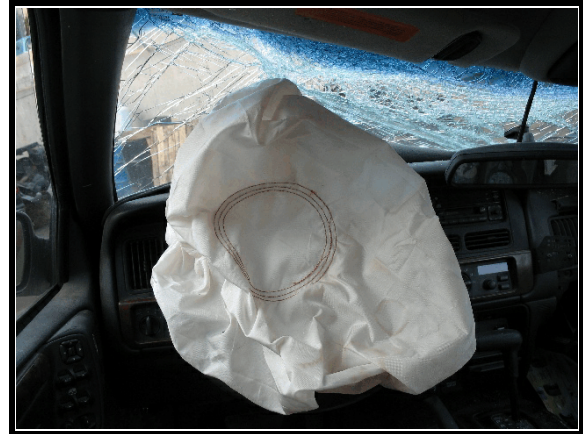
The driver's air bag deployed from the center of the steering wheel hub through asymmetrical H-configuration module cover flaps (**Figure 17**). The top flap measured 4 cm (1.6 in) in height and 16 cm (6.3 in) width. The bottom flap measured 8 cm (3.1 in) in height and 16 cm (6.3 in) width. The deployed driver's air bag measured 54 cm (21.3 in) in diameter in its deflated state. The air bag was tethered by a single internal strap. There were no vent ports. There were eight horizontal flaps across the face of the air bag. A stain was found at the top left quadrant. The stain was tested by the SCI investigator and the results were positive for blood<sup>1</sup>.

**Figure 17.** Driver's air bag (top of air bag at bottom of image)

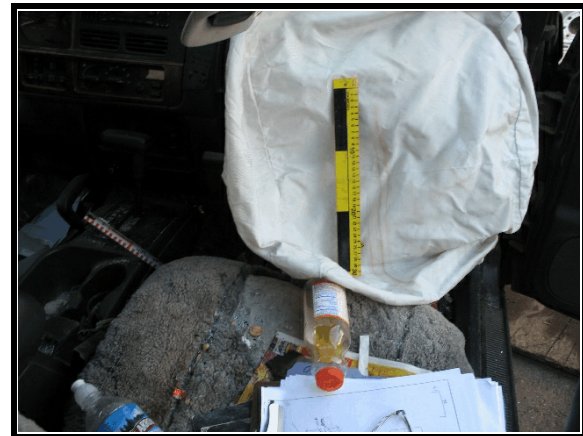
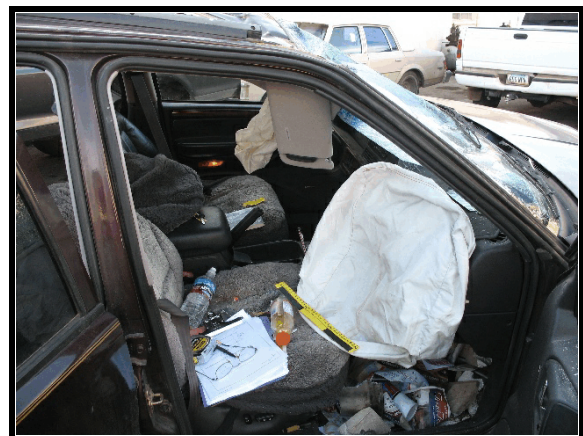
The front right passenger's air bag deployed from a mid-mount module with a rectangular cover flap that was hinged at the forward aspect (**Figures 18-19**). The module cover flap measured 36 cm (14.2 in) in width and 12 cm (4.7 in) in height. The deployed front right passenger's air bag measured 41 cm (16.1 in) in width seam to seam and 55 cm (21.7 in) in height. There was a light stain on the right side of the air bag face. There was also an orange colored scuff that was approximately 5 cm (2.0 in) wide by 32 cm (12.6 in) high just to the left of the center of the air bag.

**Figure 18.** Front right passenger air bag

**Figure 19.** Front right passenger air bag (side view)
