ON-SITE NOT-IN-TRAFFIC SURVEILLANCE BACK OVER INVESTIGATION

CASE NUMBER - IN-07-012

VEHICLE - 2006 CHEVROLET MALIBU LS

INCIDENT DATE - March 2007

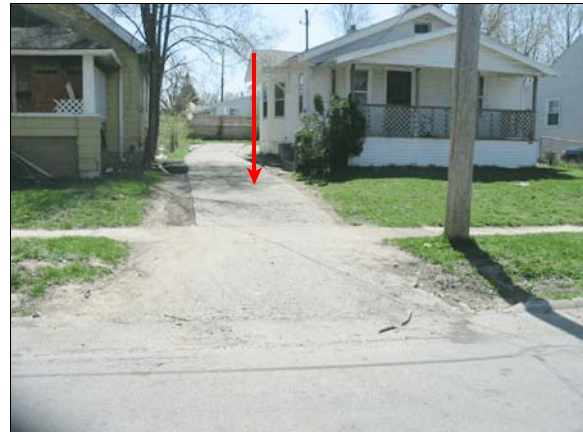
Pre-Crash: The Chevrolet Malibu was parked heading south into the driveway (**Figure 1**). The driver approached the vehicle from the front left, entered the vehicle and started the engine. According to the driver, she conversed with friends that were outside the vehicle for 3-4 minutes. During this time, the driver put her foot on the brake and shifted the vehicle's transmission into reverse as she was getting ready to back out of the driveway. Meanwhile, according to the driver, there were several youths playing ball in the street as well as other adults in the area. Just prior to backing out of the driveway, another child appeared to the driver on the right side of the case vehicle. The driver stated she told the child to get to the porch so that he would not be backed over. Once the child was on the porch, the driver stated she checked the rearview and both side view mirrors, then looked over her right shoulder out of the backlight and started to back out of the driveway. Meanwhile, the pedestrian was either standing on the sidewalk behind the vehicle's back right corner, or was walking east along the sidewalk approaching the path of the vehicle as the driver began to back up (i.e., there was conflicting information regarding the status of the pedestrian). Based on the reported parked location of the Chevrolet and approximate location of impact, the Chevrolet traveled backwards approximately 3.9 meters (12.8 feet) to impact in the intersection of the sidewalk and driveway (**Figure 2**).

Figure 1: View south into driveway, arrow shows approximate location of the back end of the Chevrolet Malibu before backing maneuver

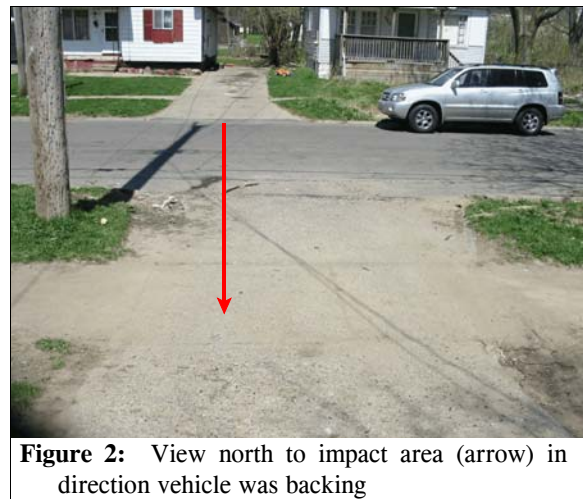
Figure 2: View north to impact area (arrow) in direction vehicle was backing

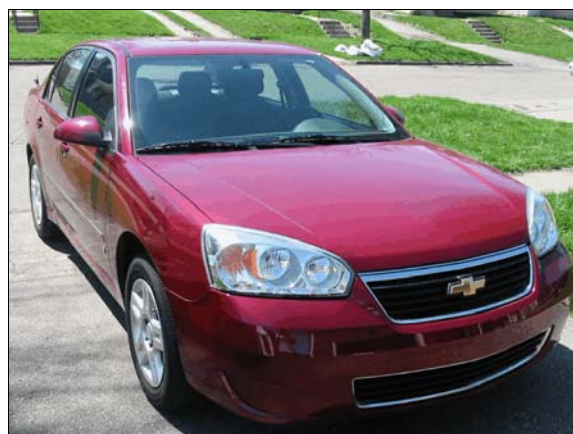
Figure 3: Overview of Chevrolet from front right

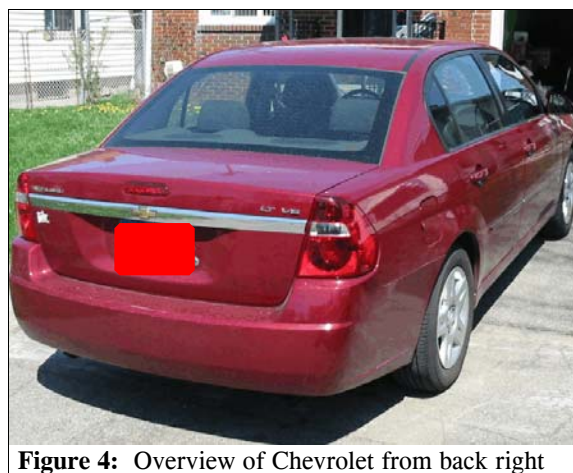
Figure 4: Overview of Chevrolet from back right

There was no evidence of pedestrian contact to the case vehicle's back bumper (**Figure 4**), undercarriage, or right rear tire. However, based on the descriptions of the events, a Collision Deformation Classification was estimated to be: **06-BRLU-1 (180 degrees)** for the back bumper impact. The Chevrolet was driven from the scene.

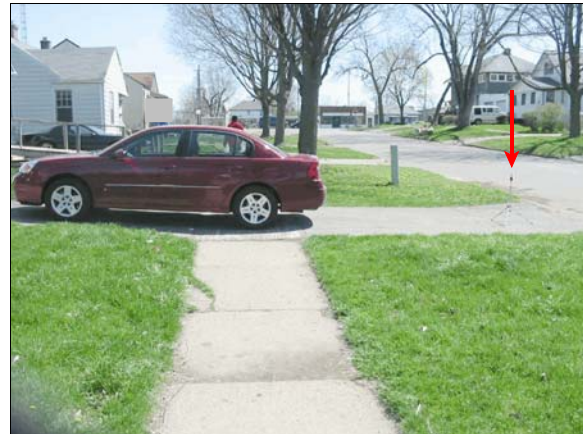
Figure 5: Arrow shows location target first came into driver's view as she looked over her right shoulder out of backlight

In order to determine the blind zone behind the Chevrolet, the standard 71 centimeters (28 inches) high target was positioned at the center of the back of the Chevrolet and moved rearward until the target came into the driver's view (**Figure 5**) as she looked over her right shoulder. It was necessary to move the target rearward 3.4 meters (11.2 feet) before the driver could see it. The target was then moved to the right from the case vehicle's approximate centerline 2.4 meters (7.9 feet) where it became obstructed by the back right head restraint. The target was not visible to the driver again until it was moved to the right an additional 1.7 meters (5.6 feet) where it became visible on the right side of the right "C"-pillar. With the target returned to 3.4 meters (11.2 feet) behind the vehicle, it had to be moved only 30 centimeters (12 inches) to the left from the centerline where it became obstructed by the back left head restraint. The driver could not see beyond the back left head restraint because she could not turn her head that far to the right and her own head restraint blocked her view.

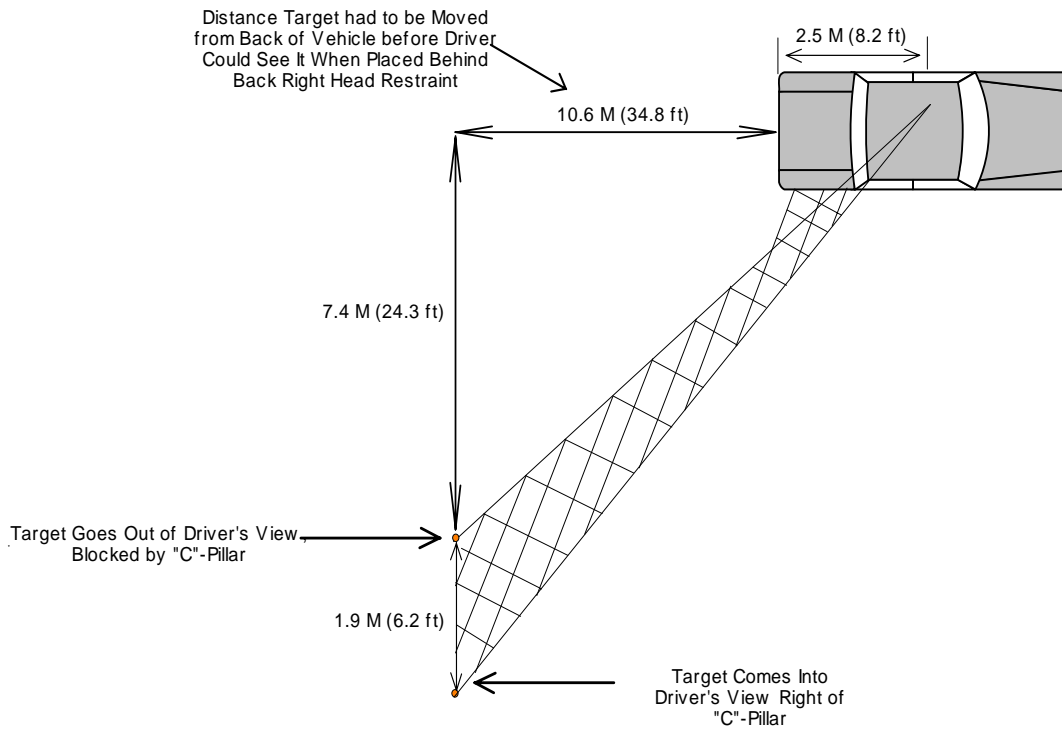
3. "C"-Pillar Blind Zone, Driver Looking Over Right Shoulder

The extent of the blind zone behind the back right head restraint was also determined. The target was placed at the back of the Chevrolet where it was obscured by the back right head restraint and moved rearward until it came into the driver's view. The target had to be moved rearward from the back of the vehicle 10.6 meters (34.8 feet) before the driver could see it. The target was then positioned at the vehicle's approximate centerline 10.6 meters (34.8 feet) from the back of the vehicle and moved to the right 7.4 meters (24.3 feet) where it became obstructed by the right "C"-pillar. The target had to be moved to the right an additional 1.9 meters (6.2 feet) before the driver could see it again on the right side of the "C"-pillar.

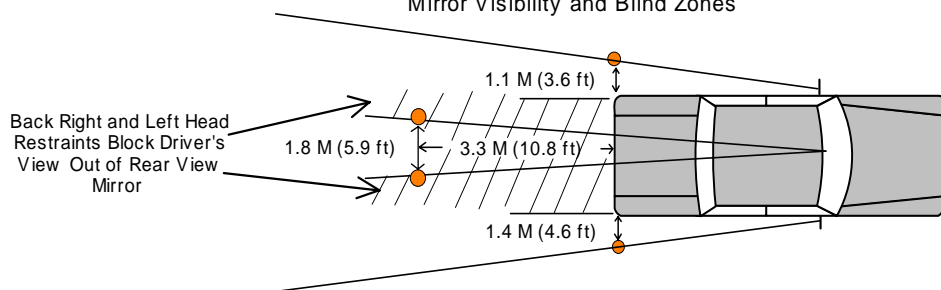
4. Side View Mirror and Rearview Mirror Visibility and Blind Zones

The driver was then asked to view behind the Chevrolet through the rearview mirror. The target did not become visible to the driver until it was moved rearward from the back of the vehicle approximately 3.3 meters (10.8 feet). The target was then moved to the right from the Chevrolet's centerline 1.2 meters (3.9 feet) before becoming obstructed by the back right head restraint. When moved further to the right, the target went out of the rearview mirror's field of view. When moved to the left from the centerline, the target was visible for only 60 centimeters (23.6 inches) before being obstructed by the back left head restraint, and did not come back into view when moved further to the left. Both side view mirror visibility zones were also assessed and are included in the visibility diagrams at the end of this report.

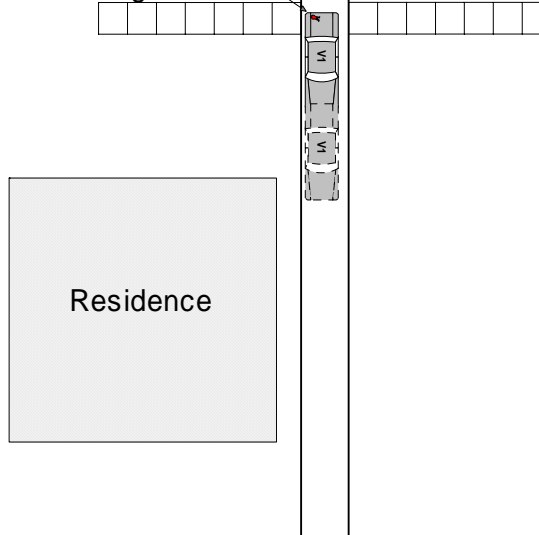
Clear, Daylight
Dry, Concrete Driveway
Grade in Direction Backing: 12.5% Negative
Grade at Sidewalk: 1.8% Negative
Estimated Coefficient of Friction: 0.75

Pedestrian Reportedly Under Back
of Case Vehicle Following Incident
