Rollover/Infant Safety Seat Investigation / Vehicle to Vehicle
Dynamic Science, Inc. / Case Number: DS07012
2006 Kia Spectra5
Nevada
February 2007

1. Report No. DS07012	2. Government Accession No.		3. Recipient Catalog No.	
4. Title and Subtitle Rollover/Infant Safety Investigation			5. Report Date June 19, 2007

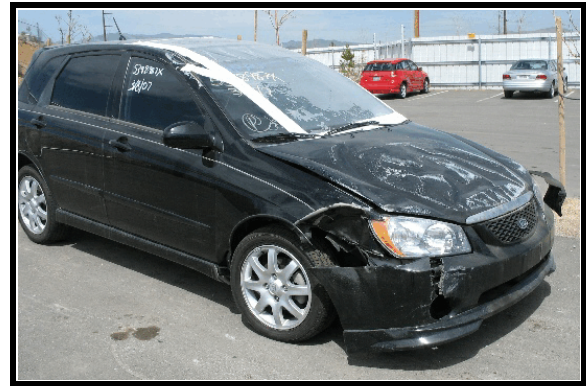
This on site rollover/infant safety seat investigation focused on the performance of a rear-facing infant seat that was installed in the left rear position of a 2006 Kia Spectra5 (**Figure 1**). The Kia Spectra5 was occupied by a 21-year-old female restrained driver, a 25-year-old male front right seat passenger, and an 8-month-old female rear left seat passenger. The 8-month-old female rear left seat passenger was restrained in the rear facing infant seat. The infant seat was secured within the vehicle by the manual 3-point lap and shoulder belt. The belt was routed through the rear-facing belt path. The Kia struck on the left side of a 2005 Cadillac Escalade in an intersection crash. The Kia was deflected laterally, contacted a concrete median, and overturned onto its roof. The driver stated that there were no injuries. All three occupants of the Kia were transported to a local hospital for evaluation. The driver of the Escalade was not injured.

Figure 1. Case vehicle. 2006 Kia Spectra5

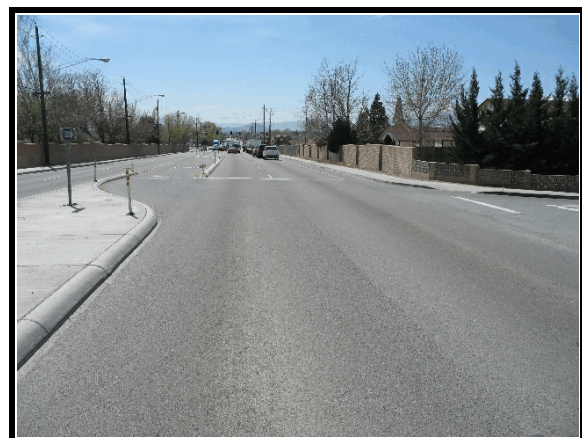
Figure 2. Approach to area of impact (south)

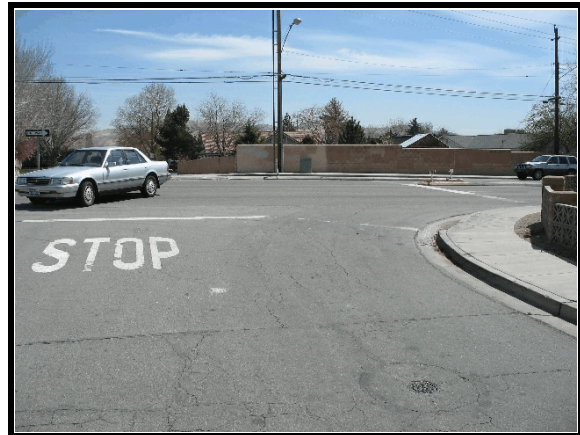
Figure 3. Approach to area of impact (west)

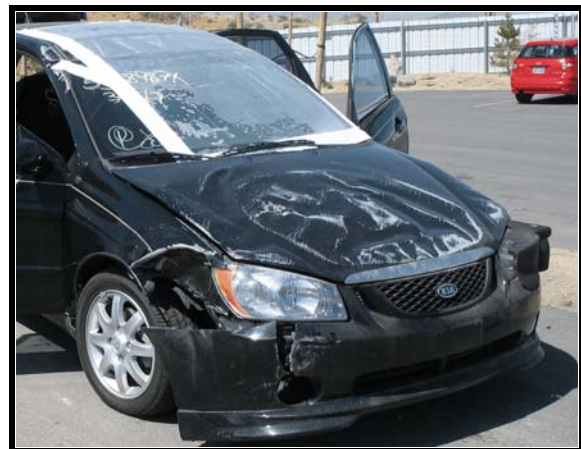
The 2006 Kia Spectra5 sustained minor frontal damage as a result of the impact with the Cadillac Escalade (**Figure 4**). The direct damage began at the right front bumper corner and extended 26 cm (10.2 in) laterally along the frontal plane. The damage extended 59 cm (23.2) down the right side of the vehicle. The right side wheelbase was compressed by 8 cm (3.1 in) and the front right tire was restricted. The Collision Deformation Classification (CDC) for the impact with the Escalade as 01FREE3.

Figure 4. Front right damage

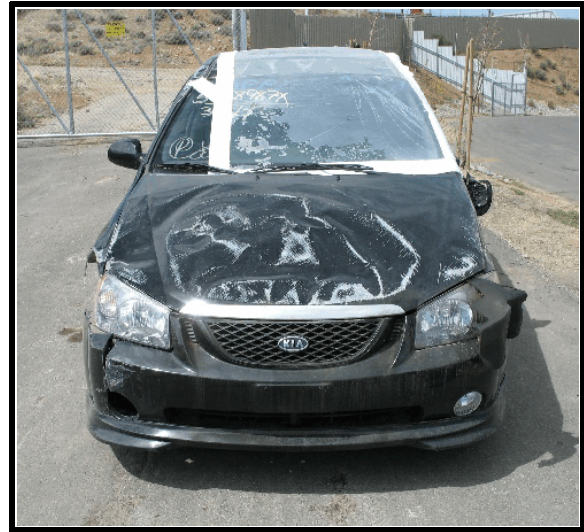
The Spectra5 also sustained moderate top and left side damage as a result of the rollover (**Figure 5**). The direct damage to the top began at the hood line and measured 152 cm (59.8 in) wide by 96 cm (37.8 in) rearward on the hood. There was also direct damage beginning at the windshield header area that measured 120 cm (47.2 in) wide by 26 cm (10.2 in) rearward on the roof. There was also direct contact along the left side plane that began 14 cm (5.5 in) forward of the rear axle and extended forward 296 cm (116.5 in) along the left side plane. The maximum vertical crush (**Figure 6**) was located at the right A pillar and measured 2 cm (0.8 in). The CDC for the rollover was 00TYDO2.

Figure 5. Rollover damage

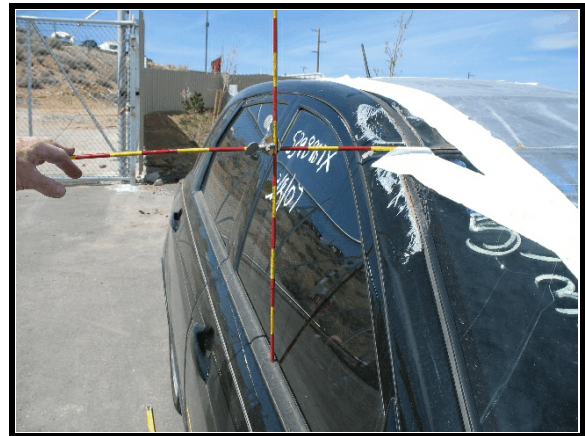
Figure 6. Maximum rollover crush

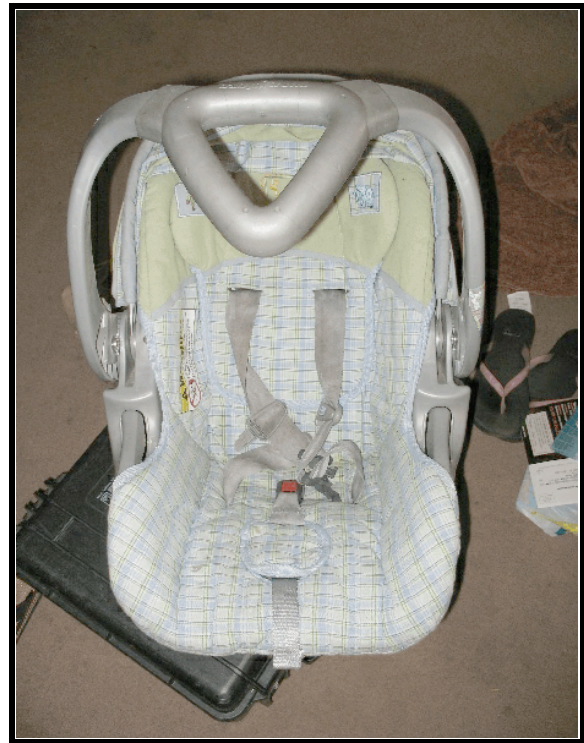
A rear facing Baby Trend Flex Loc infant seat was positioned in the left rear seat of the Kia Spectra5 (**Figure 7**). The model number was 6306 and the date of manufacture was April 5, 2006. The infant seat was purchased new by the current owner for the child involved in this crash. The infant seat was configured with a five-point harness system and an A-lock harness buckle. The seat was also configured with a level indicator that helps ensure that the seat is installed at the optimal angle (**Figure 8**). The seat is designed with a stay-in-vehicle base that is LATCH compliant. The base and LATCH system was not used in this crash. The manufacturer recommends that the seat be used rear facing for children weighing 2-10 kg (5-22 lbs). The child in this case met the weight recommendation (8 kg/17 lbs).

Figure 7. Baby Trend Flex Loc infant seat

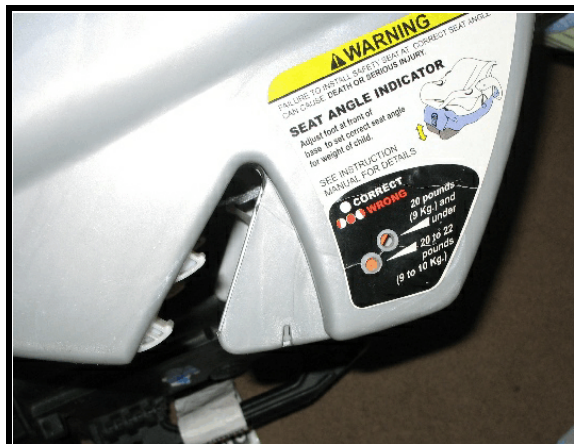
The infant seat was installed by the driver. She had received some instruction about installation from the hospital when taking the child home. She had not read any manuals and was unaware of how the belt system worked. The seat was secured to the vehicle using the lap and shoulder belt. The webbing was routed through the rear facing slots. The retractor was in the ELR mode and a locking clip was not used. The harness clip was near the arm pit level. The driver described the space between the child and the harness as being approximately two fingers wide. The carrying handle was in the UP position. There was some light scuffing to the belt guide on the right side of the seat (**Figure 9**).

Figure 8. Seat angle indicator

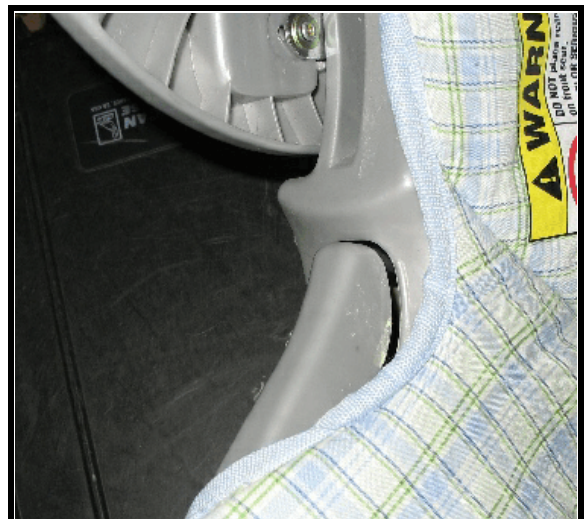
Figure 9. Scuffing, right seat belt guide 6

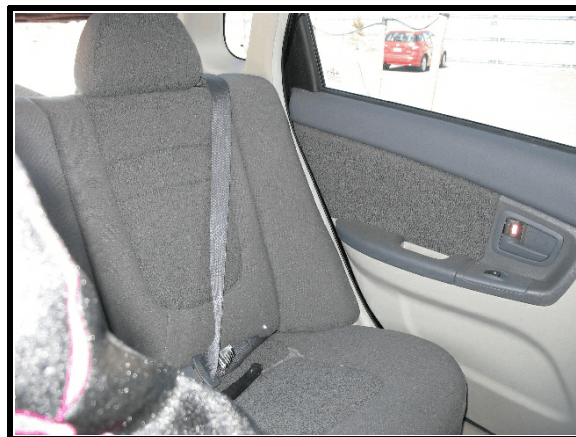
The 8-month-old female child was restrained in the rear-facing infant seat by the five-point harness (**Figure 10**). The infant seat was installed in the left rear position of the Kia Spectra5 with the vehicle's 3-point lap and shoulder safety belt. The retractor was in the ELR mode and a locking clip was not used. The harness clip was near the arm pit level. The driver described the space between the child and the harness as being approximately two fingers wide. The carrying handle was in the UP position. At impact with the Escalade, the left rear occupant initiated a slight forward trajectory to the right. She engaged to the infant seat back in some minimal fashion. As the Kia was redirected to the left, the left side tires contacted the concrete median and the vehicle began a left side leading rollover. The Kia rolled onto its left side and then onto the roof. The left rear occupant would have been displaced somewhat to her right (vehicle left) as the vehicle engaged the median and tripped. As the vehicle rolled, the left rear occupant remained in place and came to rest still restrained in the infant seat in an upside down position. She was removed from the vehicle by the front right occupant. There were no visible injuries to the child. She was transported by ground ambulance to a local hospital for evaluation.

Figure 10. Second row left seat position
