**CALSPAN ON-SITE SIDE IMPACT INFLATABLE OCCUPANT PROTECTION
SYSTEM INVESTIGATION**

SCI CASE NO. – CA07-013

SUBJECT VEHICLE – 2005 FORD FREESTYLE

CRASH DATE – MARCH 2007

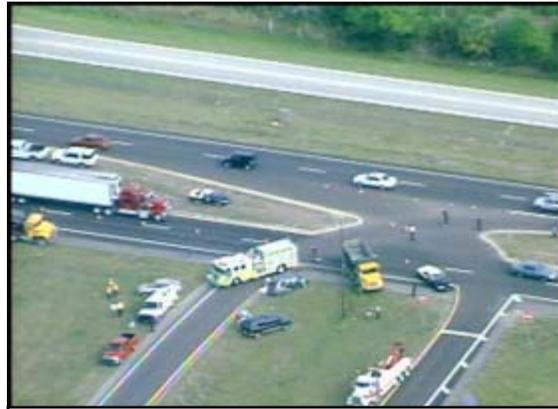
Figure 4. Overhead view of the vehicles at final rest.

The Ford departed the southwest corner of the on-ramp and came to final rest approximately 6 meters (20 feet) east of the area of impact facing northeast. The total rotation of the Ford was approximately 200 degrees. The Freightliner continued its forward trajectory and began a slight clockwise rotation. The Freightliner traveled approximately 15 meters (49 feet) east from the area of impact and departed the south roadside where it came to final rest. At rest, the Freightliner was facing a southeast direction 60 degrees from its original heading angle. **Figure 4** is an overhead view of the vehicles at final rest.

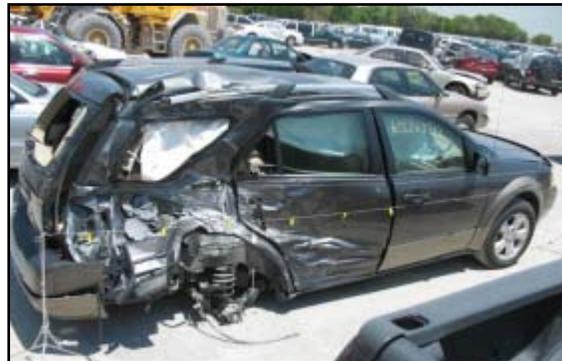
The 2005 Ford Freestyle sustained severe right side damage as a result of the impact with the Freightliner (**Figures 5 and 6**). The direct contact damage measured 185 cm (73”) and began 201 cm (79”) rear of the right front axle. The direct contact ended at the aft edge of the right quarter panel 386 cm (152”) rearward of the front axle. The total height of the direct contact damage measured 135 cm (53”) beginning 5 cm (2”) above sill extending to the top of the roof side rail. Yellow paint transfers were noted on the roof side rail indicative of direct contact.

Figure 5. Resultant damage to the right side of the Ford.

The damage consisted of lateral crush to the right center and rear aspects, separation of the right rear wheel, and deformation to the fuel filler neck. The crush was measured along the mid-door level using a combined direct and induced damage length of 211 cm (83”) and was as follows: C1 = 23 cm (9”), C2 = 43 (16.75”), C3 = 51 cm (20”), C4 = 29 cm (11.5”), C5 = 12 cm (4.75”), C6 = 0 cm. The maximum crush located at C3 measured 51 cm (20”). It was located at the third row left seat position 66 cm (26”) forward of the rear edge of the quarter-panel. The Collision Deformation Classification (CDC) for this impact was 03-RZAW-4.

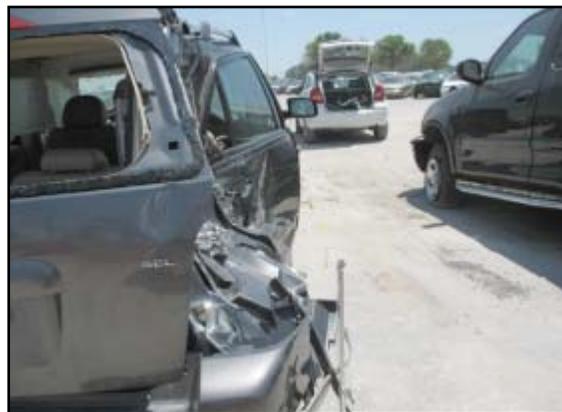
Figure 6. Longitudinal view of the crush.

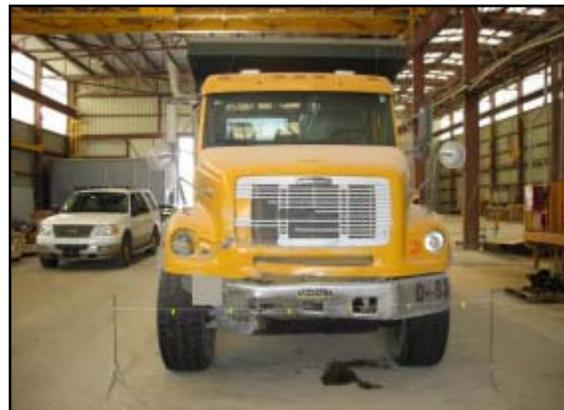
The 1999 Freightliner sustained moderate frontal damage from the impact sequence with the Freestyle (**Figure 7**). The damage involved longitudinal crush to the front steel bumper, abrasions and paint transfers to the fiber glass hood, a fractured right headlamp, and fractures to the plastic grille. The direct contact damage measured 168 cm (68") and began at the front right bumper corner terminating 46 cm (18") inboard of the front left bumper corner. The height of the steel bumper measured was 20 cm (8") and its lower aspect located 66 cm (26") from the ground. A crush profile was documented at the bumper and was as follows: C1 = 0 cm, C2 = 0 cm, C3 = 1 cm (0.25"), C4 = 3 cm (1.25"), C5 = 3 cm (1"), C6 = 21 cm (8.25"). The Truck Deformation Classification (TDC) for this impact was 12-FZEW-1

Figure 7. Damaged 1999 Freightliner.

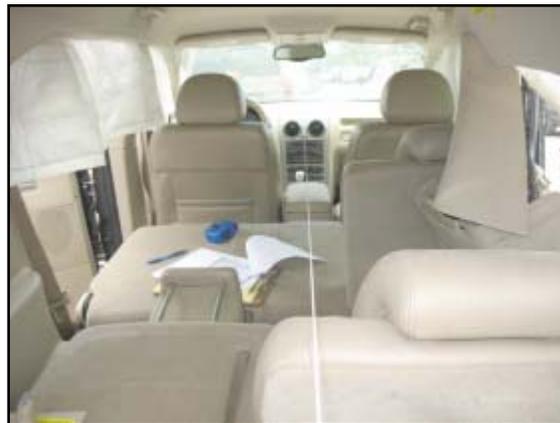
The interior damage to the Ford was severe and was attributed to intrusion of the passenger compartment (**Figure 8**) and occupant contact points. The front row of the Freestyle was free of occupant contact points from the driver and front right passenger.

Seat Position	Intruded Component	Magnitude	Direction
Front Right	Roof side rail	3 cm (1.25")	Lateral
Front Right	B-pillar	10 cm (4")	Lateral
Second Row Right	Door panel	19 cm (7.5")	Lateral
Second Row Right	Roof side rail	17 cm (6.5")	Lateral
Second Row Right	Right seatback	11 cm (4.5")	Lateral
Third Row Right	C-pillar	23 cm (9")	Lateral
Third Row Right	Side panel	33 cm (13")	Lateral
Third Row Right	Roof side rail	10 cm (3.75")	Lateral
Third Row Right	D-pillar	25 cm (10")	Lateral
Third Row Right	Right seatback	13 cm (5.25")	Lateral
Third Row Right	Side panel in cargo area	22 cm (8.5")	Lateral

Figure 8. Rear to front view of the passenger compartment intrusion.

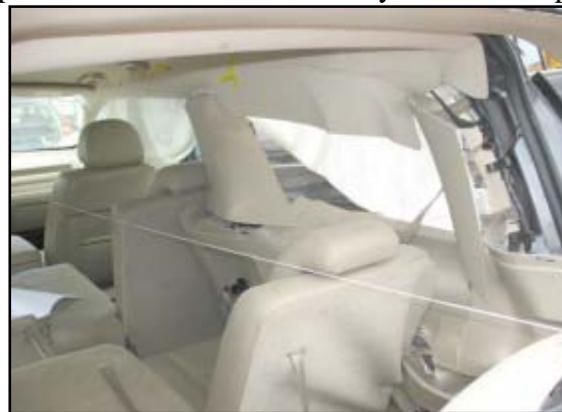
Figure 10. Deployed right canopy air bag.

The right safety canopy air bag deployed from the right roof side rail (**Figure 10**). The deployment of this air bag was partially impeded by the right C-pillar trim. At deployment, the C-pillar was beginning to intrude laterally left and top aspect of the trim separated from its closure against the headliner. As the canopy air bag expanded, the air bag membrane was captured between the C-pillar trim panel and the intruding C-pillar structure (**Figure 11**). The trim panel remained attached to the C-pillar structure by its four mounting clips. The captured air bag resulted in the membrane extending in an inverted V-shaped pattern beginning 41 cm (16”) forward of the C-pillar to 41 cm (16”) rear of the C-pillar. The C-pillar trim panel was removed from its mounting points to conduct an inspection of the partially deployed membrane. Inspection of the membrane at this location revealed that it was still partially rolled similar to its un-deployed state (**Figure 12**). Although that air bag was partially impeded, the air bag membrane expanded to its near full length and height offering a level of head protection to outboard passengers in all three rows. There were no visible occupant contact points or damage to the air bag membrane; however, spattered body fluid was present on the membrane at the area of the third row.

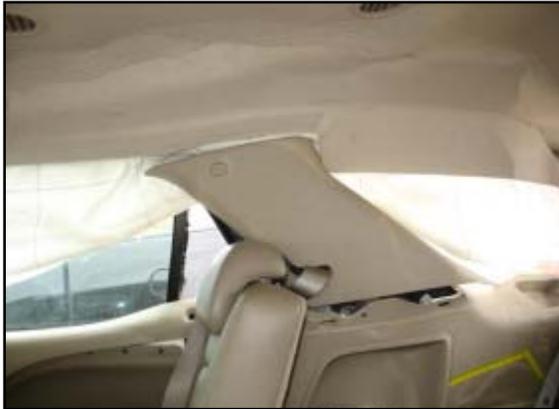
Figure 11. Canopy air bag membrane captured behind C-pillar trim panel.

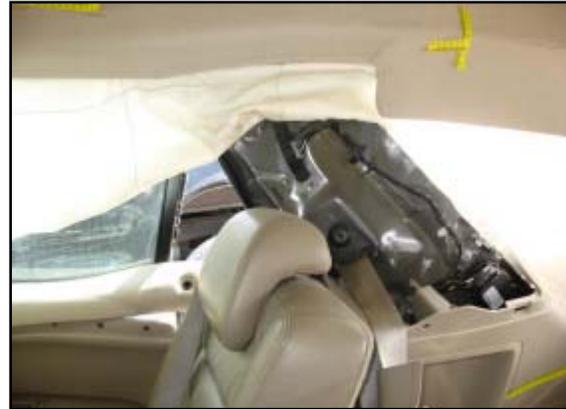
Figure 12. Air bag membrane with removed C-pillar trim panel. Note membrane was partially rolled similar to its un-deployed state.

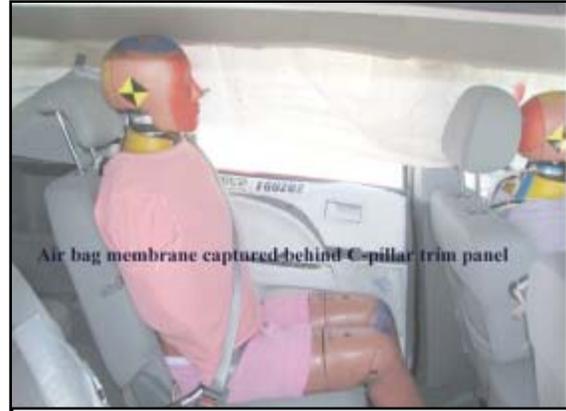
In a side impact crash test conducted by Karco on August 18, 2006 for NHTSA's SNCAP, Test number 5829, the left canopy air bag deployed in a similar pattern. The test video shows the impeded deployment of the canopy air bag. As the air bag reached its fully deployed status, the C-pillar trim panel was dislodged from its top mounting points and the membrane inflated behind the panel. **Figures 13 and 14** are images of the second row left side canopy air bag system pre- and post-test. In the post-test image the canopy air bag was captured behind the C-pillar trim panel.

Figure 14. Post-test view of the deployed canopy air bag.

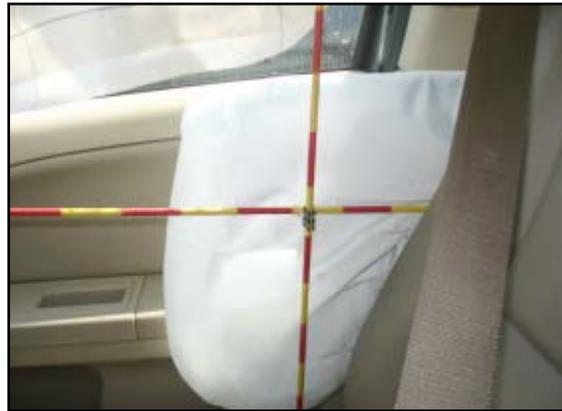
The Ford was equipped with seatback mounted side impact air bags for the front seats. The right seatback mounted side impact air bag deployed as a result of the crash (**Figure 15**). The air bag was concealed in the outboard aspect of the right front seatback. The air bag deployed through a 47 cm (18.5”) vertical tear seam. The air bag membrane measured 23 cm (9”) in height at the seatback and 37 cm (14.5”) in width. There was no occupant contact or damage to the air bag.

Figure 15. Inboard aspect of the deployed side impact air bag.

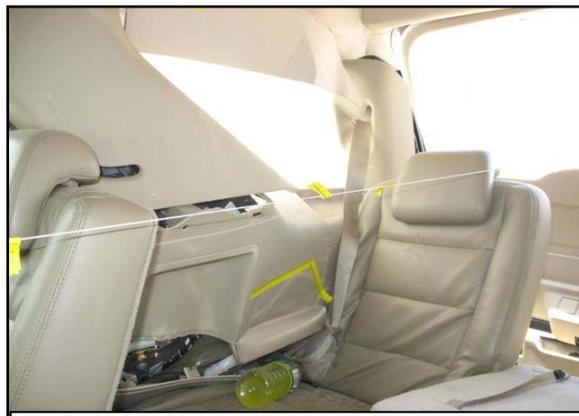
The passenger responded to the 3 o’clock impact force by initiating a rightward trajectory. As the vehicle crushed, the right side panel began to intrude into the right seating position. Due to the ride height of the Freightliner, the top aspect of the Freightliner’s front bumper was 66 cm (26”) above the ground. The third row seat cushion was located 76 cm (30”) above the ground which placed the bumper of the Freightliner and intruding side panel in the area of the 9-year-old male’s hip and torso. The 9-year-old male contacted and loaded the intruding side panel which was evidenced by a 23 x 14 cm (9 x 5.5”) area of stress (whitened plastic) to the side panel (**Figure 16**). The shape and location of the stressed area was consistent with the location of the passenger’s right flank and right lower extremity. The intruding side panel displaced his pelvic area to the left which allowed his upper body and head to flex laterally to the right. The side panel loading resulted in the fatal aortic laceration and the multiple thoracic and abdominal injuries identified during the autopsy (refer to the above table). The passenger’s fatal injuries were directly related to the location of the impact and the resulting intrusion. The right flexion

Figure 16: Right rear seat position.

movement was amplified by the loading from the unrestrained center passenger. This interaction was evidenced by the symmetrical injuries to the left and right aspects of the neck and the clavicles. Additional minor to moderate severity injuries were also
