ON-SITE NOT IN TRAFFIC SURVEILLANCE BACK OVER INVESTIGATION

CASE NUMBER - IN07013

VEHICLE - 2006 CHRYSLER 300

CRASH DATE - March 2007

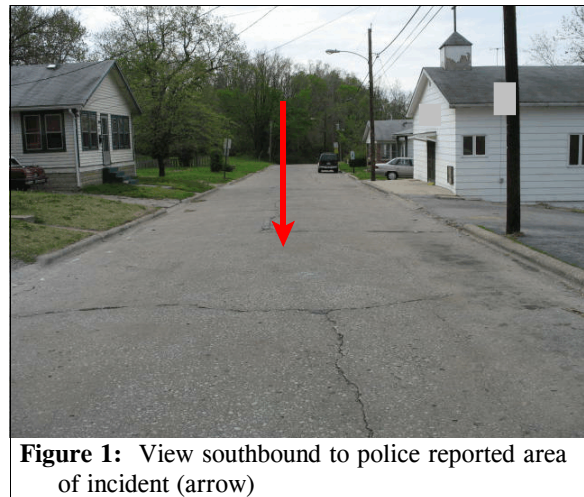
Figure 1: View southbound to police reported area of incident (arrow)

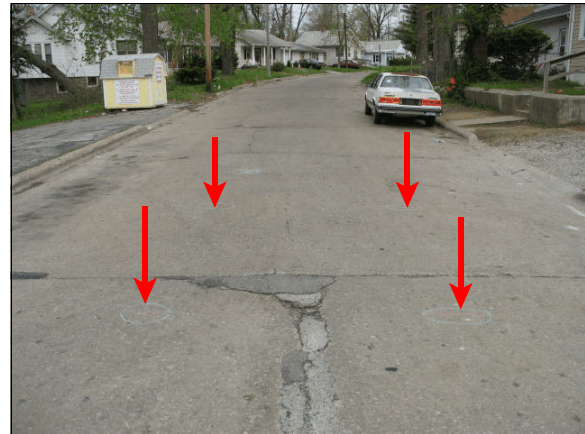
Figure 2: View northbound along path Chrysler was backing, arrows show police orange marks showing Chrysler's wheel positions (arrows) at final rest

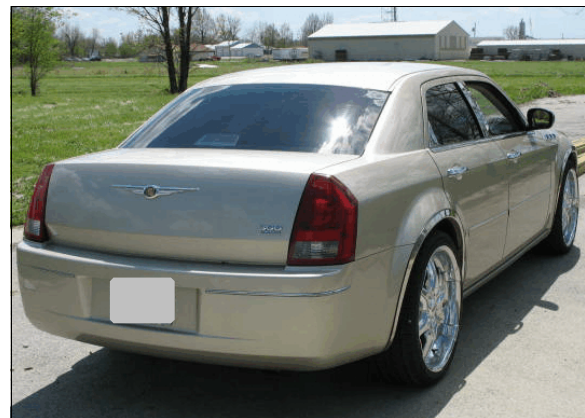
Figure 3: Overview of back of Chrysler

Based on the available information, the center portion of the Chrysler's back bumper (**Figure 3**) most likely struck the child. The child was knocked to the ground. She fell in a westerly direction, which placed the child's head in the path of the Chrysler's right rear wheel. The right rear wheel (**Figure 4**) then passed over the child's head crushing her skull. It is also likely that

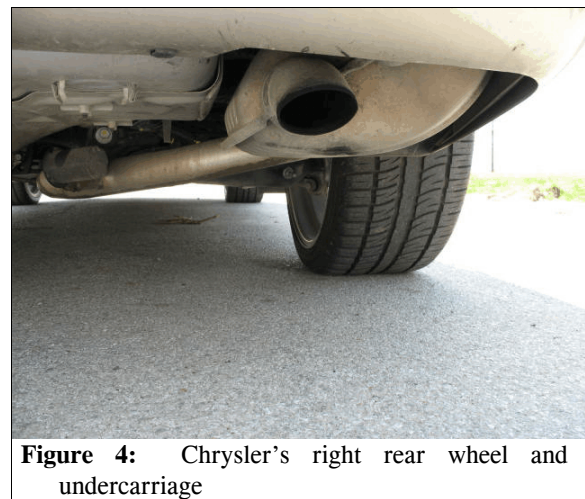
Figure 4: Chrysler's right rear wheel and undercarriage

there was some contact to the child's body by the Chrysler's exhaust pipe, axle and differential; however, examination of these components showed no evidence of contact. The police crash report indicated that a deposit of blood, hair and some plastic beads were found "several inches" in front of the right rear tire. Based on this information, knowledge of the Chrysler's rear overhang, and the tire size, it was determined that the Chrysler traveled approximately 1.6 meters (5.3 feet) backward from impact to final rest. Based on the driver's statement that she backed for only a "couple of seconds" before the impact, and using a "normal" acceleration rate of 0.1g while backing yields the following range of distances to impact and speeds at impact for the indicated backing times:

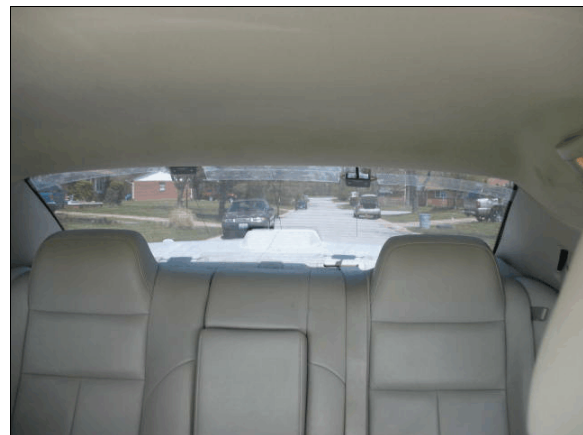
Figure 6: View through Chrysler's backlight from driver's seat

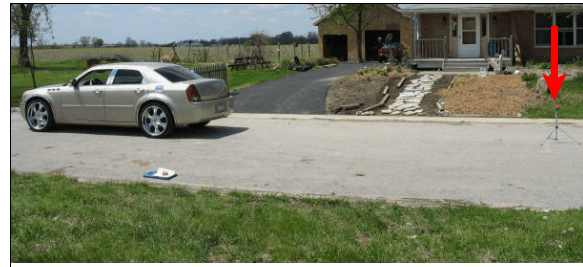
necessary to move the target rearward from the back of the Chrysler 6.7 meters (22 feet) before the surrogate driver could see it. The target was then moved to the approximate centerline of the Chrysler. The brake lamp obstructed the surrogate driver's view of the target at this position. The target was then moved back to the left until it came into view around the left side of the brake lamp. The target had to be moved left of the centerline 0.5 meters (1.6 feet) before it came into view. The target was then moved an additional 0.5 meters (1.6 feet) to the left before it became obstructed by the back left head restraint. The target continued to be moved to the left and did not come back into view again due to left "C"-pillar. The target was then moved back to the Chrysler's approximate centerline and moved to the right until it came into view around the right side of the brake lamp. This distance was 1.3 meters (4.3 feet) right of the centerline. The target was then moved to the right an additional 1.5 meters (4.9 feet) before it became obstructed by the back right head restraint. The target continued to be moved to the right and did not come back into view due to the right "C"-pillar. When the target was placed behind the center high-mounted brake lamp on an exemplar Chrysler 300, it had to be moved rearward from the back of the vehicle 8.5 meters (27.9 feet) before it could be seen. In summary, for the surrogate driver looking over his right shoulder out of the backlight and through the gap between the center high-mounted brake lamp and either head restraint, the blind zone behind the Chrysler was 6.7 meters (22 feet) deep and extended laterally well beyond the right "C"-pillar. In addition, for all practical purposes, a driver looking out of the backlight over their right shoulder would not be able to see beyond the left "C"-pillar because the driver's head restraint blocks the view. Lastly, the beginning of the visibility zone located between the center high-mounted brake lamp and the back seat head restraints [i.e., 6.7 meters (22 feet) rear of the back of the Chrysler] was 1.4 meters (4.9 feet) wide on the right side of the center high-mounted brake lamp and 0.5 meters (1.6 feet) wide on the left side of the brake lamp. The beginning of the visibility zone located behind the center high-mounted brake lamp [i.e., 8.5 meters (27.9 feet) rearward of the back of the Chrysler] was 1.7 meters (5.6 feet) wide.

Figure 7: Arrow shows location target first came into view while surrogate driver was looking over right shoulder through gap between center high-mounted brake lamp and back left head restraint.

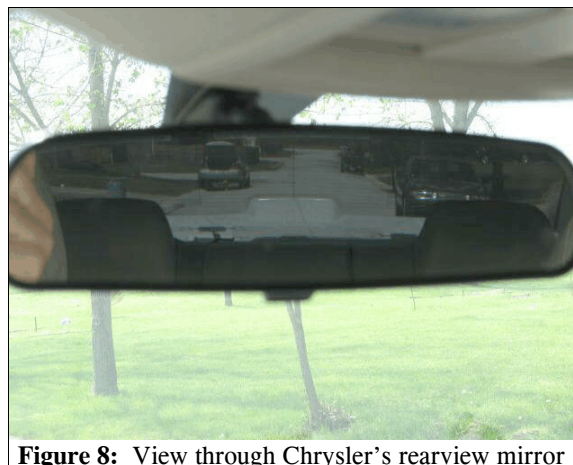
The view through the rearview mirror (Figure 8) was assessed in a similar manner as the blind zone behind the Chrysler. The surrogate driver had to move the target rearward 7.5 meters (24.6 feet) from the back of the Chrysler before the target came into view in either gap between the center high-mounted brake lamp and the back seat head restraints. The target was then moved to the left from the Chrysler’s approximate centerline 1.7 meters (5.6 feet) before it went out of view due to the left head restraint. The target was then moved to the right from the approximate centerline 1.3 meters (4.3 feet) before it went out of view due to the right head restraint. The target remained out of view due the head restraints. When the target was placed behind the center high-mounted brake lamp on an exemplar Chrysler 300, it had to be moved rearward from the back of the vehicle 9.2 meters (30.2 feet) before it came into view.

Figure 8: View through Chrysler’s rearview mirror

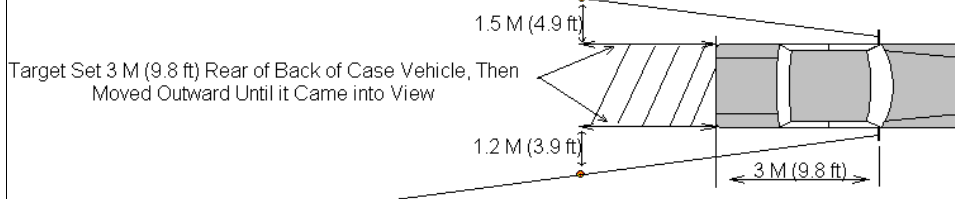
Nominal Visibility Diagram
Case Vehicle = 2006 Chrysler 300

1. Distance Back of Chrysler
To Point a 71 cm (28 in) High Reference Target
Comes Into Surrogate Driver's View as He Looks Over Right Shoulder
Through Gap Between Center High-Mount Brake Lamp and Back Seat Head Restraints

Note: Beginning of Visibility Zone In Gap Between
Center High-Mounted Brake Lamp and Back Seat Head Restraints
is 0.5 m (1.6 ft) Wide on Left Side of Brake Lamp and
1.5 m (4.9 ft) Wide on Right Side of Brake Lamp

2. Distance Back of an Exemplar Chrysler 300
To Point a 71 cm (28 in) High Reference Target
Comes Into Surrogate Driver's View as He Looks Over Right Shoulder
Over Center High-Mounted Brake Lamp

Note: Beginning of Visibility Zone Behind Center High-Mounted
Brake Lamp was 1.7 M (5.6 ft) Wide

Note: When Viewed in Rearview Mirror Through Gap Between Center High-Mounted
Brake Lamp and Back Seat Head Restraints, Target had to be Moved Rearward
from Back of Vehicle 7.5 M (24.6 ft) Before it Came into View. When Viewed in Rearview
Mirror Over High-Mounted Brake Lamp on Exemplar Chrysler 300, Target Had to
be Moved Rearward 9.2 M (30.2 ft) before it Came into View.
