**NOT-IN-TRAFFIC SURVEILLANCE
CALSPAN ON-SITE BACKOVER FATALITY INVESTIGATION**

SCI CASE NO.: CA07-014

VEHICLE: 2007 CHRYSLER 300C

CRASH DATE: APRIL 2007

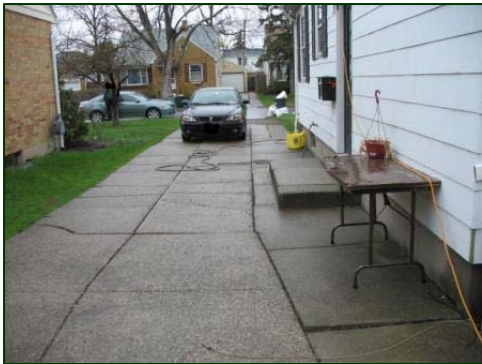
uneven surface. A garden hose was lying on the driveway in the path of the backing vehicle. **Figures 2 and 3** are of the driveway and the backing trajectory of the vehicle.

Figure 2. Backing trajectory of the Chrysler 300C.

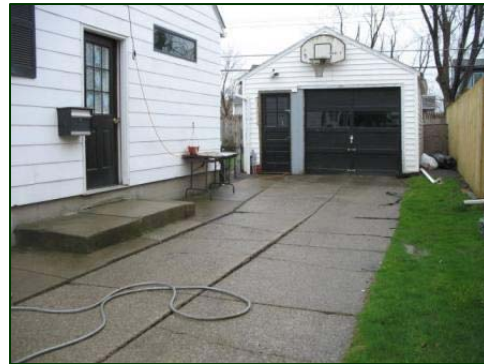
Figure 3. Lookback view of the vehicle's trajectory.

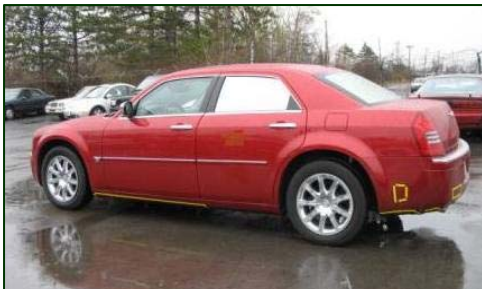
The exterior of the vehicle was finished in a red color with matching bumper fascias. The window glazing was AS1 for the windshield and AS2 for the side and backlight glass with OEM solar tint. An aftermarket mirror tint film was applied to the rear door and backlight glazing (**Figures 4 and 5**). This film prevented viewing through the glass from the exterior, but provided a deep tint view from the interior of the vehicle.

Figure 4. Left side view of the 300C and the aftermarket window tint.

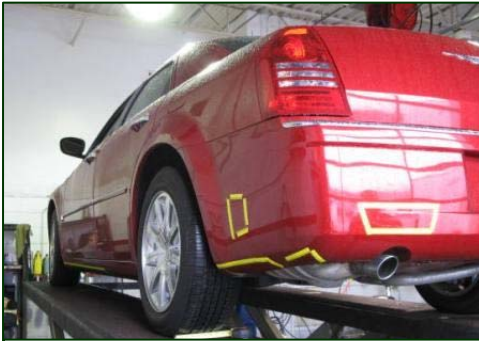
A circular wipe mark was noted to the left side surface of the bumper fascia. This wipe mark was observed by the investigating officer on the day of the crash. The mark was 6 cm (2.5") in height and 9 cm (3.5") in width, centered 62 cm (24.5") aft of the left rear axle and 47 cm (18.5") above the ground. Two additional wipe marks were located on the bottom surface of the bumper fascia, below the circular wipe mark (**Figure 8**). The most rearward mark was 7x5 cm (3x2") in size and centered 87 cm (34.25") rearward of the reference axle and 32 cm (12.75") above the ground. Located forward of this wipe mark was a wipe mark that began 74 cm (29.25") aft of the left rear axle extending 29 cm (11.5") forward to the forward edge of the bumper fascia. The rear edge of the mark was 30 cm (12") above the pavement while the forward edge was 26 cm (10.4") above the pavement.

Figure 8. Contact evidence (wipe marks) to the left side surface of the rear bumper fascia.

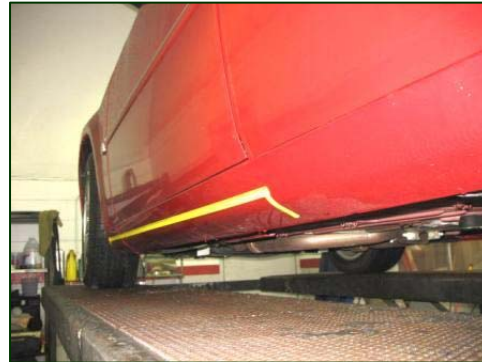
Figure 9. Left lower sill wipe marks.

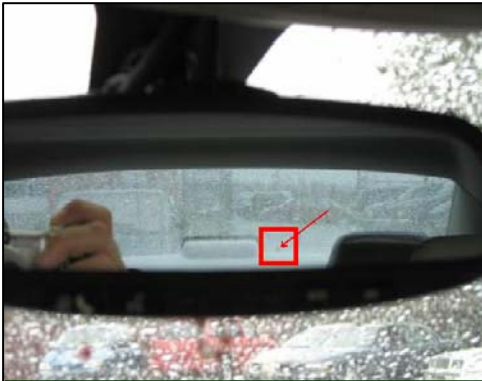
Figure 10. Visible red target in rear view mirror.

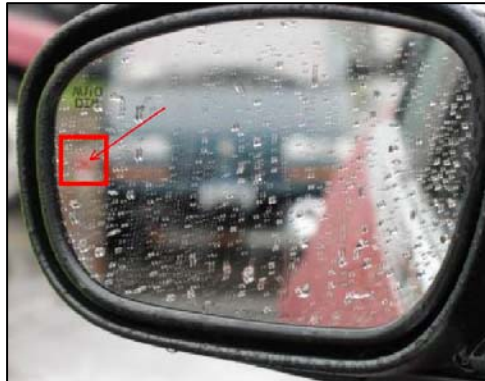
Figure 11. Visible red target in left outside rear view mirror.

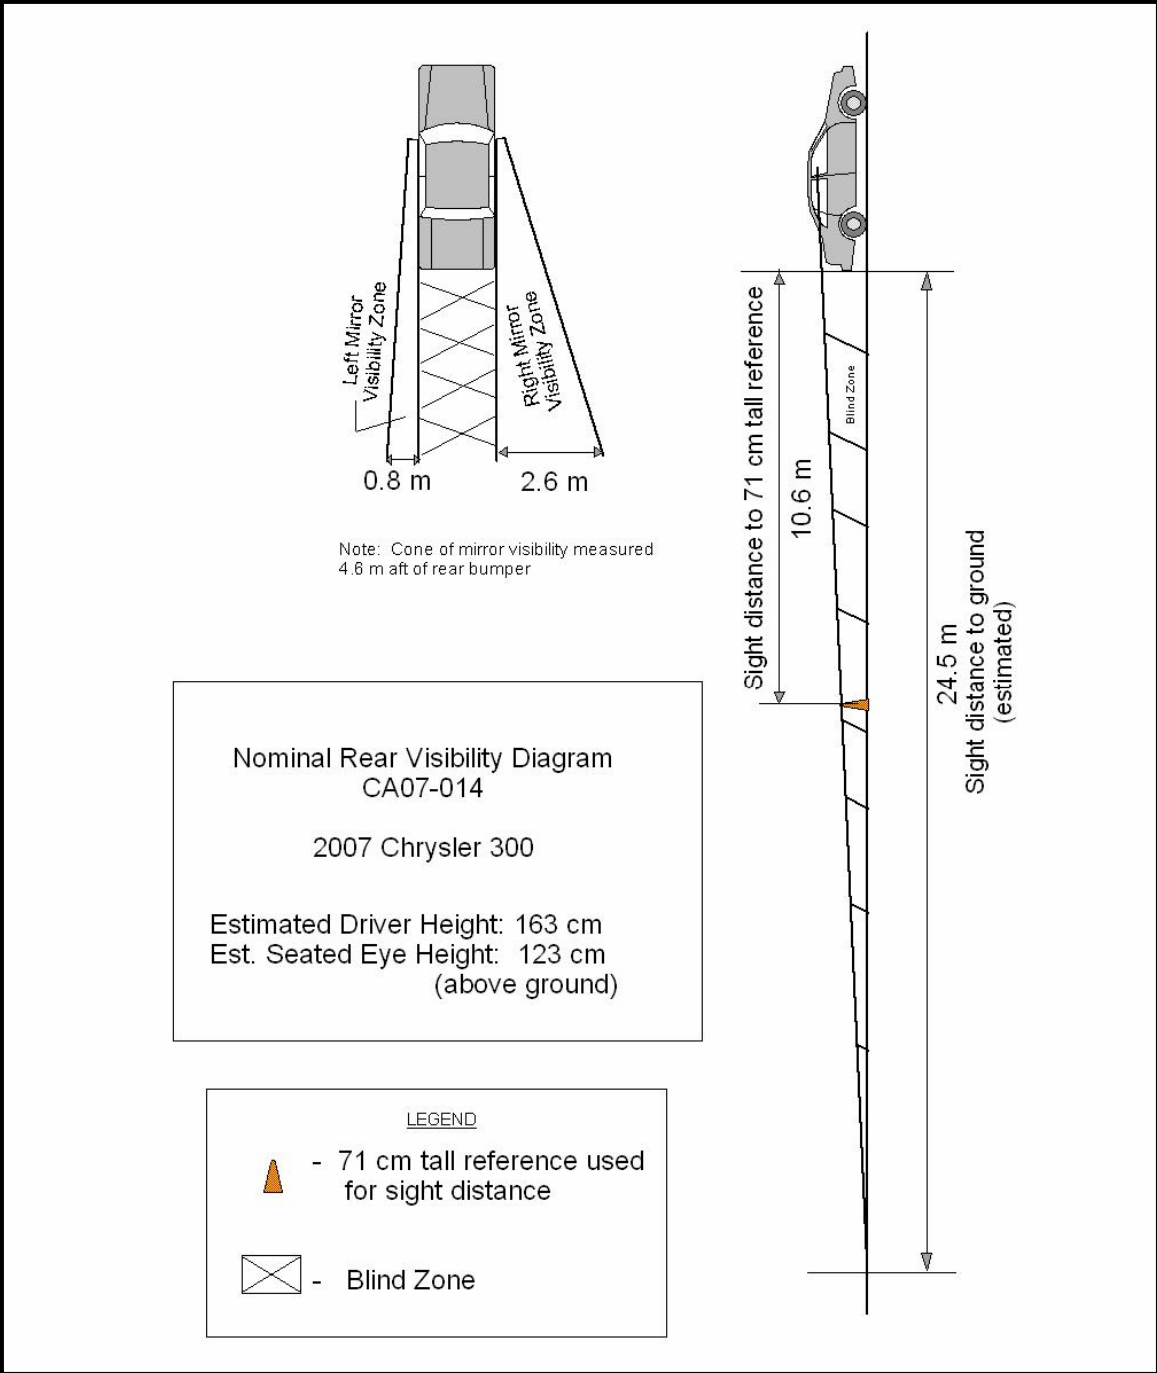
Figure 12: Nominal Rear Visibility Diagram.

subject driver's eye height was estimated at 122 cm (48") above ground level based on her reported height and the adjusted levels of the rear view mirrors. The rear visibility was measured along the centerline of the vehicle through the center of the backlight. The location of the vehicle's pillars and height of the adjustable head restraints did not effect this measurement. The centerline visibility distance was measured from the rear bumper to the location of the target. The centerline visibility distance to ground level was estimated by projecting that sight line to the ground intercept. The visibility distance is summarized below and depicted in a diagram attached to the end of this report (**Figure 12**):

- Sight distance to 71 cm (28 in) target: 10.6 m (34.7 ft)
- Sight distance to ground level target: 24.5 m (80.4 ft)

Cones of visibility were also established using the outside mirrors. A 4.6 m (15 ft) distance from the rear bumper was used as an arbitrary reference location. The substitute driver was asked to locate the 71 cm (28 in) target using the outside mirrors. The target location was then measured to the side plane of the vehicle. The cone for the left mirror began along the left side plane and extended 0.8 m (2.75 ft) left. The cone for the right mirror began along the right side plane and extended 2.6 m (8.5 ft) right. The visibilities through the rear view mirrors are depicted in **Figures 10 and 11**. These visibility measurements are depicted graphically in **Figure 12** at the end of this report.

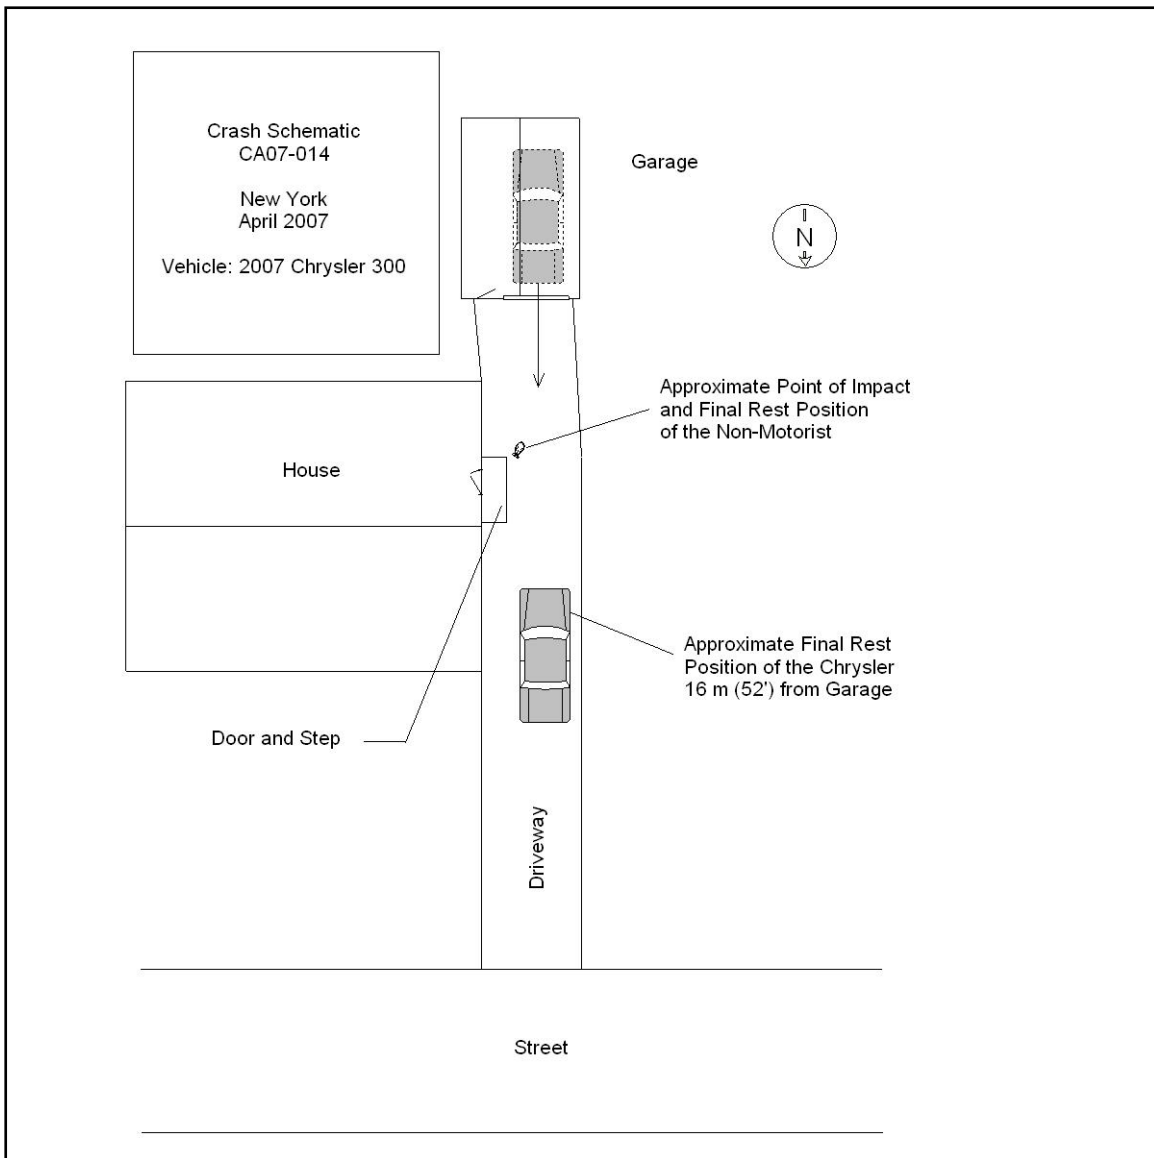
Figure 13: Crash Schematic.

As the driver began to back from the garage, the 18-month old toddler apparently exited the residence and negotiated two steps from the door to the level of the driveway. The driver was unaware of the child's presence and continued backing, striking the toddler with the back left area of the bumper and knocking the child to the concrete driveway surface. This event was not detected by the driver as she continued her backing maneuver. Subtle wipe marks (i.e. road film removed) were noted to the lower aspect of the bumper fascia aft of the rear tire from probable contact by the child. The left rear tire of the vehicle ran over the child and rolled the toddler. Additional wipe marks were present of the left sill of the vehicle between the axles. As the vehicle continued to back, the left front tire ran over the child. Again, the driver was unaware of these events. She continued to back approximately 10 m (33'), stopped the vehicle, placed it in park and exited the 300C. At this point, the driver observed the child lying on the driveway in front of the Chrysler. The Chrysler was parked at final rest approximately 16 m (52') from the garage. There were no witnesses to this backover event. The crash schematic is attached as **Figure 13** on this report.
