ON-SITE NOT IN TRAFFIC SURVEILLANCE BACK OVER INVESTIGATION

CASE NUMBER - IN-07-014

VEHICLE - 1989 CHEVROLET CAMARO

INCIDENT DATE - April 2007

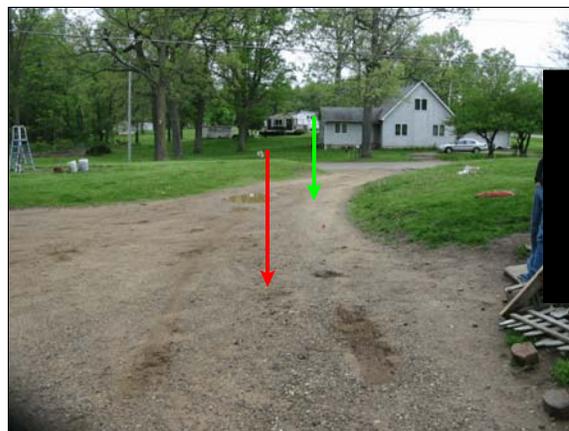
Pre-Crash: The Chevrolet Camaro was parked headed north on the east side of the residence near the entrance to the residence [Figure 1, (Note: The field investigation was conducted several weeks post-crash, and it had rained since the incident. The tire marks visible in the area where the vehicle was parked were relatively “fresh” and therefore, not related to this incident)]. The driver and his two passengers exited the residence and approached the Chevrolet from its left side.

Figure 1: View south, red arrow shows parked location of Chevrolet, green arrow shows approximate area of impact (Note: tire marks are not incident related)

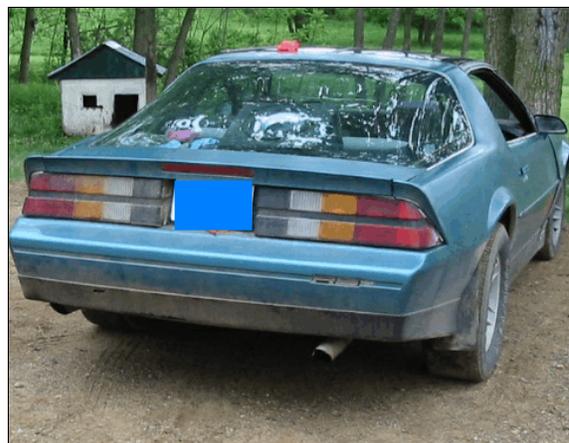
Figure 2: Overview of back of Chevrolet

There was no evidence of pedestrian contact to the Chevrolet Camaro's back bumper or undercarriage. It was not possible to thoroughly inspect the undercarriage due to the restricted space under the vehicle. A partial CDC was estimated as follows: **06-B9LU-1 (180 degrees)**. The Chevrolet was not damaged.

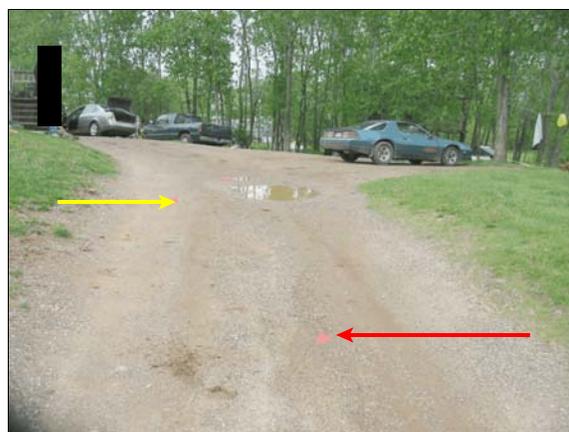
Post-Crash: The Chevrolet Camaro and pedestrian came to rest in the driveway (**Figure 3**). It was determined that the Chevrolet had traveled backward approximately 5.3 meters (17.4 feet) from impact to final rest. In the process, the Chevrolet had passed over the pedestrian and she had become lodged between the undercarriage and the ground. It was determined that the pedestrian was most likely dragged approximately 1 to 1.5 meters (3.2 to 4.9 feet) as the vehicle passed over her. The pedestrian's rest position was described by a witness (i.e., the adult who had been working in the back yard) as facing towards the front of the vehicle with her left shoulder partly pinched between the left front tire and the ground. The Chevrolet's driver, the passengers, the adult male and some other people managed to lift the left front of the vehicle enough for the pedestrian to be pulled out from under the vehicle. The pedestrian was conscious and being held by the adult male when the investigating sheriff's deputy arrived. The pedestrian was subsequently transported by ambulance to a hospital and admitted for treatment of her injuries.

Figure 3: View northeast to overview of final rest position as reported by driver and front right passenger, red arrow shows reported location of back end of Chevrolet and yellow arrow shows reported location of pedestrian

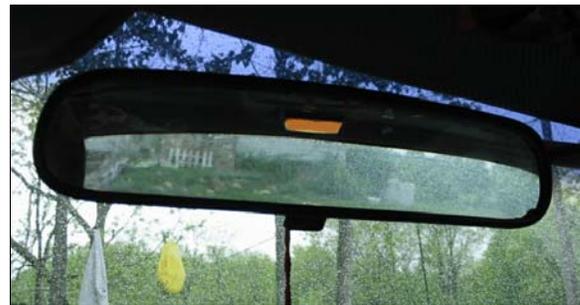
The driver was also asked to view behind the Chevrolet through the rearview mirror (**Figure 4**) with the speaker removed from the cargo area. The target was then moved rearward from the back of the vehicle until it came into the driver’s view. The target had to be moved rearward approximately 2 meters (6.6 feet) before the driver could see it. The target was then placed in this position at the vehicle’s approximate centerline and was moved 1.8 meters (5.9 feet) to the right before going out of the rearview mirror’s field of view. When the target was moved to the left from the centerline, it was visible for 1.2 meters (3.9 feet) before being obstructed by the image of the driver’s head in the rearview mirror. In summary, the depth of the rearview mirror blind zone with the speaker removed was determined to be 2 meters (6.6 feet). The total width of the beginning of the visibility zone at this

Figure 4: View through Chevrolet’s rearview mirror

point was 3 meters (9.8 feet). With the speaker in place in the cargo area, it was necessary to move the target rearward from the back of the vehicle 4.3 meters (14.1 feet) before the driver could see it over the top of the speaker.

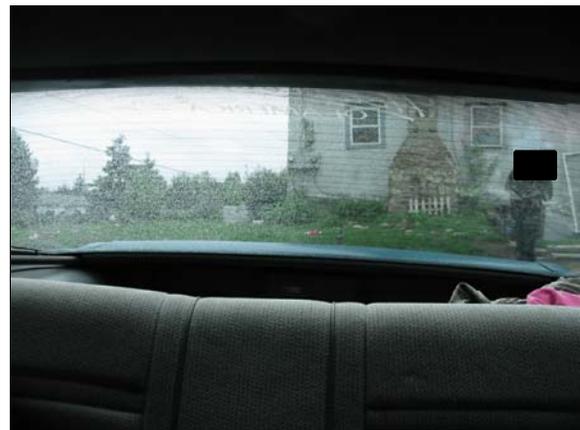
Figure 5: View out of Chevrolet’s backlight from driver’s seat with the speaker removed from the cargo area

With the speaker removed from the cargo area, the driver was asked to look over his right shoulder out of the backlight (Figure 5 above) and indicate when the target came into view as it was moved rearward from the back of the vehicle. It was necessary to move the target rearward 2.1 meters (6.9 feet) before the driver could see it (Figure 6). The target was then moved to the right from this position at the vehicle's approximate centerline 5 meters (16.4 feet) where it became obstructed by the right B-pillar. It was necessary to move the target an additional 3.2 meters (10.4 feet) to the right before the driver could see it again on the right side of the B-pillar. When the target was moved 2 meters (6.6 feet) to the left from the vehicle's centerline, it became obstructed by the left B-pillar. With the speaker in the cargo area (Figure 7), it was necessary to move the target rearward from the back of the vehicle 5.1 meters (16.7 feet) before the driver could see it over the top of the speaker. The target had to be moved 1.1 meters (3.6 feet) to the right from the centerline to position out of the driver's view behind the speaker prior to determining the depth of the blind zone behind the speaker.

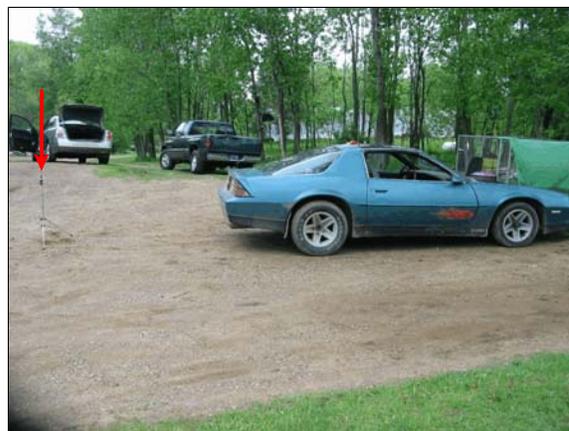
Figure 6: Arrow shows location target first came into driver's view as he looked over right shoulder out of backlight (speaker removed from cargo area)

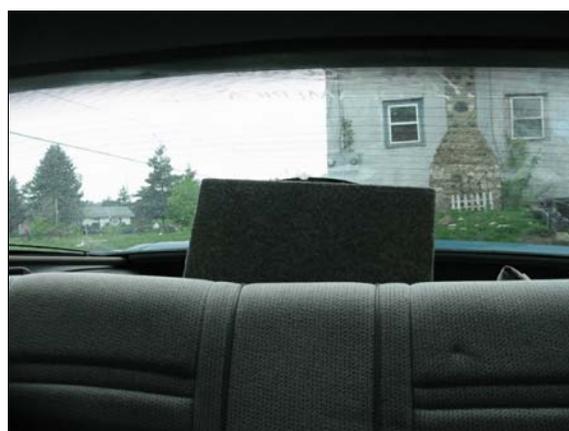
Figure 7: View out backlight from driver's seat with speaker in cargo area

The visibility study indicated that the left side view mirror gave the driver a limited field of view as he backed up, and the pedestrian was most likely outside of the mirror's field of view. In addition, it is possible that the speaker in the cargo area blocked the driver's view of the pedestrian when he checked his rearview mirror prior to backing up.

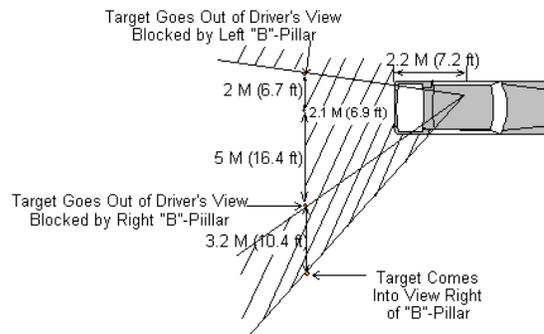
Nominal Visibility Diagram
Case Vehicle = 1989 Chevrolet Camaro

1. Side View Mirror and Rearview Mirror Visibility Zones
(Note: rearview mirror visibility zone as shown is without speaker in cargo area; depth of blind zone behind speaker with driver looking through rearview mirror was 4.3 Meters (14.2 feet); width of speaker blind zone was not determined)

2. Distance Back of Chevrolet To Point a 71 cm (28 in) High Reference Target Comes Into Driver's View as He Looks Over Right Shoulder
(Note: blind zone as shown is without speaker in cargo area; depth of blind zone behind speaker with driver looking over right shoulder was 5.1 Meters (16.7 feet); width of speaker blind zone was not determined)

3. Blind Zone Behind Chevrolet, Driver Looking Over Right Shoulder
(Note: blind zone as shown is without speaker in cargo area; depth of blind zone behind speaker with driver looking over right shoulder was 5.1 Meters (16.7 feet); width of speaker blind zone was not determined)
