Rollover Investigation
Dynamic Science, Inc. / Case Number: DS07014
2006 Mitsubishi Raider
California
March 2007

1. Report No. DS07014	2. Government Accession No.		3. Recipient Catalog No.	
4. Title and Subtitle Rollover Investigation			5. Report Date October 16, 2007

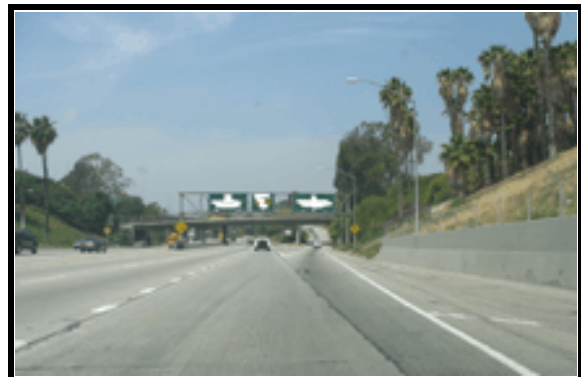
This two vehicle crash occurred in March 2007 at 2100 hours. The crash occurred on a three-lane divided state highway near the approach to an interstate on-ramp/transition road (**Figure 2**). At the time of the crash, there were no adverse weather conditions and the concrete roadway surface was dry. It was dark at the time of the crash and the street lights were on. The westbound roadway was configured with three

Figure 2. Approach to area of impact and rollover

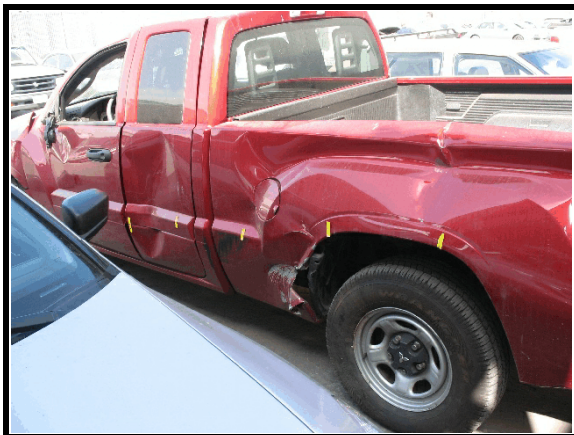
The Mitsubishi Raider sustained moderate left side damage as a result of the impact with the Freightliner (**Figure 3**). The direct damage began 63 cm (24.8 in) rear of the rear axle and extended 233 cm (91.7 in) forward along the left side plane. There were spinning tire marks along the front part of the bed. The metal fender well at the left rear was torn in a forward direction. Six crush measurements were documented at the mid door level as follows: C1 = 0, C2 = 0 cm, C3 = 0 cm, C4 = 0 cm, C5 = 0.5 cm (0.2 in), C6 = 0 cm. The maximum lateral crush was located between C5/C6 and measured 6.0 cm (2.4 in). The Collision Deformation Classification (CDC) for this impact was 09LZEW2.

Figure 3. Left side damage, impact 1

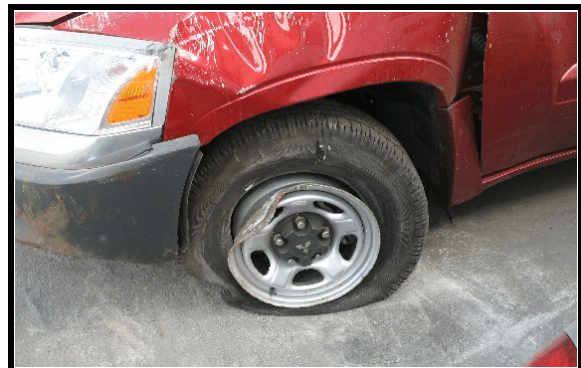
The Raider sustained moderate damage to the left front wheel from the impact with the curb (see **Figure 4**). The steel rim was dented and the tire flattened. The CDC for this impact was 11FLWN3.

Figure 4. Tire/rim damage, impact 2

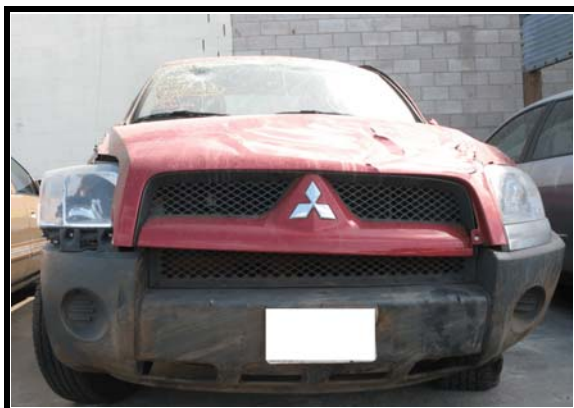
The Raider sustained minor contact damage to the front bumper from the impact with the dirt/grass embankment. The CDC for this impact was 09FDLS1.

Figure 5. Front bumper contact, impact 3

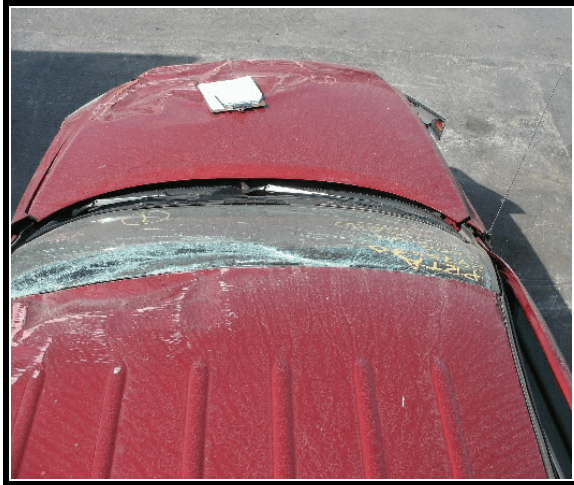
The Raider also sustained moderate damage to top of the vehicle from the rollover (**Figure 6**). The direct damage began at the left hood line. The damage measured 99.0 cm (39.0 in) wide and extended 79.0 cm (31.1 in) rearward along the hood where it stopped. The direct damage began again at the windshield header/windshield area. This damage measured 63.0 cm (24.8 in) wide by 52.0 cm (20.5 in) in length. The maximum vertical crush was located at the left A pillar (**Figure 7**) and measured 4.0 cm (1.6 in). The CDC for this impact was 00TYYO2.

Figure 6. Roof and hood damage

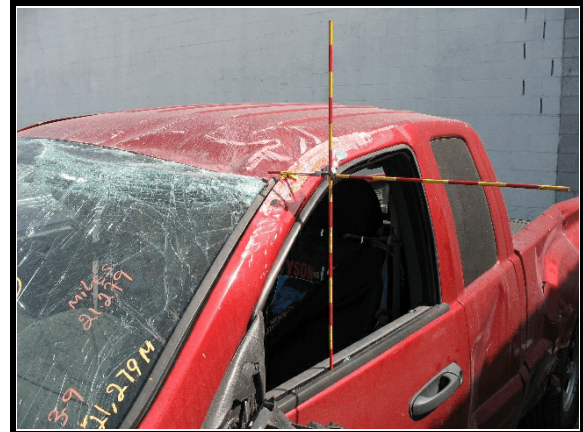
Figure 7. Maximum roof crush

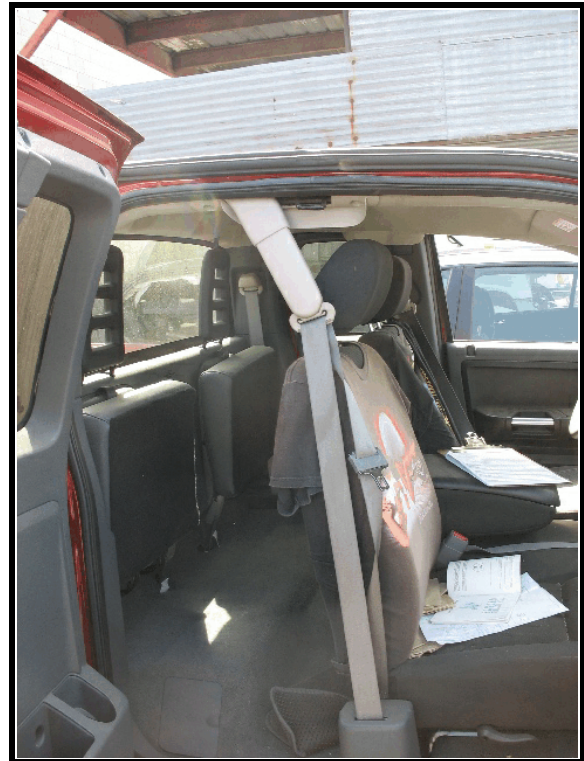
The 2006 Mitsubishi Raider was configured with manual 3-point lap and shoulder belts for each of the four outboard seating positions. The front middle seat was equipped with a manual lap belt. Both front seat safety belts were equipped with buckle retractors and adjustable D rings that were in the full down position. The outboard seat belts were configured with Emergency Locking Retractors. The driver's seat belt exhibited a slight amount of loading.

Figure 8. Overview of seat belts and seating
