**CRASH DATA RESEARCH CENTER**

**NOT-IN-TRAFFIC SURVEILLANCE  
CALSPAN REMOTE HYPERTHERMIA INVESTIGATION**

**SCI CASE NO: CA07-015**

**VEHICLE: 2002 BMW M5  
LOCATION: TENNESSEE  
INCIDENT DATE: MAY 2007**

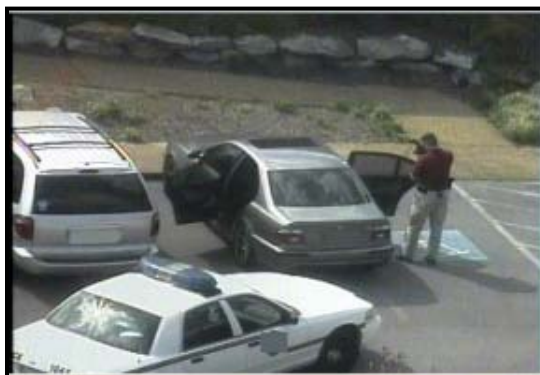
**Figure 1: On-scene photo of the BMW.**

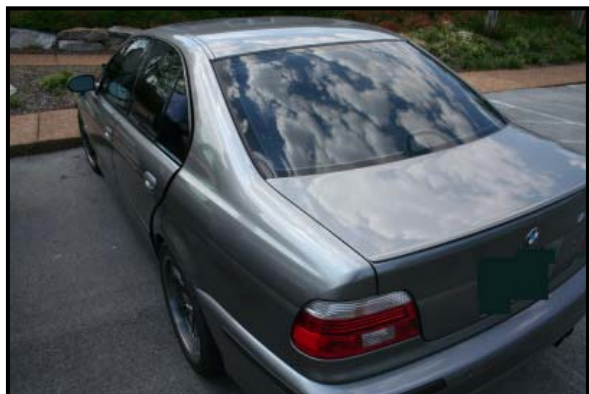
**Figure 2: Left rear oblique view of the BMW at the incident site.**

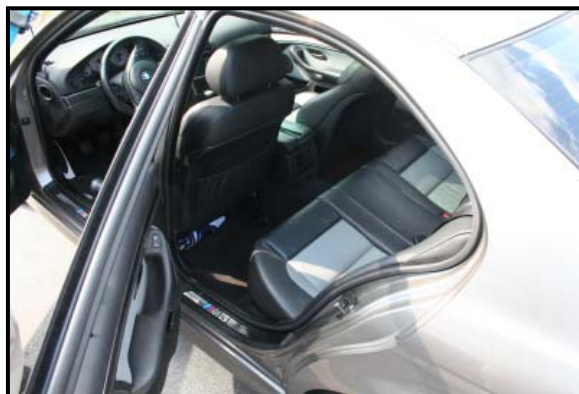
**Figure 3: Interior view of the subject vehicle.**

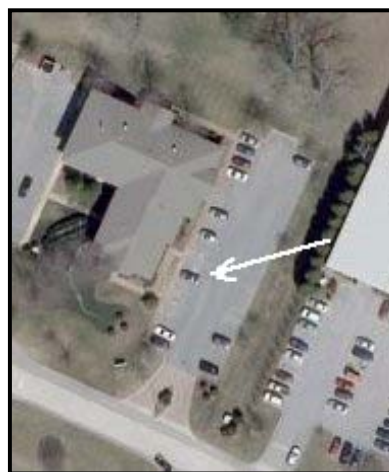
The incident occurred in the asphalt parking lot of a commercial business that was located in a suburban office park, **Figure 4**. At the scene, the business office was located on the north side of a two lane road. A large rectangular parking lot was located immediately east of the office building. The estimated dimensions of the parking lot were 52 m x 24 m (170 ft x 80 ft). Traffic flowed from the road northward into the center of the parking lot. The parking spaces were located in two columns on opposite sides of the parking area and were oriented in an east/west direction. The subject vehicle was parked on the west side of the lot in the approximate center of the parking column. The approximate parked position of the BMW is identified by the arrow of Figure 4. Due to the configuration of the parking lot and the location of the vehicle relative to adjacent trees or buildings, no shade from the daytime sun would have been available to the vehicle. A schematic of the site is attached to the end of this report as **Figure 8**.

**Figure 4: Overhead view of the incident site.**

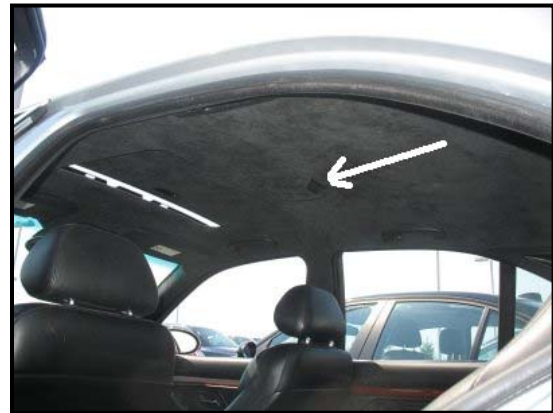
The vehicle was then transported to the BMW dealership. A BMW technician was able to download data from the security system's computer. The downloaded data indicated the alarm had been activated a total of five times. Although the alarm times were not time-stamped, it was concluded that the alarm was activated four times by the subject child during the morning hours and once by the police evidence technician.

**Figures 5 through 7** are views of the interior motion sensor that was incorporated in the design of the BMW's alarm system. The photographs of an exemplar BMW M5 were taken during the SCI investigation. The ultra-sonic sensor was mounted to the center aspect of the roof and provided 360 degrees of coverage. The alarm feature set automatically with the key was removed from the ignition and when the doors of the vehicle were locked. The vehicle's side windows and sunroof could be either open or closed. The alarm activated in response to movement either within the interior or through a side plane. The activated alarm could be turned off by depressing a button on the key fob. The alarm feature could also be disabled by repeatedly depressing the key fob button in sequence.

**Figure 5: Center roof mounted interior motion sensor in an exemplar BMW M5.**

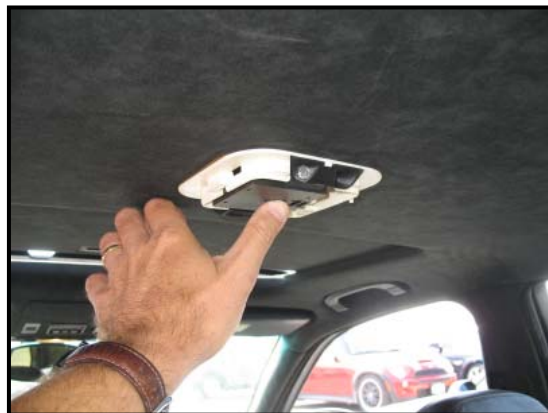
**Figure 6: Center roof mounted sensor (exemplar BMW).**

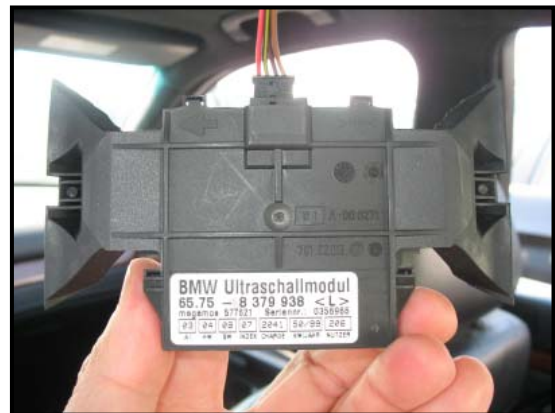
**Figure 7: Exemplar ultra-sonic sensor.**

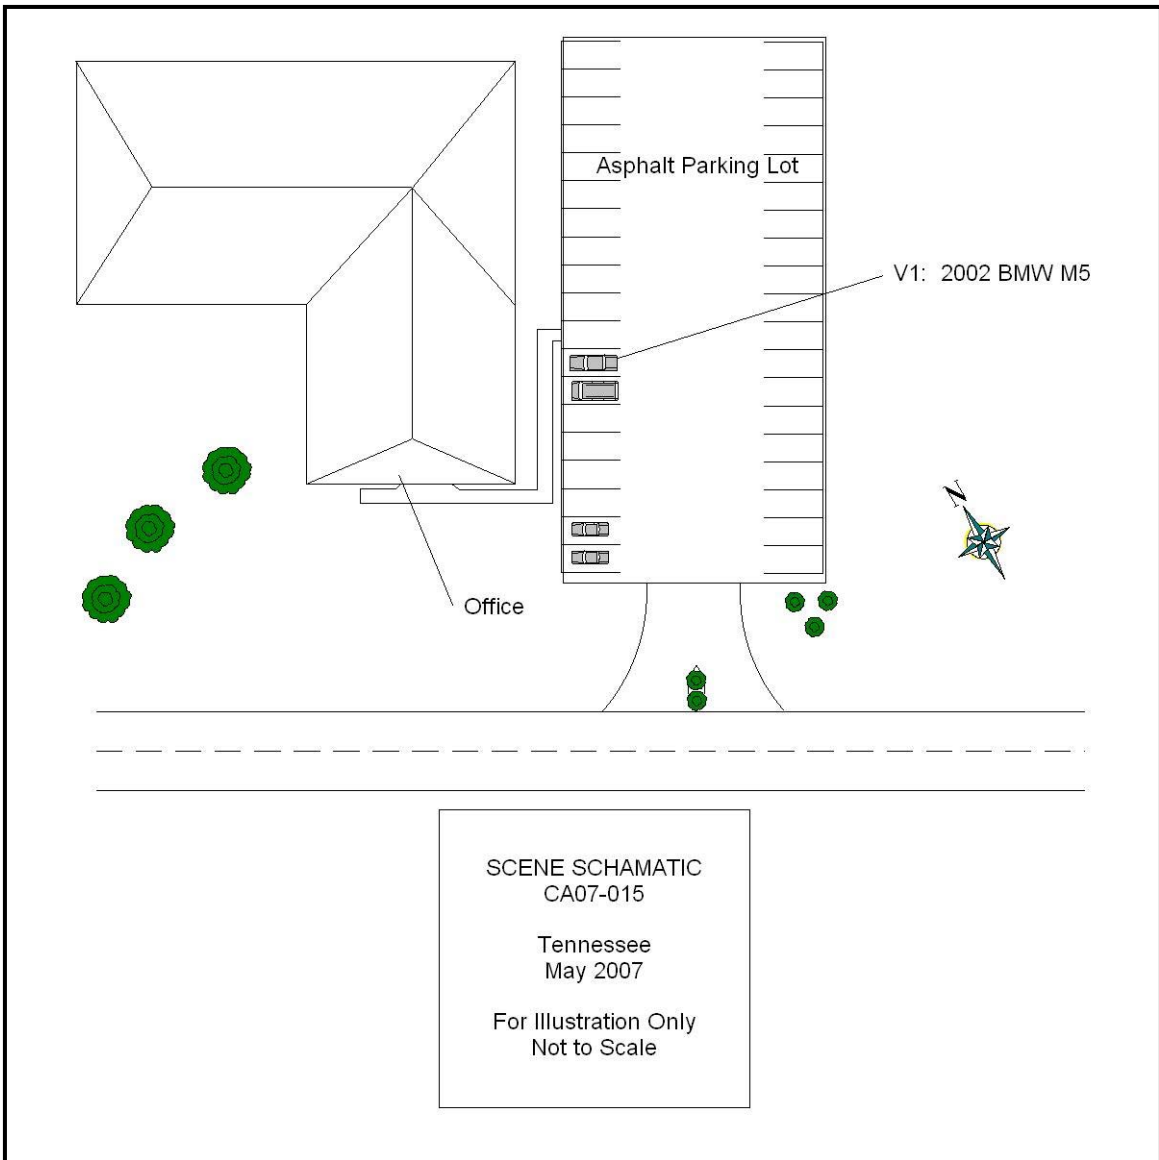
Figure 8: Scene Schematic.

The spouse drove a Dodge Grand Caravan and parked it immediately south of the BMW (refer to Figures 1 and 8). She entered the business and began her normal work routine. At approximately 1030 hours, the subject driver spoke to the spouse and borrowed the Dodge to run some errands. He returned around 1130 hours. Around 1200 hours the driver and spouse left the premises with the Dodge for an appointment and then stopped for lunch. They returned to work around 1330 hours, parked next to the BMW and entered the building to finish the work day. During these trips with the Dodge, neither the driver nor his wife noticed anything "abnormal" with the BMW sedan parked next to them.
