NOT-IN-TRAFFIC SURVEILLANCE

CALSPAN REMOTE POWER WINDOW INVESTIGATION

SCI CASE NO.: CA07-016

VEHICLE: 1999 CHEVROLET MONTE CARLO

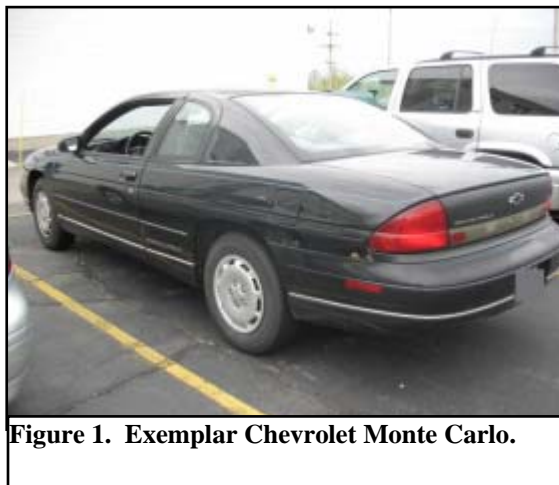
Figure 1. Exemplar Chevrolet Monte Carlo.

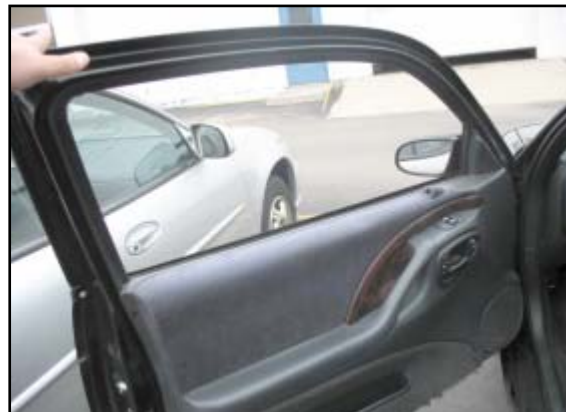
Figure 2. Left front door and main switch panel.

(**Figure 2**). The left window was equipped with an Auto-down feature. Full depression to the rear aspect of the rocker switch was required to activate this feature. The Chevrolet was not equipped with a lock-out switch for the right window; this was also noted in the police incident report.

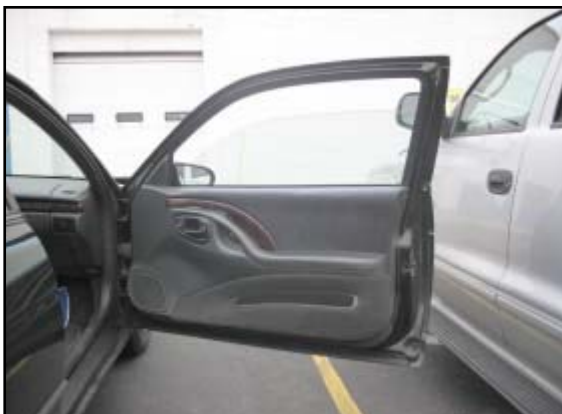
Figure 3. Overall view of the front right door.

The front right window was operated by a rocker switch that was horizontally mounted on the top of the door panel arm rest at the forward aspect. **Figure 3** is an overall view of the front right door. This window was not equipped with an Auto-Down feature. The rocker switch was flush mounted within a plastic trim face plate (**Figure 4**). The switch was located 81 cm (31.75”) forward of the lower right corner of the glazing and 8 cm (3.25”) below the bottom of the window frame. Additionally, the switch was located 34 cm (13.25”) above the seat cushion.

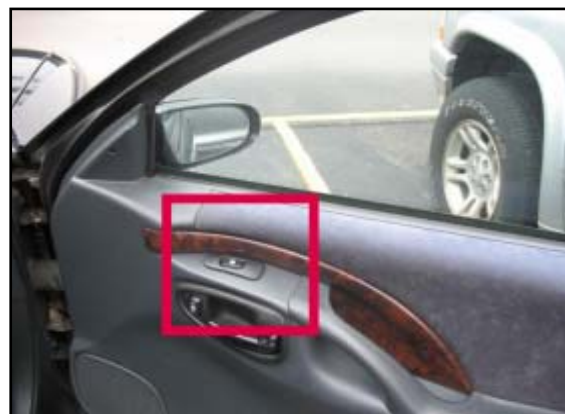
Figure 4. Front right window rocker switch.

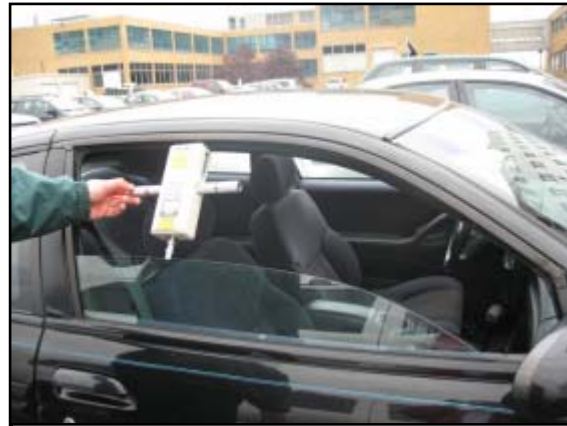
The closing force test of the front right window was conducted on the exemplar Chevrolet Monte Carlo by the SCI team. The instrument used to conduct this test was an IMADA digital force gauge that was calibrated to 311 N (70 lbs) of force on 11/6/2006. The gauge consisted of a plunger with a duck-bill cut on the bottom. The test was conducted by placing the top aspect of the gauge against the top of the window frame and the plunger against the glazing (**Figure 5**).

Figure 3. Placement of the force gauge.

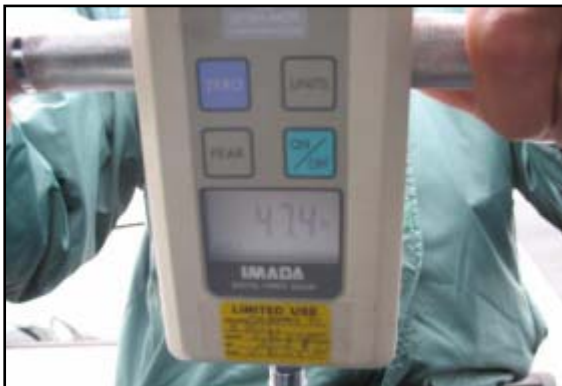
The test was conducted by raising the glazing against the force gauge with the vehicle ignition in the accessory position with the engine off (battery power) and with the vehicle engine on (maximum power). The window operating force was lower using solely battery power to open and close the window. With the engine off, the maximum force measured 211 N (47.4 lbs). The maximum closing force measured 238 N (53.4 lbs) with the engine on. **Figures 6 and 7** are of the force gauge readings.

Figure 6. Maximum force achieved with battery power.

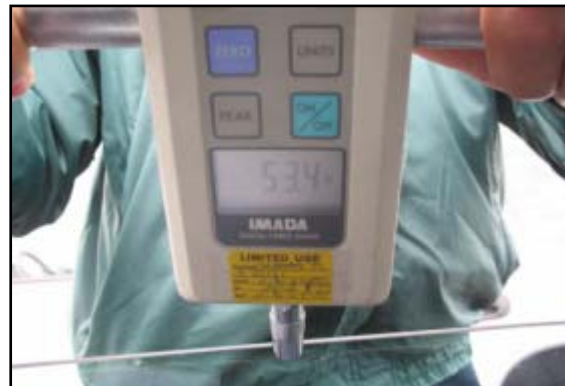
Figure 7. Maximum force with the engine on.
