Child Safety Seat/Rollover Investigation
Dynamic Science, Inc. / Case Number: DS07016
2005 Toyota Tundra
Arizona
February 2007

1. Report No. DS07016	2. Government Accession No.		3. Recipient Catalog No.	
4. Title and Subtitle Child Safety Seat/Rollover Investigation			5. Report Date February 10, 2008

BACKGROUND

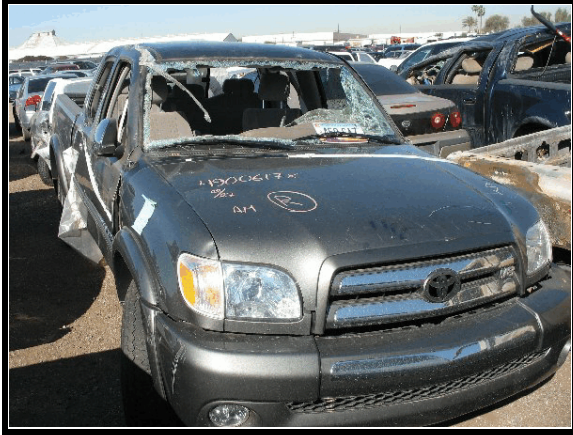
Figure 3. Front right, 2005 Toyota Tundra

The 2005 Toyota Tundra sustained minor contact damage on the front right side of the bumper fascia (**Figure 3**). The direct damage began at the bumper corner and extended 30.0 cm (11.8 in) rearward down the right side plane. There were light scratches found on the hood and roof. There was also direct contact damage above the beltline on the right side. The damage began at the B-pillar and extended 67.0 cm (26.4 in) rearward along the right roof rail (**Figure 4**). These irregular contacts are possibly due to a glancing impact with a tree and its branches. The police report indicated that a large juniper tree was struck as the vehicle left the roadway. The Collision Deformation Classification (CDC) for this impact was 12RYAS2.

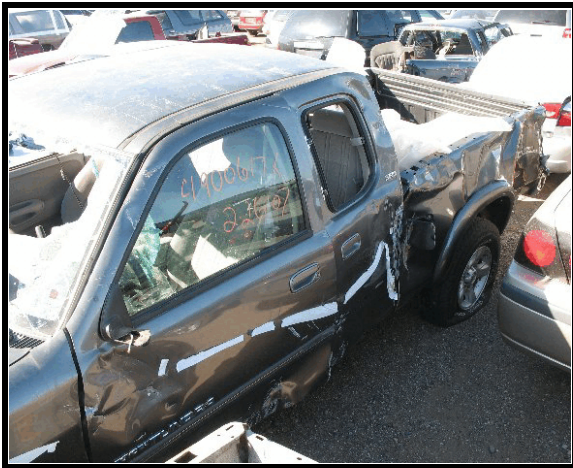
Figure 5. Left side rollover damage

The Toyota Tundra also sustained moderate damage to the left side as a result of the rollover on the embankment (**Figure 5**). The direct damage began at the left rear bumper corner and extended 509.0 cm (200.4 in) forward along the left side plane. The maximum crush was located at C3 and measured 12.0 cm (4.7 in). The CDC for this impact was 00LDDO2.

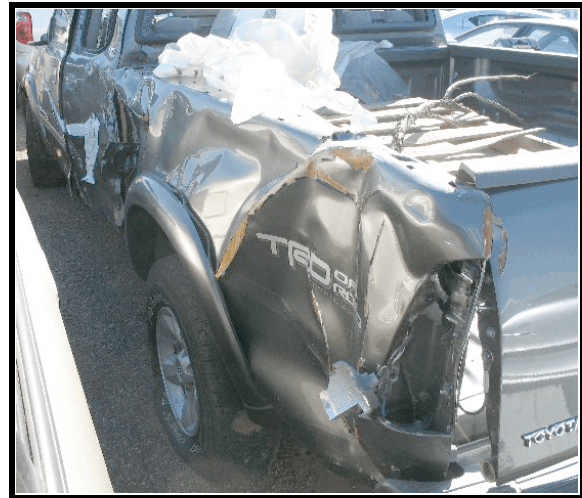
Figure 6. Damage at the tail gate area

Both left side tires were flattened during the tripping/rollover. There was grass in the bead of the front right tire. The bottom of the tailgate was separated from the bed on both sides (**Figure 6**).

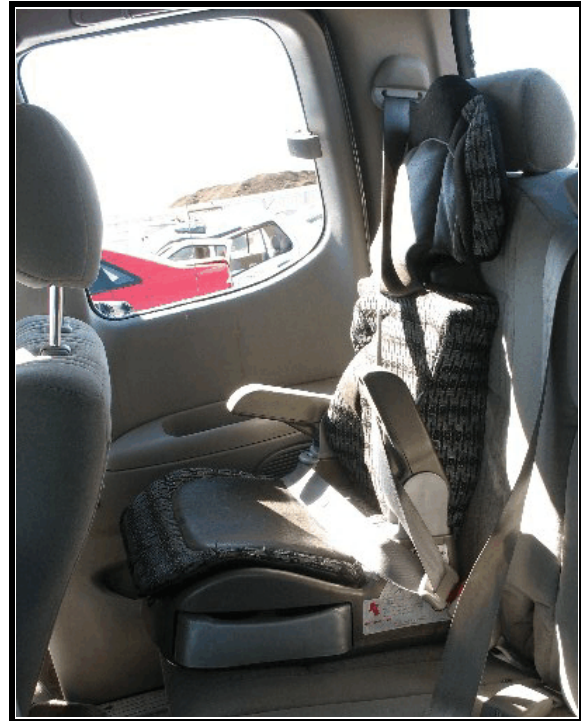
An Evenflo Big Kid Booster Seat was positioned in the second row right position of the Toyota Tundra (Figure 9). The model number was 3351463A and the date of manufacture was November 18, 2003. The booster seat was designed to be used with or without the detachable seatback. The manufacturer's owner manual recommends the booster seat usage as follows:

The booster seat was being used with the seatback at the time of the crash. The child weighed less than the recommended weight by 2.3 kg (5 lbs), although he did meet the height and age recommendations.

Prior to the crash, the child had been placed in the booster seat by the driver. The arm rests were in the lower of the two available positions. The lap and shoulder belt was used in conjunction with the booster seat. The belt webbing was routed through the right upper shoulder belt guide and the retractor was in the ELR mode. According to the interviewee, the belt was snug against his collarbone. The lap portion of the webbing was routed across the lower belt guides. There were no indications of loading to the seat belt webbing. There were indications of historical usage.

Figure 9. Big Kid Booster seat positioned in second row right.

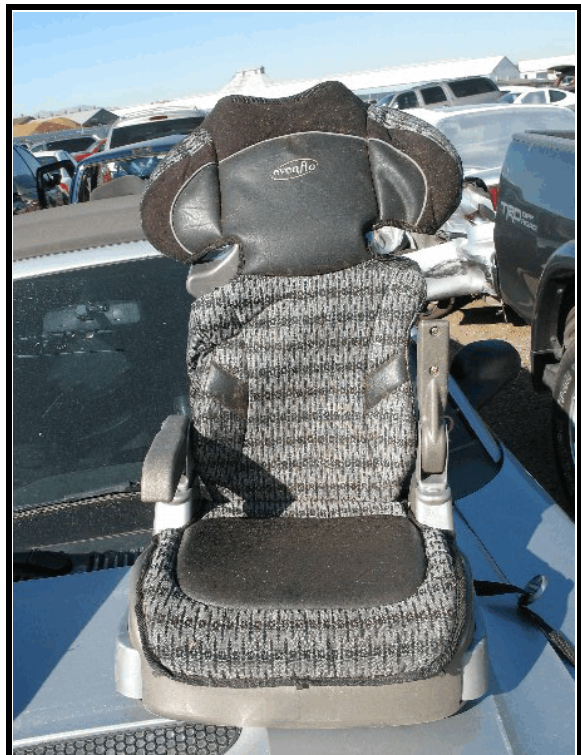
Figure 10. Evenflo Big Kid Booster Seat. Damage to upper right seatback.

The seatback was deformed and creased on the upper right side (**Figure 10**). The source of the damage is not known. This damage may have been caused by some interaction between the shoulder belt and the upper belt guide, but more likely occurred during the extrication process. The left arm rest was found in the UP position but was not damaged. It was likely moved as the seat belt was unbuckled and taken off the child.
