ON-SITE ROLLOVER INVESTIGATION

CASE NUMBER - IN07016
LOCATION - TEXAS
VEHICLE - 1998 FORD EXPLORER 4X2
CRASH DATE - May 2007

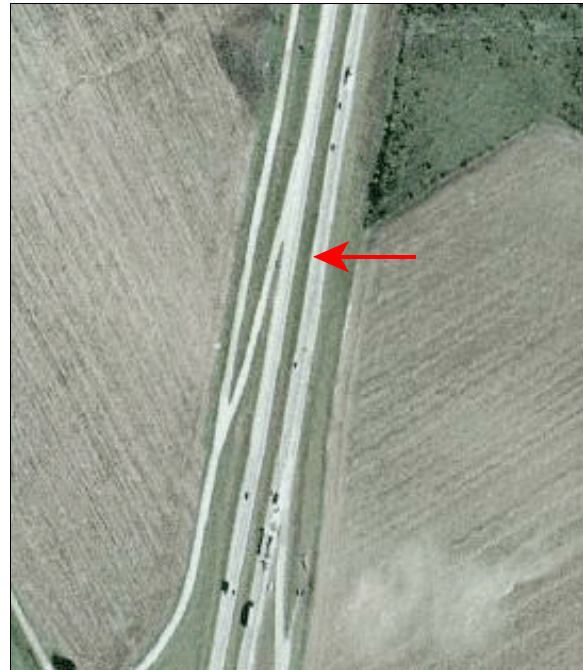
Figure 1: Aerial view of the crash site. The arrow shows the area of the crash based on police crash report.

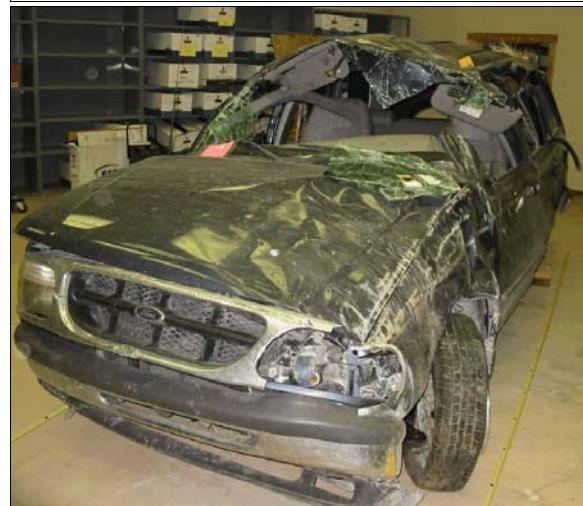
Crash: The Ford rotated counterclockwise and entered the median. The Ford's right side wheels furrowed into the soil, and the vehicle tripped and rolled over with the right side leading. The rollover was primarily side-to-side (**Figure 2** and **Figure 3** below). As the vehicle rolled over, it landed in the grass median on the left fender, hood, left A-pillar, roof and left roof side rail (**Figure 2**). Grass was found embedded in the top seam of the rear hatch near the left D-pillar (**Figure 4** below). The Ford rolled over through the median and across the southwestbound lanes of the interstate and onto an exit ramp. The vehicle rolled over at least eight quarter turns.

Figure 2: Front left view of rollover damage to the Ford. The left side pillars had been cut by rescue personnel, and the roof crush was altered during rescue operations.

Exterior Damage: The Ford's impact with the ground involved the top, both sides and the undercarriage. The areas of greatest damage were to the left A-pillar, left roof side rail and left fender. The maximum vertical and lateral crush occurred at the left A-pillar (**Figure 2** above). The maximum vertical crush was approximately 33 centimeters (~ 13 inches), and the maximum lateral crush was approximately 24 centimeters (~ 10 inches). The crush values were based on measurements from the subject vehicle and an exemplar vehicle. The crush values are considered approximate because rescue personnel altered the damaged structure when they cut all the left side pillars and the right A-pillar.

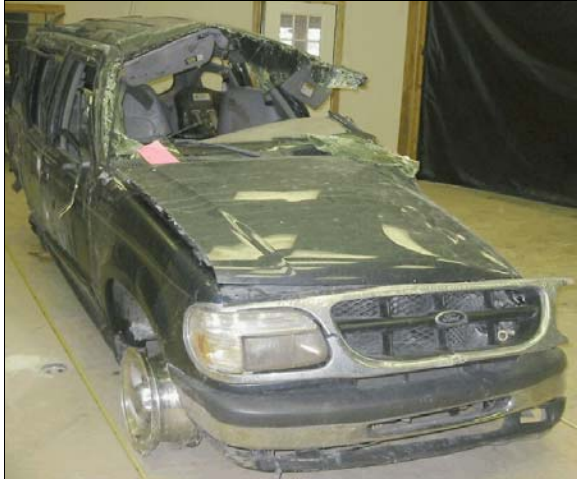
Figure 3: Front right view of damage to the Ford.

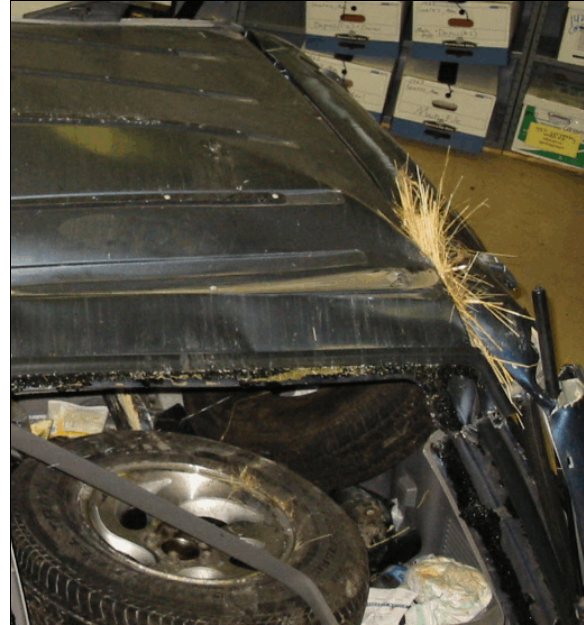
Figure 4: Grass embedded in the top seam of the Ford's rear hatch near the left D-pillar.

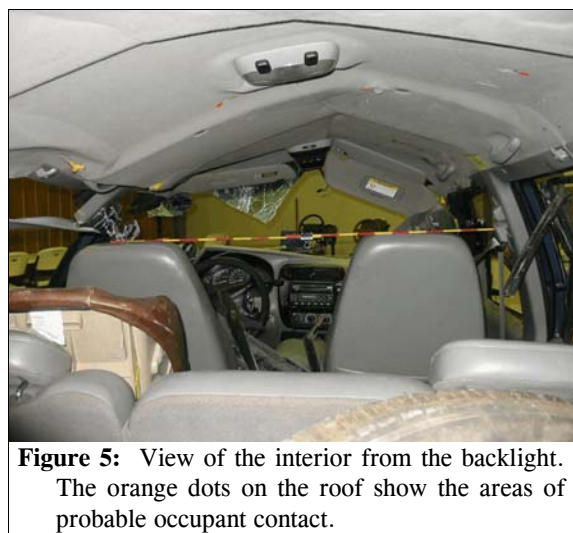
Vehicle Interior: Inspection of the Ford's interior revealed evidence of occupant contact to the roof (**Figure 5**). There was also intrusion of the left roof side rail, roof and all the left side pillars. The intrusion occurred in the front and back seating rows as well as the rear cargo area. The most severe intrusions were located in the driver's seating position. These involved vertical intrusion of the left A-pillar, left roof side rail and the roof. These intrusions measured approximately 27 centimeters (~11 inches). The left roof side rail intruded laterally approximately 24 centimeters (~9 inches). There was no evidence of deformation of the steering wheel rim or compression of the energy absorbing steering column.

Figure 5: View of the interior from the backlight. The orange dots on the roof show the areas of probable occupant contact.

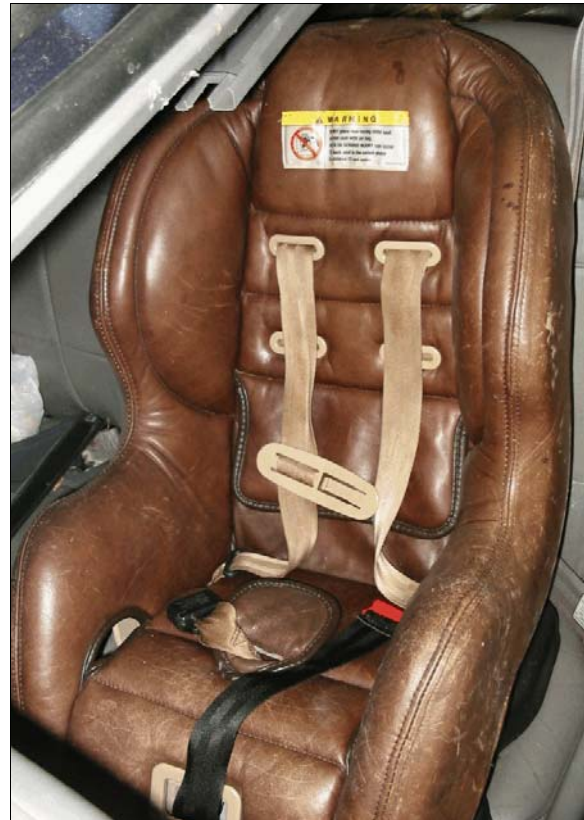
The back left passenger was seated in an Evenflo Medallion, forward facing, convertible child safety seat (CSS) with five-point internal harness (**Figure 6** below). The CSS was manufactured on September 22, 2000. Its model number was 2541243P1. The CSS was constructed of a one-piece plastic shell with a padded vinyl cover. The CSS could not be fully inspected because the attorney did not allow manipulation or removal of the CSS from the Ford.

The CSS was equipped with two sets of harness strap slots. The harness straps were threaded through the top slots. The harness strap was equipped with a retainer clip. The latch plates latched into a non-recessed buckle. The CSS was secured in the Ford by the lap-and-shoulder safety belt system. The belt was routed through the belt path on the back of the CSS. The belt was equipped with a light weight locking latch plate. It appeared that the CSS was securely fastened within the Ford. There was no visible damage or deformation to the CSS.

Figure 6: The Evenflo Medallion convertible CSS as found in the back left seat position.

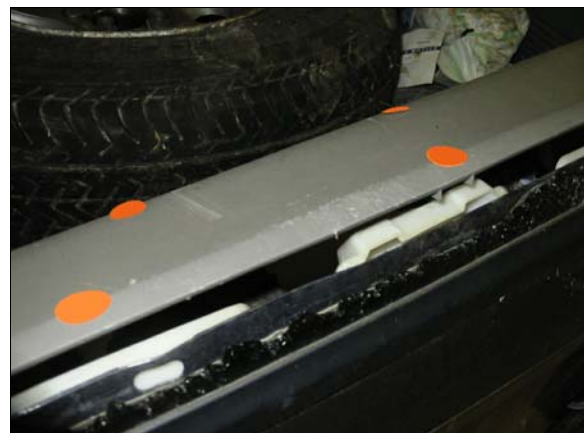
As the Ford rolled over, this passenger contacted the roof and side surfaces within the cargo area. Occupant contact abrasions on the left window sill in the cargo area (**Figure 7**) indicated that this passenger was ejected through the left cargo window during the rollover. He sustained skull fractures and brain injuries from contacting the ground. This passenger also sustained rib and sternum fractures, lacerations to the liver and mesentery and contusions to the lungs. The injury pattern suggests that the passenger was contacted by the vehicle at some point during the rollover. The final rest position of this passenger in relation to the rest position of the Ford was indeterminable.

Figure 7: Abrasions (outlined by orange dots) located on the left window sill in Ford's cargo area.
