Rollover Investigation
Dynamic Science, Inc. / Case Number: DS07017
2005 Chevrolet Trailblazer
Arizona
February 2007

1. Report No. DS07017		2. Government Accession No.		3. Recipient Catalog No.	
4. Title and Subtitle Child Safety Seat/Rollover Investigation				5. Report Date February 22, 2008

Dynamic Science, Inc.
Crash Investigation
Case Number: DS07017

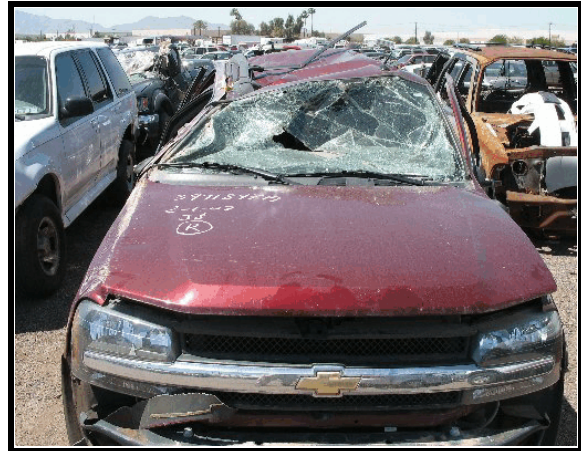
Figure 3. Overview of roof crush as seen from the front of the vehicle

The 2005 Chevrolet Trailblazer sustained moderate damage due to the rollover event (**Figure 3**). The direct damage on the roof began near the top of the tailgate and was 121 cm (47.6 in) wide. The damage narrowed down to 10 cm (3.9 in) along the right A pillar area down to the hood. There was direct contact damage along the right side of the vehicle that began at the right front bumper corner area and extended 465 cm (183.0 in) rearward.

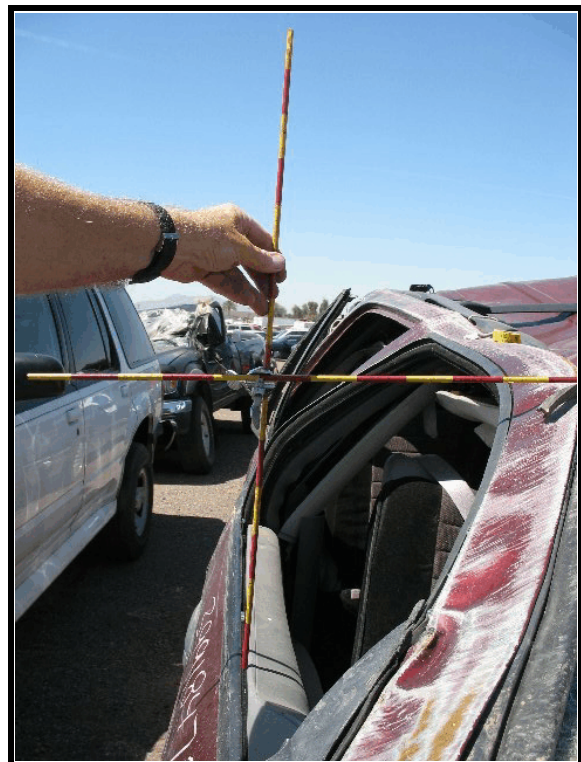
Figure 4. Maximum crush

The maximum crush was located at the right A pillar and measured 12 cm (4.7 in) vertically and 13 cm (5.1 in) laterally (**Figure 4**). The Collision Deformation Classification (CDC) was 00TDDO3.

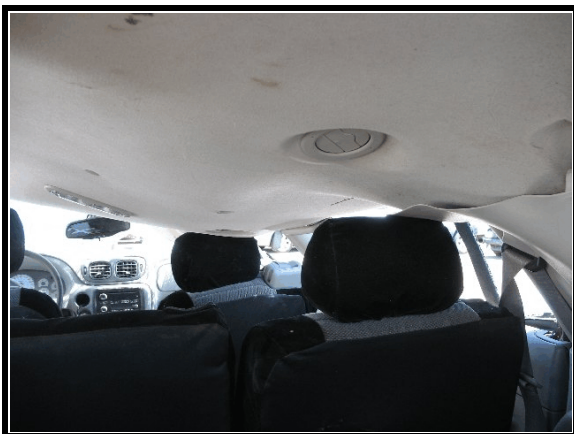
Figure 5. Overview of right side intrusion

The 2005 Chevrolet Trailblazer sustained moderate interior damage as a result of passenger compartment intrusion (**Figure 5**). There was intrusion damage along the entire right roof rail area and its supporting structures. There were scuffs and blood located on the roof, primarily about the front right seat (**Figure 6**). The roof structure intruded to a degree that it was in contact with the front right head restraint.

Position	Intruded Component	Magnitude of Intrusion	Direction
1R	A pillar	18 cm (7.0 in)	Vertical
1R	A pillar	13 cm (5.1 in)	Lateral
1R	Roof side rail	14 cm (5.5 in)	Vertical
1R	B pillar	8 cm (3.1 in)	Vertical
1R	B pillar	18 cm (7.0 in)	Lateral
1R	Roof	25 cm (9.8 in)	Vertical
2R	Roof side rail	24 cm (9.4 in)	Vertical
2R	Roof	28 cm (11.0 in)	Vertical
3R	Side rail	22 cm (8.7 in)	Vertical
2M	Roof	21 cm (8.3 in)	Vertical

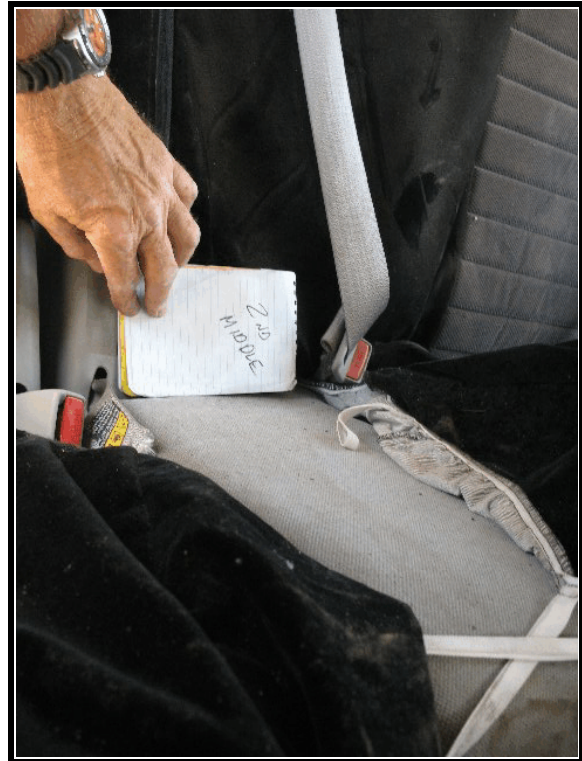
Figure 7. Second row middle safety belt, cut by EMS

The 2005 Chevrolet Trailblazer was configured with 3-point manual lap and shoulder belts for each of the seven seating positions. The front seats were equipped with integral safety belts and buckle pretensioners that did not actuate. The second row middle seat was also equipped with an integral safety belt. The driver's safety belt was configured with a sliding latch and an Emergency Locking Retractor (ELR). The remaining safety belts were configured with sliding latch plates and switchable ELR/Automatic Locking Retractors (ALR). There were indications of historical usage on all of the safety belts. The second row middle safety belt was cut, possibly by emergency personnel (**Figure 7**). The second row right was found to be jammed in the stowed position.

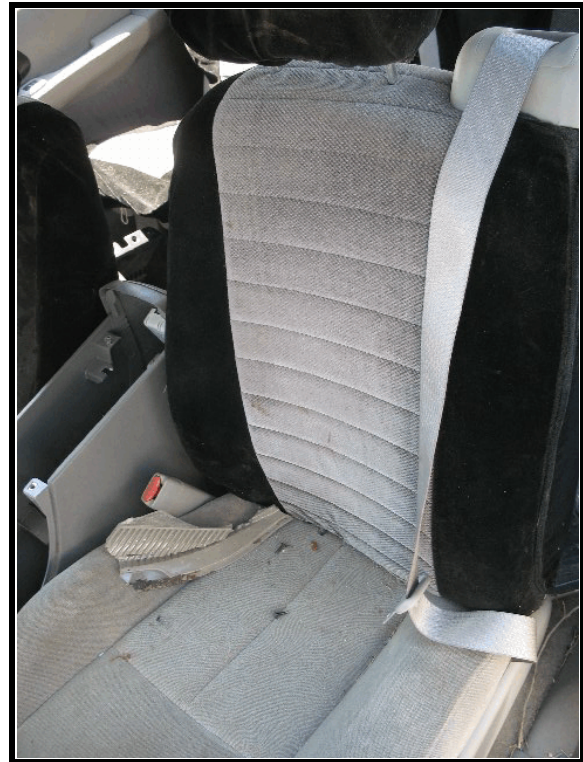
Figure 9. Driver's seated position

The 49-year-old driver of the Trailblazer was seated in a somewhat upright posture and was restrained by the 3-point manual lap and shoulder belt (**Figure 9**). The seat track was positioned in the rearmost position. The driver had fallen asleep. As the Trailblazer drifted off the left side of the roadway, the driver woke up. He steered the vehicle to the right and the vehicle began a clockwise rotation. The driver pitched to the left due to the rotation. As the vehicle returned to the roadway, the vehicle tripped and began a left side leading rollover. The driver generally stayed in place during the rollover sequence. He sustained contusions to his scalp and chest wall and abrasions to his right hand. He was able to exit the vehicle under his own power. He was transported to a local hospital where he was treated and released.

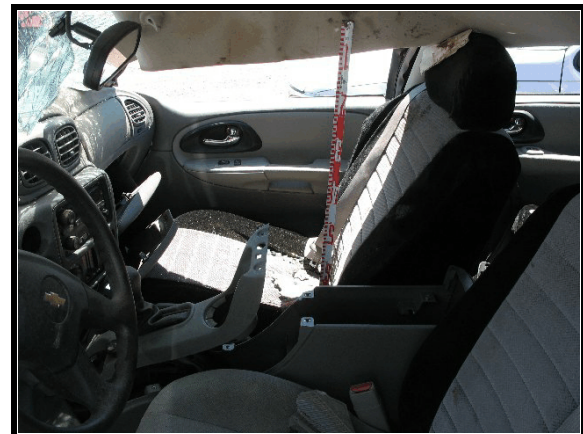
Figure 10. Front right seat occupant seated position

The 44-year-old female front right seat occupant was seated in an unknown posture and was restrained by the 3-point manual lap and shoulder belt (**Figure 10**). The seat was positioned to the forward most track position. The driver had fallen asleep. As the Trailblazer drifted off the left side of the roadway, the driver woke up. He steered the vehicle to the right and the vehicle began a clockwise rotation. The right front occupant pitched to the left due to the rotation. As the vehicle returned to the roadway, the vehicle tripped and began a left side leading rollover. The right front occupant generally stayed in place during the rollover sequence. It appears that this occupant's head contacted the intruding right side roof. She sustained a scalp laceration and multiple lacerations to the right elbow. She was able to exit the vehicle under her own power. She was evaluated at the scene. She was then transported by air ambulance to an area trauma center where she was admitted and hospitalized for one day.

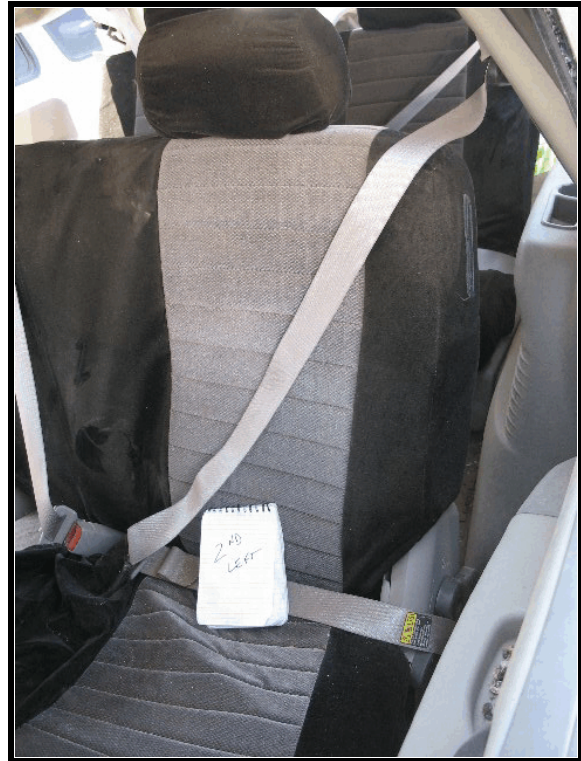
Figure 11. Second row left occupant seated position

The 29-year-old male second row left seat occupant was seated in an unknown posture and was restrained by the 3-point manual lap and shoulder belt (**Figure 11**). As the Trailblazer drifted off the left side of the roadway, the driver woke up. He steered the vehicle to the right and the vehicle began a clockwise rotation. The second row left occupant pitched to the left due to the rotation. As the vehicle returned to the roadway, the vehicle tripped and began a left side leading rollover. The second row left occupant generally stayed in place during the rollover sequence. He sustained a cervical strain due to impact forces. He also sustained abrasions to the left shoulder that were possibly related to seat belt loading. He was able to exit the vehicle under his own power. He was transported to a local hospital where he was treated and released.

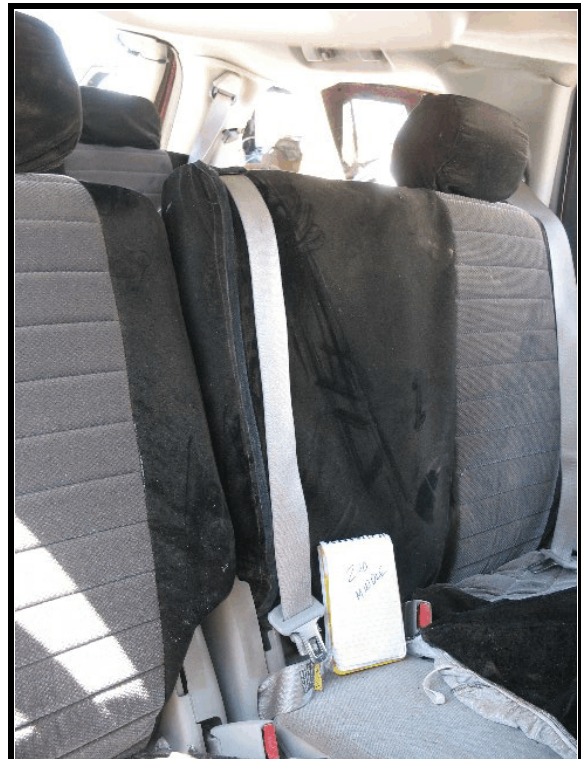
Figure 12. Second row middle occupant seated position

The 8-year-old female second row middle occupant was seated in an unknown posture and was restrained by the 3-point manual lap and shoulder belt (**Figure 12**). As the Trailblazer drifted off the left side of the roadway, the driver woke up. He steered the vehicle to the right and the vehicle began a clockwise rotation. The second row middle occupant pitched to the left due to the rotation. As the vehicle returned to the roadway, the vehicle tripped and began a left side leading rollover. The second row middle occupant generally stayed in place during the rollover sequence. There were no reported injuries for this occupant.

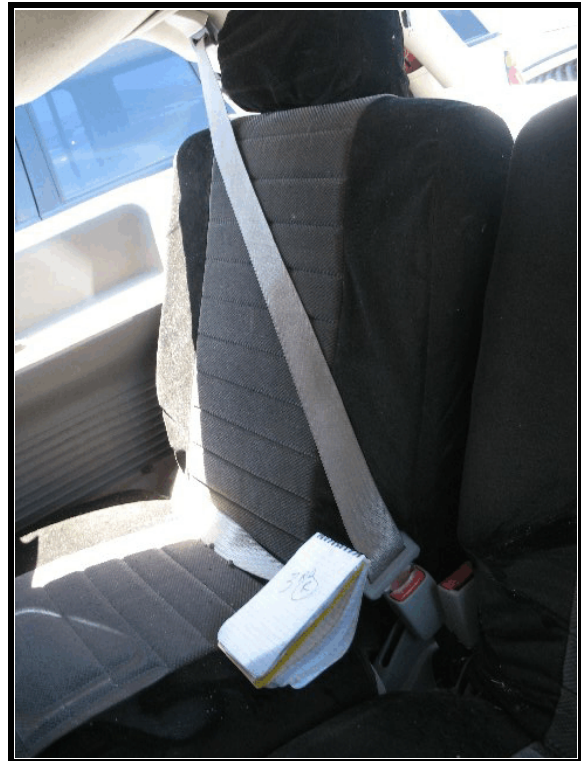
Figure 15. Third row right occupant seated position

The 5-year-old male third row right seat occupant was seated in an upright posture and was restrained by the 3-point manual lap and shoulder belt (**Figure 15**). The driver had fallen asleep. As the Trailblazer drifted off the left side of the roadway, the driver woke up. He steered the vehicle to the right and the vehicle began a clockwise rotation. The third row right occupant pitched to the left due to the rotation. As the vehicle returned to the roadway, the vehicle tripped and began a left side leading rollover. The third row right occupant generally stayed in place during the rollover sequence. This occupant likely contacted the intruding right side roof/roof rail. He sustained a skull fracture, as well as miscellaneous lacerations, contusions and abrasions. He was evaluated at the scene. He was then transported by air ambulance to an area trauma center where he was arrived with a GCS of 15. He was hospitalized one day.
