NOT-IN-TRAFFIC SURVEILLANCE

CALSPAN REMOTE POWER WINDOW INVESTIGATION

SCI CASE NO.: CA 07-019

VEHICLE: 1998 TOYOTA CAMRY

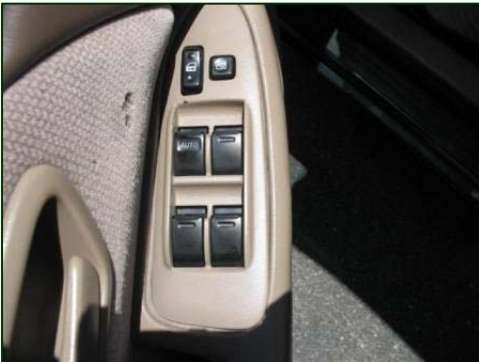
An exemplar 1998 Toyota Camry was examined and tested for this remote-level investigation. The main power window switch control panel was mounted on the forward aspect of the door armrest in a near horizontal position (**Figure 2**). The switch panel consisted of four rocker-style switches for the four door windows with the fronts located forward of the rear. The driver's door window switch was equipped with an auto-down feature. Each switch required down-pressure on the leading edge to lower the windows. The leading edge of the switch had to be lifted to power the window to close the windows. The Camry was equipped with a window lockout feature that consisted of a detent switch that was located forward of the window switches. The power lock rocker switch was located to the left (outboard) of the lockout switch. The Camry was also equipped with a reserve power feature that allowed the power windows to operate from any door position for 43 seconds after the ignition was turned to the off-position. This feature as described in the vehicle Owner's Manual is disabled when either front door is opened.

Figure 3. Driver's power switch console on an exemplar vehicle.

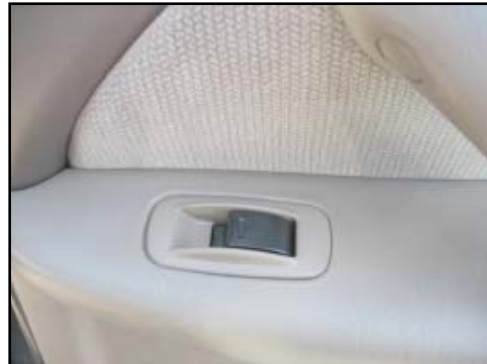
Figure 2. Rear right power window switch on an exemplar vehicle.

The rear door window switches were positioned 13-16 cm (5.25-6.4”) aft of the leading edge of the door and 20 cm (8”) below the top of the door panel. The switches were positioned in a trim that was secured to the 9 cm (3.5”) wide armrest. The switches required approximately 3 mm (0.125”) of movement to activate the windows in either direction.

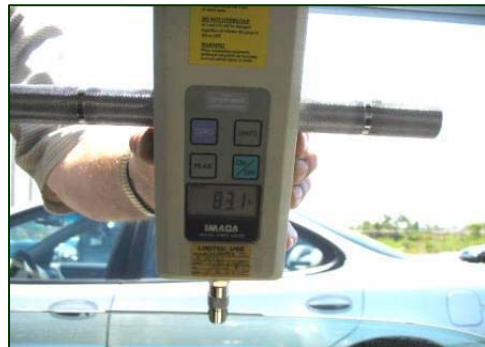
The exemplar vehicle was tested to determine the closing force of the rear right power window using an IMADA Digital Force Gauge that was calibrated to 311 N (70 lbs) of force on 11/26/2006. The vehicle’s engine was started and the rear right power window was opened using the driver’s switch. The force gauge was positioned between the window and the window frame. The plunger end of the gauge was equipped with a duck-bill end that was positioned over the top of the glazing. With the engine running to fully power the vehicle’s electrical system, the window was closed against the gauge.

Figure 4. Peak closing force reading of 370 N (83.1 lbs) of the rear right power window.

A peak closing force of 370 N (83.1 lb) was recorded (**Figure 4**). With up-pressure applied to the switch, the closing force began to drop within one second of the peak recording. Within seconds, the closing force dropped to 338 N (76 lbs). This test was repeated which yielded lower results as the power window motor heated up.
