Remote Not in Traffic Surveillance Back Over Investigation / Vehicle to Pedestrian  
Dynamic Science, Inc. / Case Number: DS07019  
1991 Isuzu Trooper  
Arizona  
January 2007

1. Report No. DS07019	2. Government Accession No.		3. Recipient Catalog No.	
4. Title and Subtitle Remote Not in Traffic Surveillance Back Over Investigation			5. Report Date October 19, 2007

**Dynamic Science, Inc.**  
**Crash Investigation**  
**Case Number: DS07019**

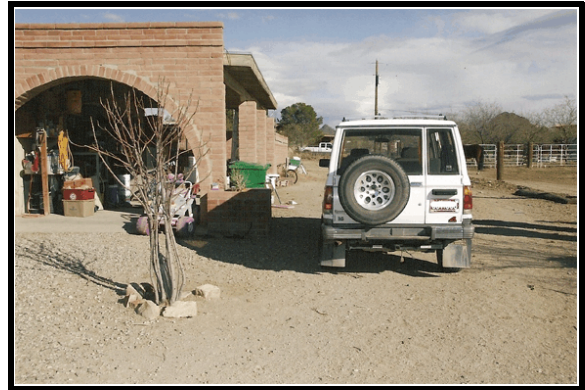
**Figure 1.** Case vehicle, 1991 Isuzu Trooper

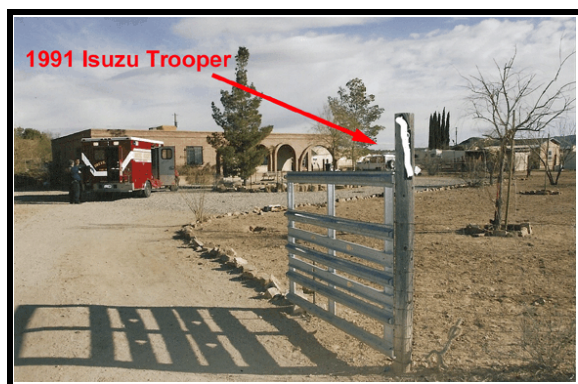
The driver began backing toward the front gate. She indicated that she heard a “thump”. She stopped the vehicle and saw the child in front of the vehicle and realized she had run over her. It appears that the child was knocked down by the right rear bumper and then run over by both right side tires.

**Figure 2.** Overview of crash scene (case vehicle in background on right)

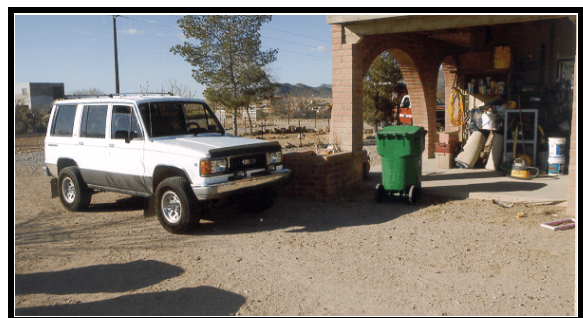
**Figure 3.** Look back view of pedestrian path

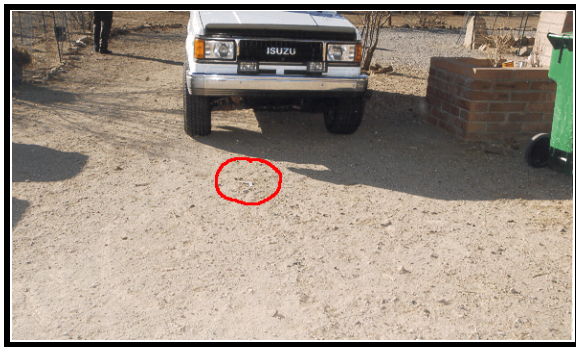
**Figure 4.** Case vehicle at final rest. Circle marks location of pooled blood.

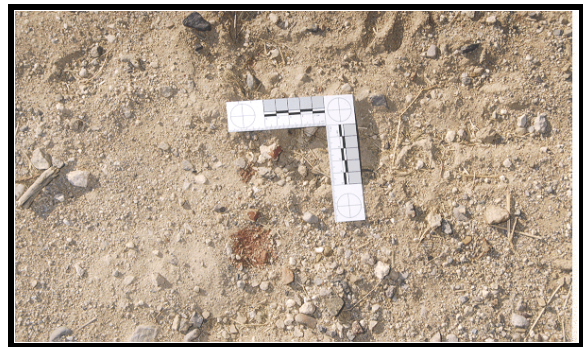
**Figure 5.** Close up of blood mark on driveway

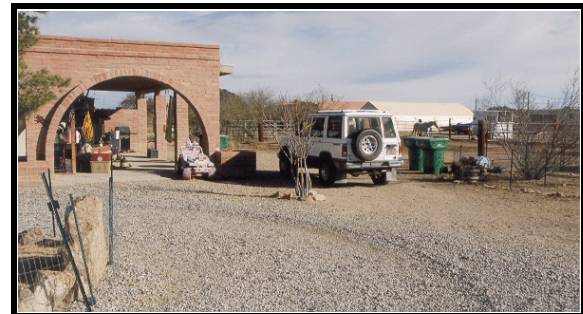
**Figure 6.** Case vehicle at final rest (east)

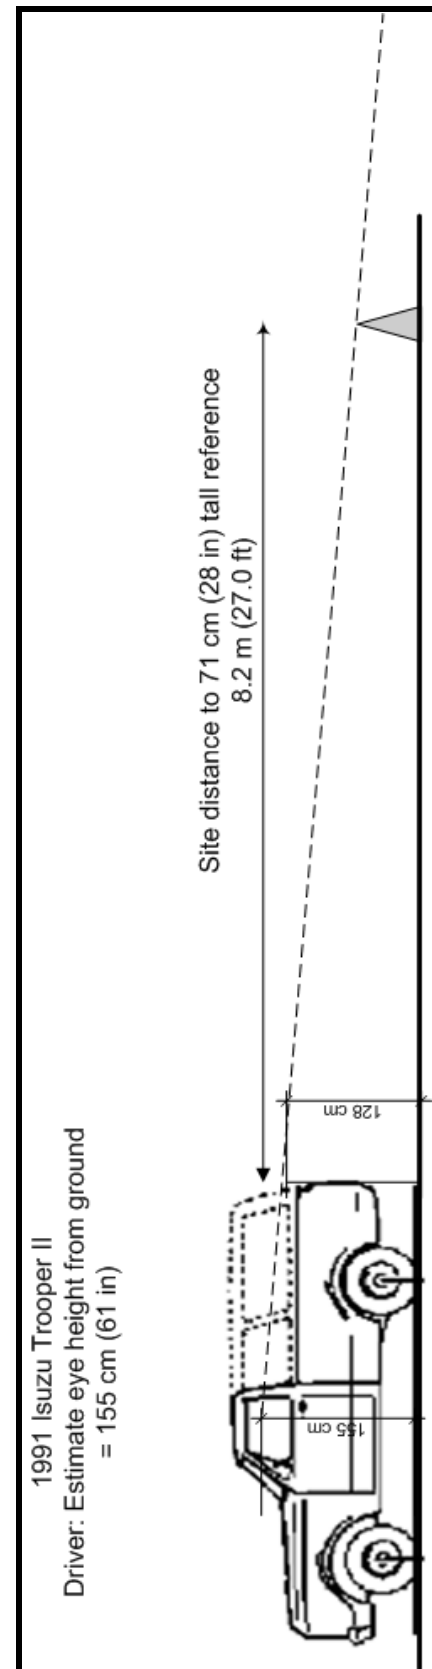
The site distance shown is based on the view through the rear window. The driver's seated height was based on the seated eye height of a 50<sup>th</sup> percentile male as measured within an exemplar vehicle.

The Isuzu was configured with a spare tire attached to the rear hatch. The tire partially blocks the rear window. The distance from the ground to the top of the tire was 157.5 cm (62.0 in). At this height, the driver would not have been able to see any objects out the back window.

**Figure 7.** Nominal Sight Distances

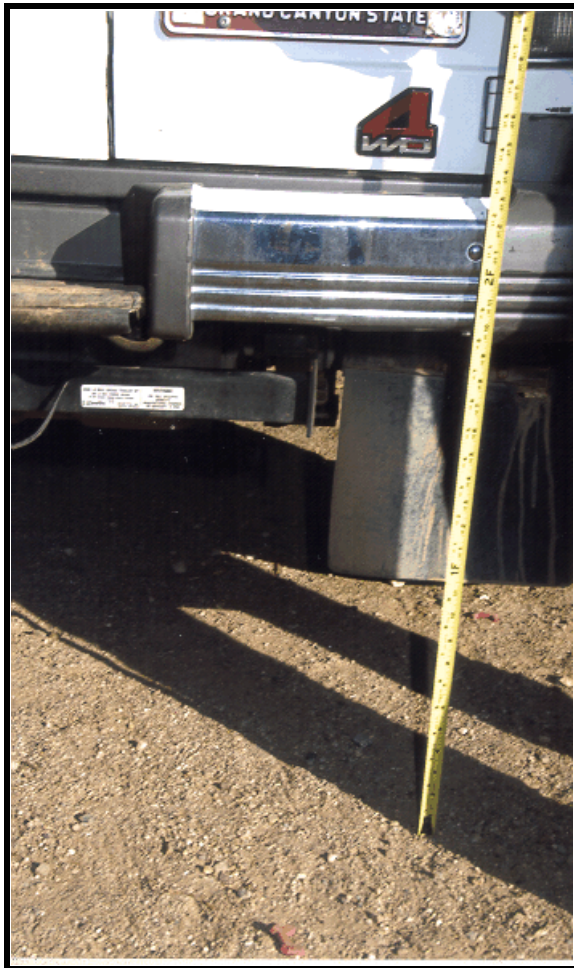
There was no exterior damage to the vehicle. There was a cleaning mark found on the rear bumper, but it is not known if this was related to this incident (see Figures 8-9).

**Figure 8.** Overview of cleaning mark to rear bumper

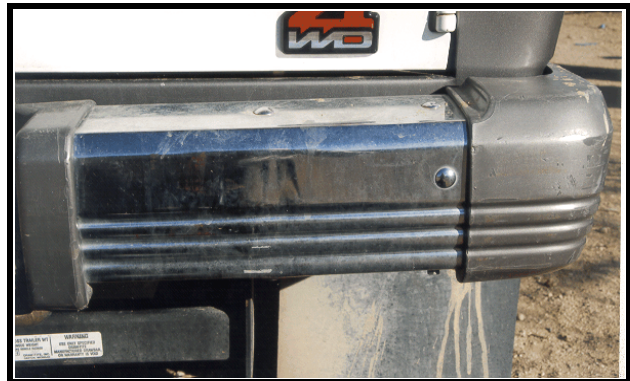
**Figure 9.** Close up of cleaning mark to rear bumper
