ON-SITE NOT IN TRAFFIC SURVEILLANCE BACK OVER INVESTIGATION

CASE NUMBER - IN-07-019

VEHICLE - 2006 DODGE DAKOTA SLT

INCIDENT DATE - March 2007

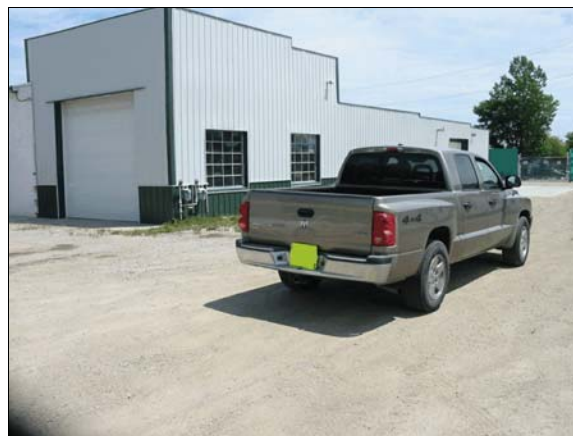
the passenger side of the other vehicle. The southwest corner of the building was located approximately 12 meters (~39 feet) north of the Dodge (**Figure 1**). The distance between the two vehicles was estimated to be approximately 2 meters (~7 feet). At the time of the incident the light condition was daylight, the surface condition was dry, the atmospheric condition was partly cloudy, and the temperature was approximately 0 degrees Celsius (32 degrees Fahrenheit). The site of the incident was rural, undeveloped. See the Scene Diagram at the end of this report.

Figure 1: View northeast to incident site and Dodge, which is parked in approximate same location as at time of incident

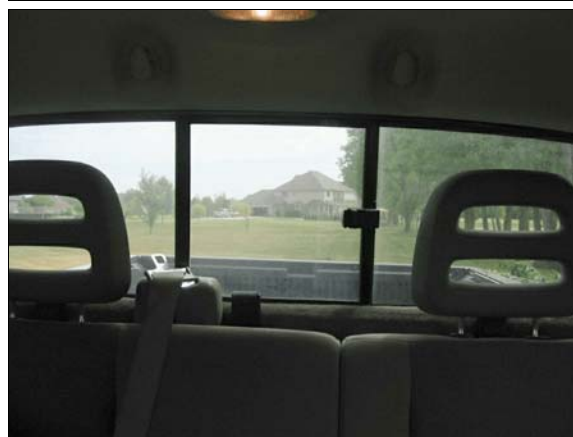
Figure 2: View out of Dodge's backlight from driver's seat

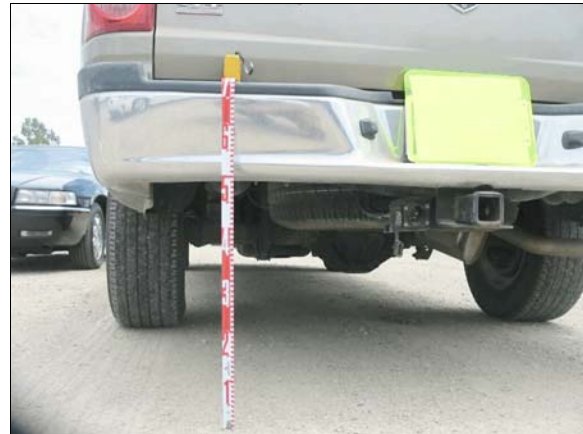
driver's interview, he reacted and began to stop the vehicle at approximately the same time he felt the left rear wheel (Figure 3) run over something. It is this contractor's opinion that when the pedestrian saw the Dodge backing and heard her father yell stop, she tried to stop and her feet slipped out from under her on the gravel and she fell backwards. The Dodge's driver stopped the vehicle, got out and saw that the Dodge's left rear tire was on the pedestrian's left hip and abdomen area. The pedestrians father told the driver to pull the vehicle off of the pedestrian. The driver immediately got back in the Dodge and pulled it forward off of the pedestrian's body.

Figure 3: Dodge's left rear tire and back bumper, measurement tape is in tenths of meter

There was no evidence of pedestrian contact to the Dodge Dakota's's back bumper and no evidence of contact to any of the Dodge's rear undercarriage components or the left rear tire. Based on the driver interview indicating the left rear tire struck the pedestrian and the Collision Deformation Classification (CDC) guidelines for pedestrian impacts, a CDC was assigned as: **06-BLWN-4 (180 degrees)** to describe the left rear tire contact to the pedestrian. The Dodge was driven from the scene.

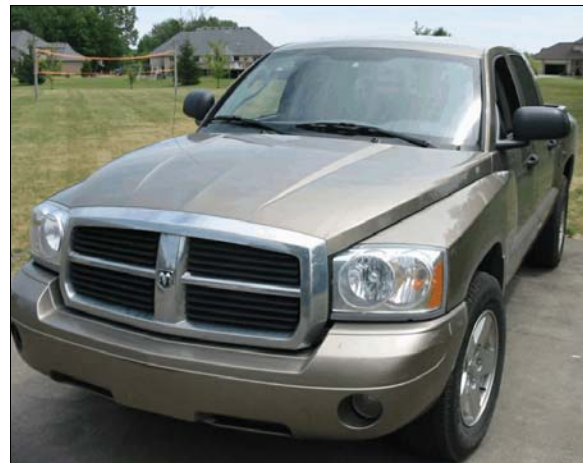
Figure 4: Overview of Dodge Dakota from front left

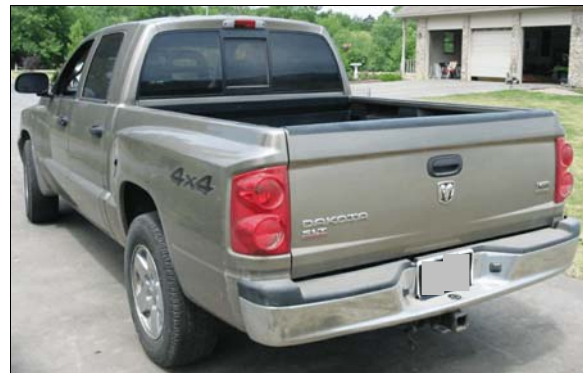
Figure 5: Overview of Dodge Dakota from back left corner

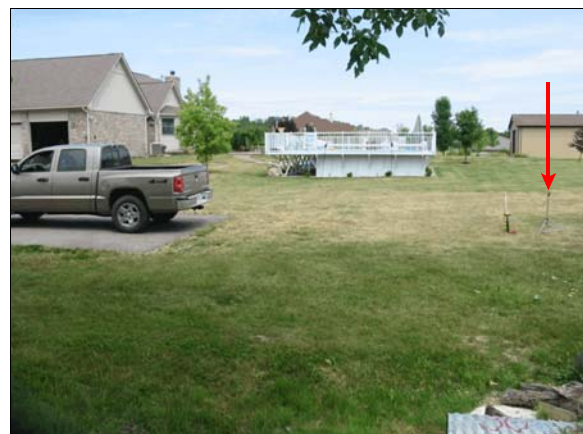
The blind zone behind the Dodge was determined by placing the target at the back of the vehicle and moving it rearward until it came into the driver's view as he looked over his right shoulder out of the backlight. The target had to be moved 6.7 meters (22 feet) rearward before

Figure 6: Arrow shows location of target where it was first visible to Dodge's driver as he looked over his right shoulder out of backlight

becoming visible to the driver (**Figure 6** above). When the target was moved 4.3 meters (14.1 feet) to the right of the Dodge's approximate centerline, it became obstructed by the back right head restraint (**Figure 7**). The head restraint was constructed with two rectangular cut-out sections located above and below a central solid cross-section. It was possible to see through these two small cut-outs in the head restraint, but these views were limited and were not assessed. The target had to be moved an additional 2.7 meters (8.9 feet) to the right of the centerline before it was visible once again at the right side of the head restraint. The target was moved an additional 0.8 meters (2.6 feet) to the right where it became obstructed by the right C-pillar and was not visible again until it was moved an additional 4 meters (13.1 feet) to the right, where it became visible through the right rear window. When the target was moved 1.3 meters (4.3 feet) to the left of the centerline, it became obstructed by the back left head restraint (**Figure 2** above). The target was not visible to the driver again because it was unnatural for him to turn his head any further to the right. The target was also placed at the back right corner of the Dodge and moved to the right. It could not be seen through the backlight because it was blocked by the right side of the truck bed. However, it became visible through the right rear window when moved out 3 meters (9.8 feet) from the back right corner.

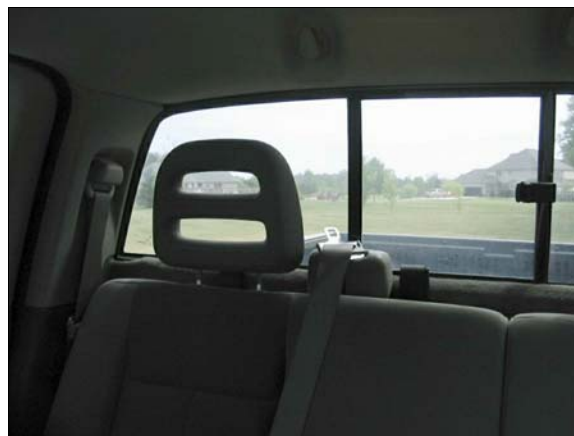
Figure 7: View of Dodge's back left head restraint and view out of backlight from driver's seat

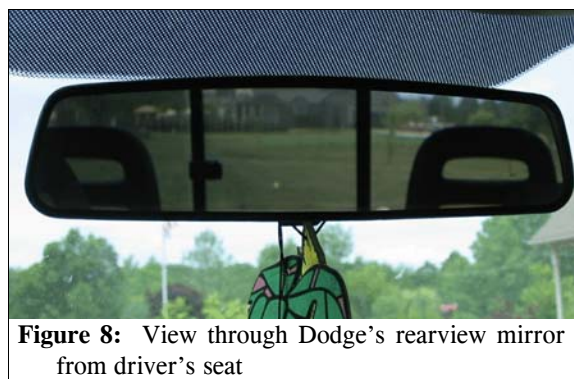
Figure 8: View through Dodge's rearview mirror from driver's seat

The driver was then asked to view behind the Dodge through the rearview mirror (**Figure 8**). The target was again moved rearward from the back center of the Dodge. The target was not visible to the driver until it had been moved 6.1 meters (20 feet) rearward. The target was then moved to the right of the Dodge's approximate centerline 1.6 meters (5.2 feet), where it became obstructed by the left edge of the back right head restraint. If moved further to the right, the target could be seen through the head restraint, but when moved 2.7 meters (8.9 feet) from the centerline, the target became obstructed by the right edge of the head restraint. The target could not be seen beyond this point because it was beyond the rearview mirror's field of view. The target was then moved to the left 1.1 meters (3.6 feet) where it became obstructed by the back left head restraint. The driver could not see beyond the back left head restraint because it was beyond the rearview mirror's field of view.
