Remote Not In Traffic Surveillance Back Over Investigation
Dynamic Science, Inc. (DSI), Case Number (DS07020)
2007 Hyundai Sonata
Colorado
February 2007

1. Report No. DS07020	2. Government Accession No.		3. Recipient Catalog No.	
4. Title and Subtitle Remote Not In Traffic Surveillance Back Over Investigation			5. Report Date February 11, 2008

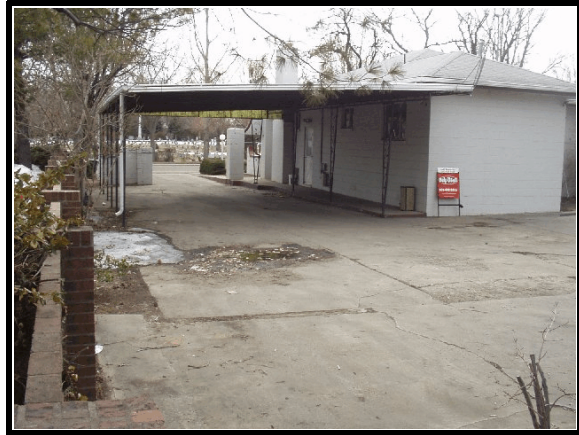
The incident occurred in a parking area on private property (see Figure 2). The parking area is behind a private building. Access to the parking area is through a south to north driveway. The parking area measured 19.8 m (65.0 ft) east to west and 12.5 m (41.0 ft) north to south. The driveway is 5.8 m (19.0 ft) wide. Just to the west of the driveway, there is a raised 0.9 m (3.0 ft) sidewalk. The driveway is covered by a metal roof structure. The parking area is level and the concrete surface was dry. There were no other vehicles in the parking area. The temperature at the nearest reporting station was 4 degrees C (39 degrees F).

Figure 2. Overview of incident area. Driver backing from right to left.

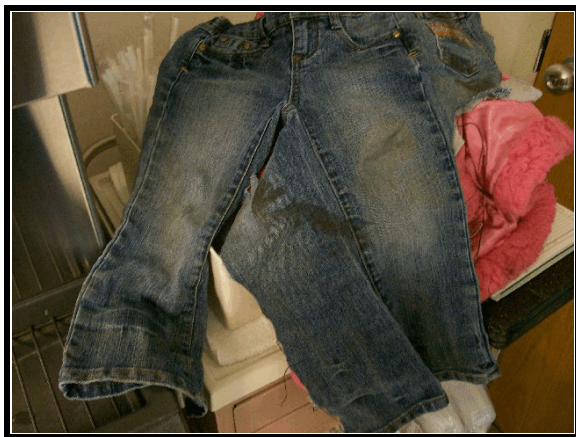
As the backing motion began, she heard her daughter screaming. She saw her daughter on the ground and went to her. It appears that the child was knocked down by the left rear bumper and then run over by the left rear tire. There were tire mark contacts to both legs of the child (see Figure 5) and to portions of the child's jacket (see Figure 6).

Figure 5. Contacts to child's jeans

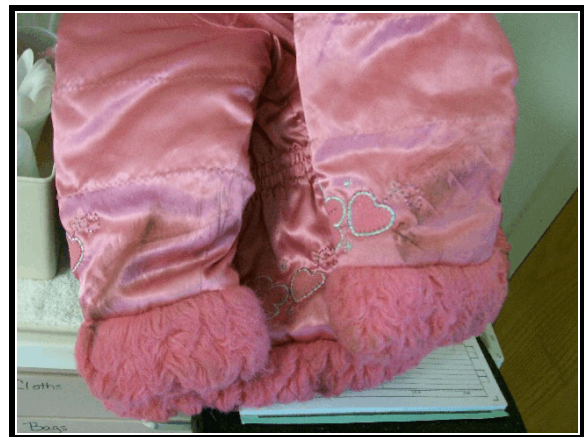
Figure 6. Contact to child's jacket

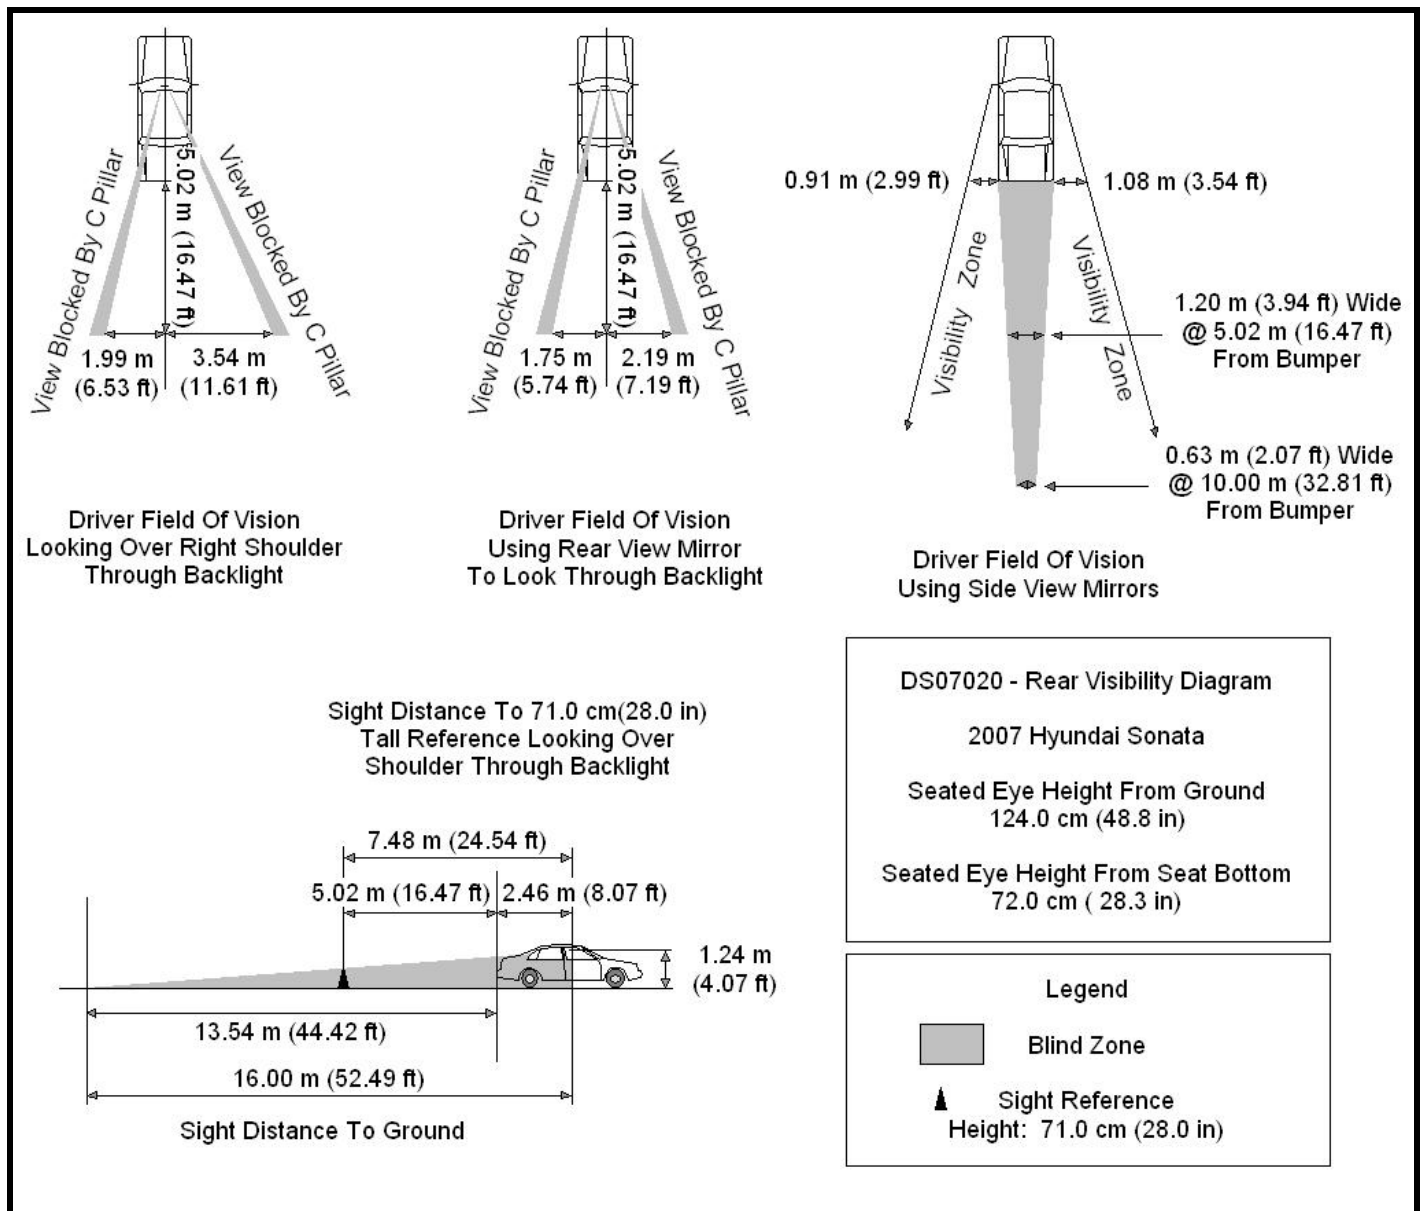
It appears that the child was in the driver's blind spot at the time of the incident. It is possible that the driver may have been able to see the child transition from the building to the vehicle through the left hand mirror if the driver were looking through the mirror at that time. It is not clear where the driver was looking at the time of the incident, but it would seem more likely than not that she was looking over her right shoulder as she was backing in that direction.

Figure 8. Nominal sight diagram

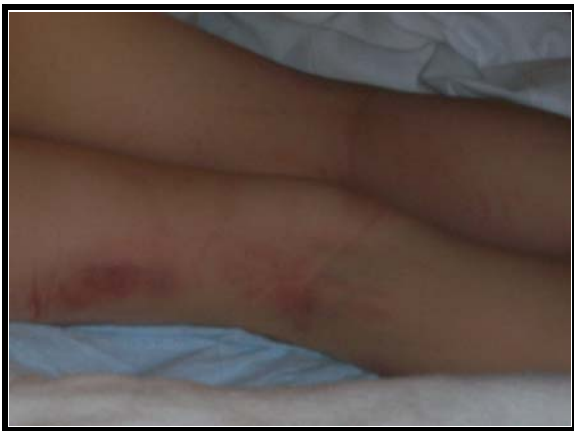
<u>Injury</u>	<u>OIC Code</u>	<u>Injury Mechanism</u>	<u>Confidence Level</u>
Right tibia fracture	853404.2,1	Left rear tire	Certain
Abrasion, left thigh	890202.1,2	Left rear tire	Probable
Abrasion, behind left knee	890202.1,2	Left rear tire	Probable
Contusion, right thigh	890402.1,1	Left rear tire	Probable
Abrasion, right thigh	890202.1,1	Left rear tire	Probable

Figure 9. Injuries to child's legs (back view)

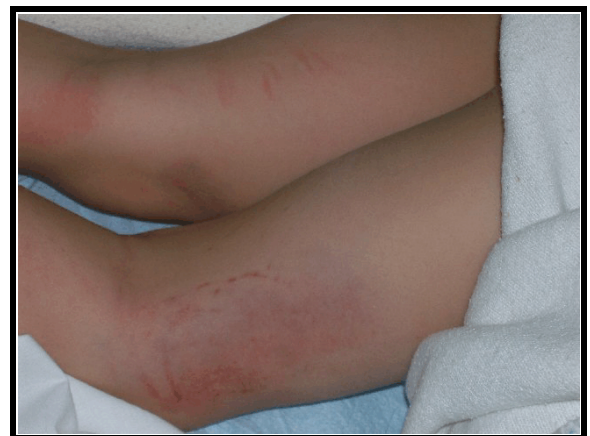
Figure 10. Injuries to child's legs (side view)
