CRASH DATA RESEARCH CENTER

**CALSPAN ON-SITE ROLLOVER CRASH INVESTIGATION
SCI CASE NO: CA07-021**

**VEHICLE: 2007 CHEVROLET HHR
LOCATION: FLORIDA
CRASH DATE: MAY, 2007**

Contract No. DTNH22-07-C-00043

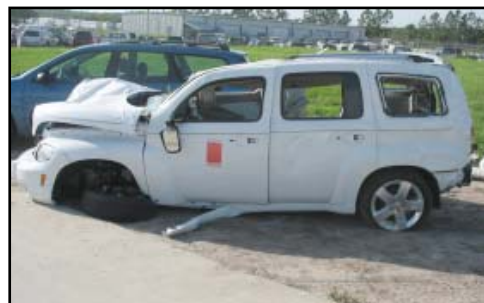
Figure 1: Left side view of the 2007 Chevrolet HHR.

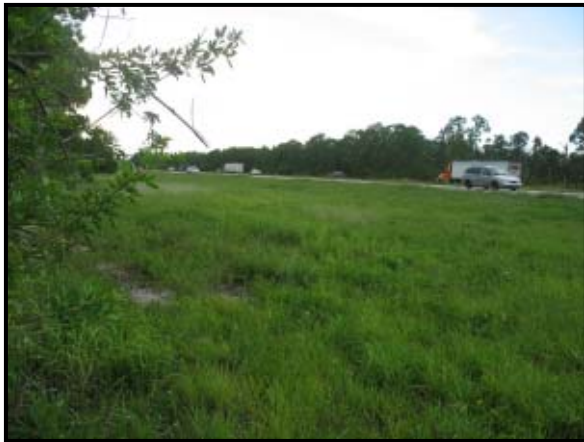
the fence. The SCI inspection of the scene identified a 2 m (6 ft) damaged section of the fence that was attributed to the vehicle's contact.

Figure 2: Look back view from the Chevrolet's final rest position.

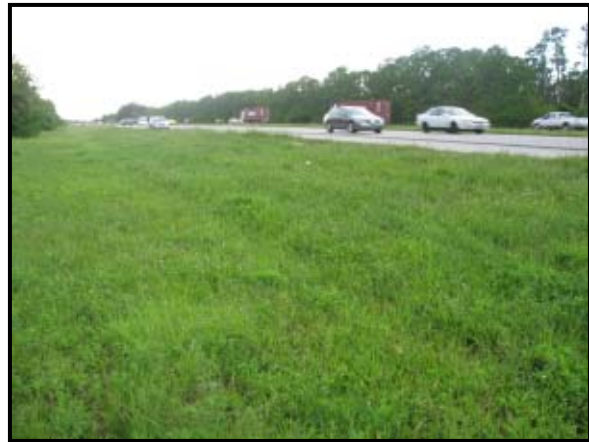
From the road edge, there was a gradual roadside slope in the west direction for drainage. The cross slope was estimated at less than two percent over a lateral distance of 9.0 m (29.4 ft) At that location, the roadside transitioned to a predominately level grade westward to the fence line. The change in the slope caused the tires of the vehicle to furrow resulting in a tripped rollover. The police report indicated the vehicle began to rollover approximately 9 m (30 ft) west of the road edge consistent with the transition. Due to the passage of time between the crash date and the SCI inspection, the physical evidence of the vehicle's roll trajectory was masked by the growth of the vegetation. **Figure 2** is a lookback view from the Chevrolet's final rest area along the approximate rollover trajectory of the vehicle. **Figure 3** is a lookback view from the vehicle's approximate trip location toward the roadside departure. A schematic of the crash is included at the end of this report as **Figure 12**.

Figure 3: Look back view from Chevrolet's approximate trip location.

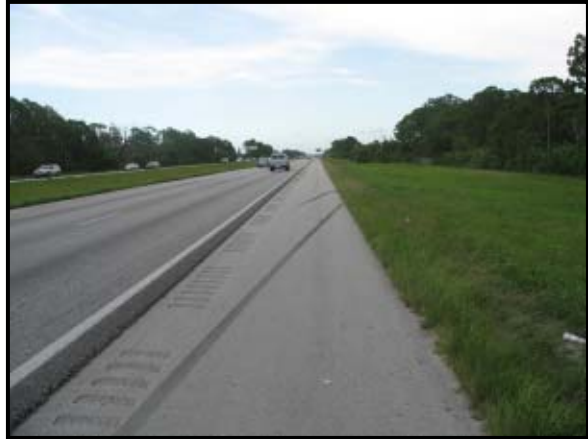
The police documented a 45 m (148 ft) counterclockwise yaw mark along the shoulder consistent with the driver's left steer input. The mark reportedly reentered the outboard lane and stopped. The driver had responded to the counterclockwise yaw by steering back to the right. The right steering input corrected the counterclockwise yaw and initiated a clockwise yaw. The clockwise yaw was evidenced by a 58.5 m (192 ft) mark that was also police documented. The mark departed the right lane, traveled through the shoulder and departed the pavement edge. At the time of the SCI inspection, two tire marks 32 m (84 ft) and (41 ft) in length respectively were documented on the shoulder in the area of the road departure. These marks were attributed to the left front and left rear tires of the HHR, refer to **Figure 4**. An additional unrelated tire mark was

Figure 4: Trajectory view of the HHR and the documented yaw marks.

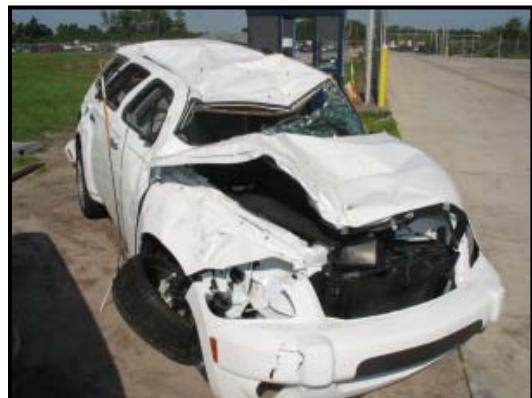
The exterior damage to the Chevrolet was consistent with a six quarter turn rollover event. **Figure 5** is a front right oblique view of the vehicle. The vehicle's two side planes and top plane were deformed from multiple ground impacts. The surface abrasions (scratches) to the left roof rail were oriented in two directions indicative of two ground contacts. The front and back end planes did not sustain direct contact damage indicating the roll was primarily lateral in direction. The most severe damage was located in the forward roof area and to the right A-pillar. The right roof rail deformed inboard and down. The right fender was deformed downward. The damage at these locations occurred during the first ground impact when the

Figure 5: Front right oblique view.

vehicle was rolling between quarter turns 2 and 3. At this time, the vehicle's momentum/energy was the greatest. The roof deformation extended from the header to the right D-pillar area.

The windshield fractured from ground contact and separated along the right A-pillar and across the header. The glazing of all the side windows had disintegrated with the exception of the partially open driver's window and the quarter window glazing of the rear left door. The front left, rear left and rear right doors were operational post-crash. The right front door was jammed shut. The rear lift gate of the vehicle had been removed and was inside the cargo area of the vehicle upon initial inspection. There was no evidence that the rear latch had released. The upper hinges of the lift gate appeared to have been cut.

During the rollover, both the left and right front wheels impacted the ground. These two separate impacts fractured the control arms of the respective suspensions. The left front tire was lying flat on the ground at the time of the inspection. The right front wheel was canted at a 60 degree angle.

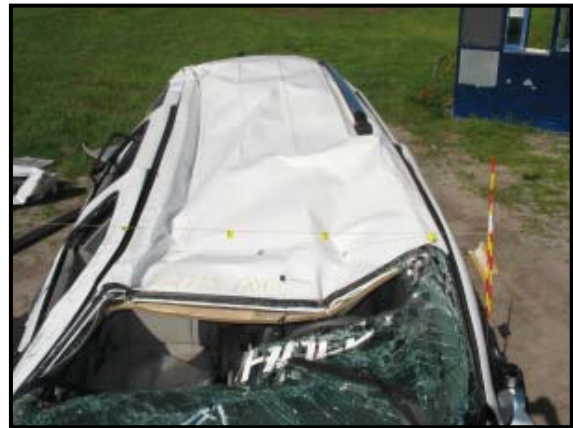
The deformation of the roof was documented along the windshield header. A string line parallel to the lateral belt line was established and the vertical crush was measured relative to the string. The Field L (upper left A-pillar to upper right A-pillar) measured 99 cm (39 in). The residual crush profile was as follows: C1 = 0, C2 = 22 cm (8.7 in), C3 = 18 cm (7.2 in), C4 = 15 cm (6.1 in). The maximum vertical crush measured 22 cm (8.7 in) and was located on the windshield header 28 cm (11 in) left of the centerline. The maximum lateral crush was located at the right upper A-pillar and measured 24 cm (9.5 in). The Collision Deformation Classification (CDC) of the rollover event was 00-TDDO4. As the HHR slid to final rest, the right rear quarterpanel of the vehicle contacted the chain link fence bordering the road side. This contact resulted in minor body panel deformation and abrasions. The CDC of the contact was 03-RBAW1.

Figure 6: View of the roof deformation.

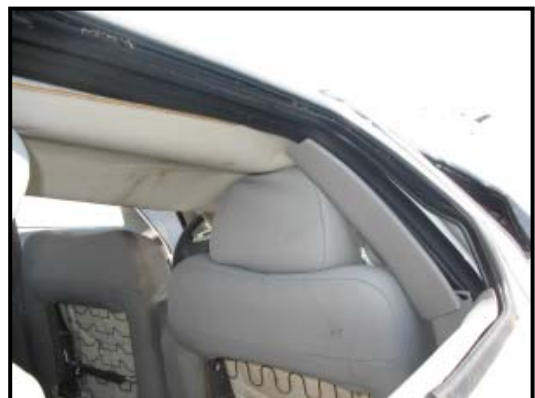
The interior damage of the HHR consisted of the intrusion of the roof and right side pillars and the occupant interior contact points. The roof was intruded over the first and second row. The right B-pillar and right roof area deformed around, and were in contact with, the head restraint of the front right seat. Refer to **Figure 7**. The roof deformed in a V-shape pattern inboard of the right front seat. The documented intrusions to the interior of the Chevrolet are listed in the table below.

Figure 7: View of the front right seat back and intrusion.

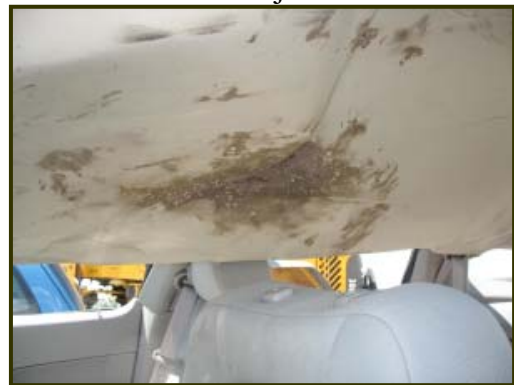
At the time of the SCI inspection, the six-way powered driver seat was adjusted in a mid to forward track position that measured 6 cm (2.5 in) rear of full forward. The total seat track travel measured 23 cm (9 in). The seat back was reclined 60 degrees aft of vertical and the head restraint was removed. The seat recline mechanism was not damaged by occupant loading. Examination of the bolster and foot well was unremarkable for occupant contact evidence. A driver head contact was located 48 cm (19 in) aft of the header and 55 cm (21.5 in) right of the left B-pillar (**Figure 8**). The contact measured 51 cm x 30 cm (20 in x 12 in) in gross overall area. In the center of the area was a 30 cm x 30 cm (12 in x 12 in) region of blood/dirt and debris.

Figure 8: Driver head contact.

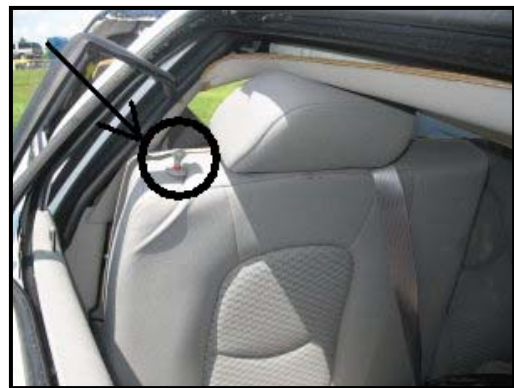
Figure 9: Rear right seat back.

During the inspection of the rear seat area, it was observed that the right split bench seat was folded down. The seat could not be returned to the upright position due to the interference with the intruded right roof rail and C-pillar. Refer to **Figure 9**. The seat back latch was noted to be jammed in the unlatched

position (denoted by the orange band in the Figure and highlight by the circle). It may have been unlatched prior to the crash, unknown to the occupants. During the rollover event, the occupant in the cargo area probably loaded the seat back causing it to fold forward prior to the roof/pillar intrusion.

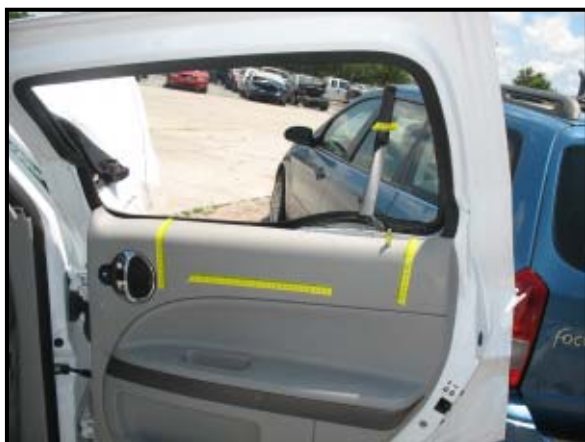
The right rear passenger was ejected through the window opening of the right rear door. Multiple areas of contact evidence were observed on the door and window frame that indicated this as the ejection portal. **Figures 10 and 11** are views of the right rear door and contact evidence. A 41 cm x 10 cm (16 in x 4 in) area located on the apex of the door panel (window sill) was scuffed and abraded in a vertical direction. The decorative top of the door lock fractured from the stem and was missing. The quarter window glazing was disintegrated and the frame was deformed outboard. Several strands of hair were found embedded into the upper third aspect of the frame. The injuries sustained by the ejected right rear passenger were consistent with the physical evidence identified on the door panel.

Figure 10: View of the right rear door.

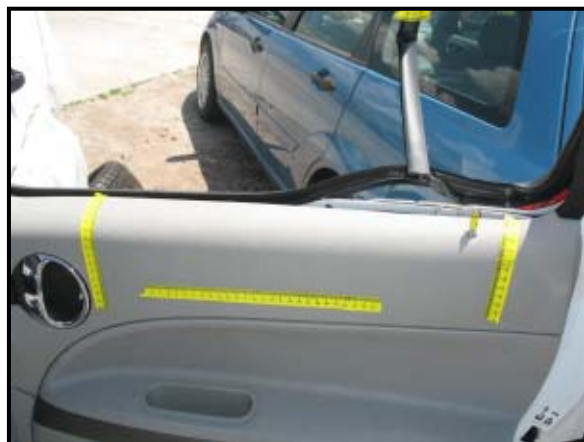
Figure 11: Close-up view of the ejection portal.

The unrestrained rear right passenger was seated in an unknown posture. The passenger was displaced to the right and contacted the right door panel in response to the rollover of the Chevrolet. The passenger’s right flank was loaded by the displaced rear and center and rear left passengers. As the vehicle rolled between two and three quarter turns, the right roof and right roof side rail impacted the ground. The passenger responded to the ground impact with a rightward trajectory and loaded the right door panel and window sill. The right humerus and right ribs fractured as a result of the contact. The rear center and rear left passenger loaded the passenger’s left side and fractured the left humerus. The passenger’s head contacted the frame of the right rear quarter window resulting in a forehead contusion and likely contacted the ground. The frame was deformed outward upon inspection and strands of hair were found in the frame.

As the vehicle continued to rollover, the passenger was continually loaded by the center and left passengers and began to be ejected through the windows opening. The passenger’s right upper extremity contacted and fractured the decorative top of the door lock stem resulting in a laceration. The centripetal force of the rollover completely ejected the passenger through the opening resulting in a liver laceration and multiple bilateral lower extremity abrasions. During the ejection sequence, the rear right seat back folded forward due to possible loading from the 25 year old female in the cargo area. As the seat folded forward, the seat contacted and possibly fractured the passenger’s right lower extremity late in her ejection sequence.

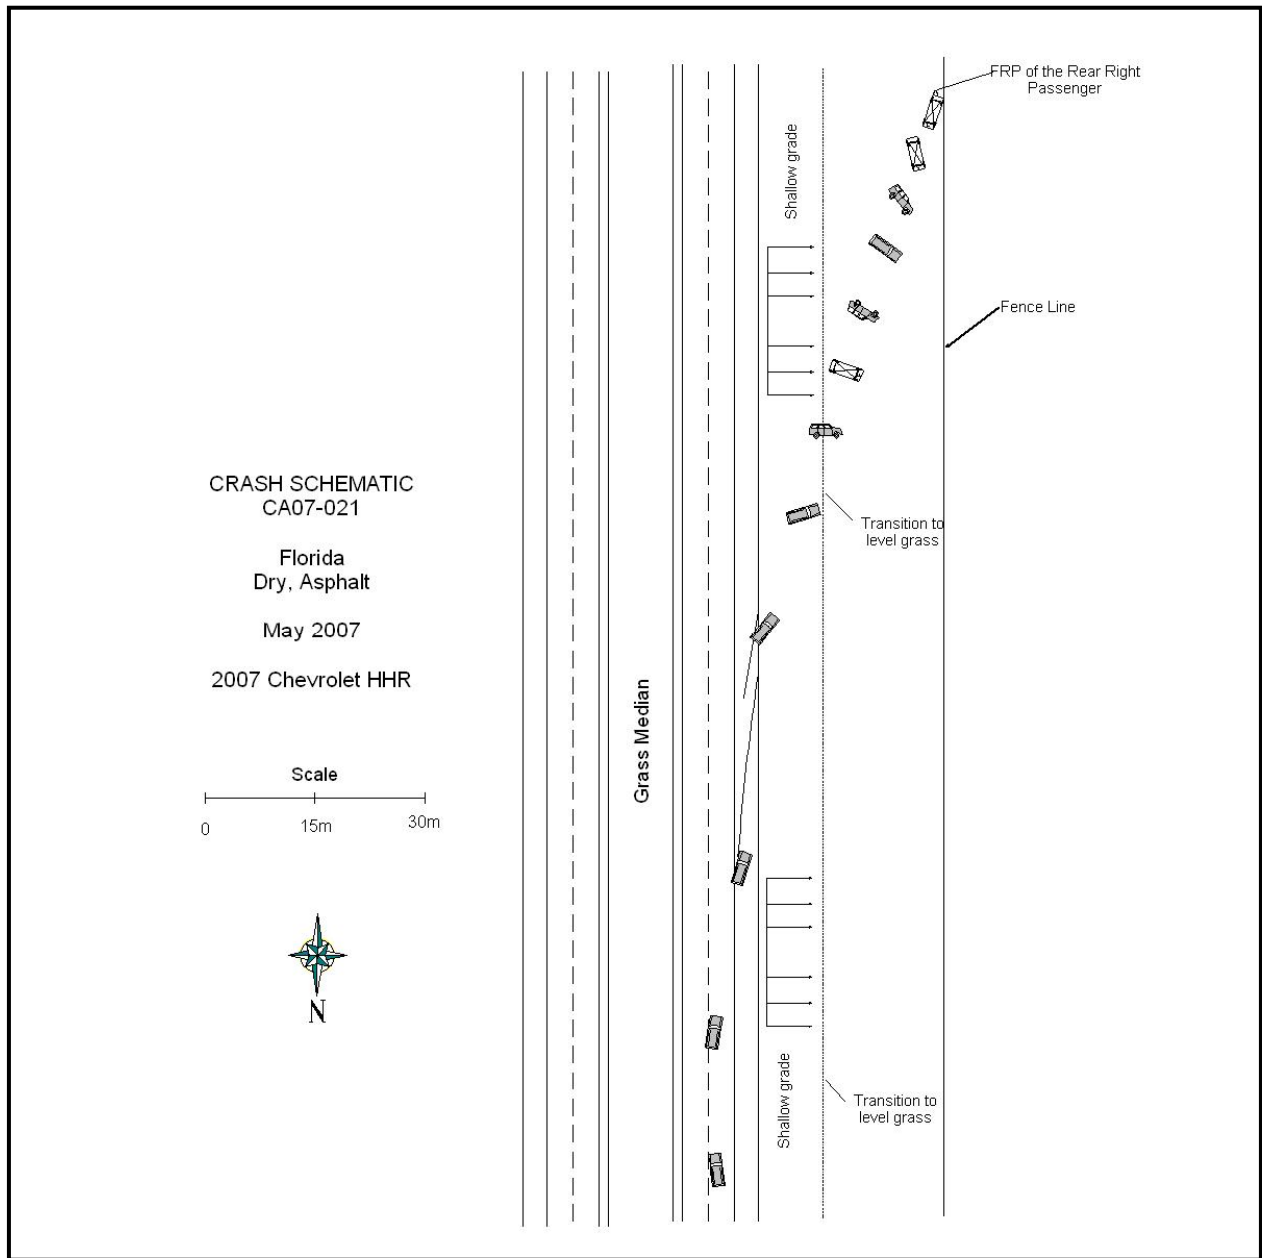
Figure 12: Crash schematic.
