INDIANA UNIVERSITY

TRANSPORTATION RESEARCH CENTER

ON-SITE CHILD SAFETY SEAT INVESTIGATION

CASE NUMBER - IN07022
LOCATION - ILLINOIS
VEHICLE - 1992 HONDA ACCORD EX
CRASH DATE - July 2007

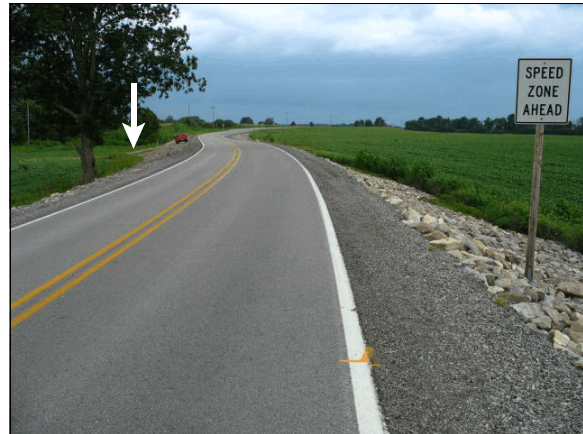
Pre-Crash: The Honda was traveling west. The driver was negotiating a left curve and intended to continue westbound. The vehicle's right side wheels departed the right side of the roadway and entered the gravel shoulder (**Figure 1**). The driver told police he inadvertently ran off the

Figure 1: Approach of Honda, orange mark shows where the vehicle's right side tires entered the shoulder, arrow shows location of final rest

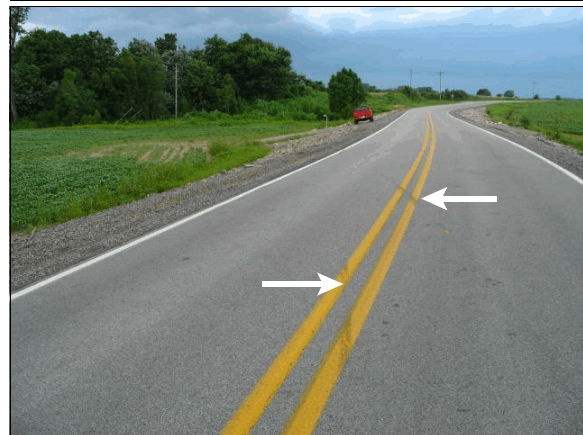
roadway in the curve. The driver steered left and the vehicle began to rotate CCW as it reentered the roadway. The vehicle continued to rotate CCW across both travel lanes (**Figure 2**). The crash occurred on the south side of the roadway.

Figure 2: Approach of Honda in CCW rotation to roadway departure and rollover; left arrow shows right front tire mark, right arrow shows right rear tire mark

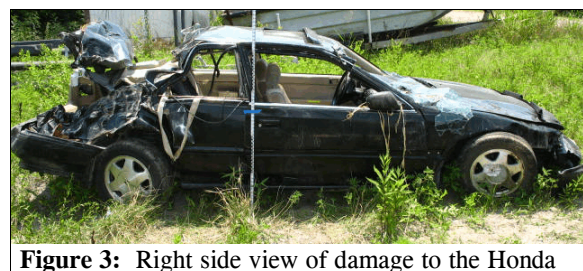
Figure 3: Right side view of damage to the Honda

Exterior Damage: The Honda sustained damage to its top, both sides and the undercarriage as a result of the rollover. The direct damage on the top plane began 60 centimeters (23.6 inches) forward of the right front axle and extended 390 centimeters (153.5 inches) rearward along the top. The direct damage also extended across the full width of the top plane. The maximum vertical crush occurred to the backlight header 60 centimeters (23.6 inches) inboard of the left C-pillar and was measured as 14 centimeters (5.5 inches, **Figure 6**). The maximum lateral crush occurred to the right C-pillar and was measured as 5 centimeters (2 inches). The induced damage involved the front bumper, right headlamp, both turn signal assemblies, the hood, roof, windshield glazing, left fender and back bumper.

Damage Classification: The CDC for the Honda Accord was **00-TDDO-3**. The WinSMASH reconstruction program could not be used to reconstruct the Honda’s Delta V because rollovers are out of scope of the program. The severity of the rollover damage was moderate based on the extent of the roof crush.

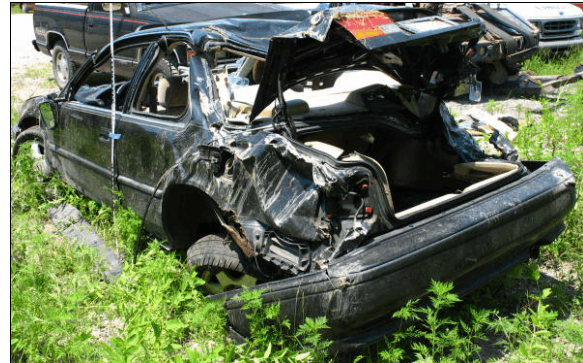
Figure 4: Back left view of damage to the Honda

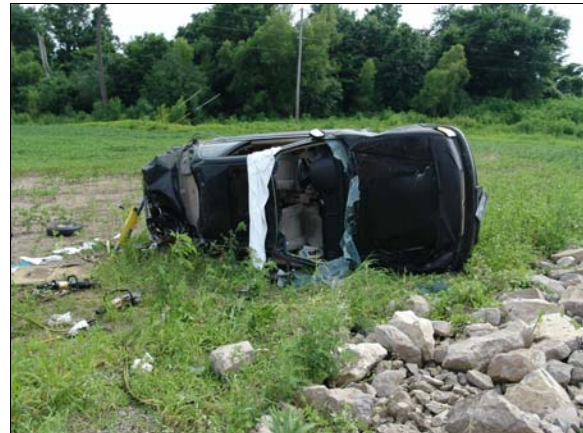
Crash: The Honda departed the left side of the roadway, tripped and rolled over with the right side leading across the rock-covered embankment and a gravel field access roadway. The vehicle rolled over 9 quarter turns traversing a distance of approximately 27 meters (89 feet). The most severe ground impacts occurred to the left and right quarter panels, right C-pillar, and the backlight header (**Figures 3** and **4**). The vehicle came to final rest on its right side (**Figure 5**) heading north.

Figure 5: Sheriff department’s on-scene photo of Honda’s final rest; windshield cut out by rescue to extricate front right passenger

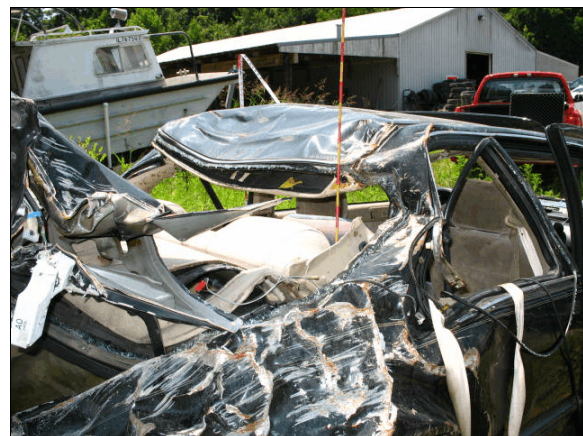
Figure 6: Overview of crush to the Honda’s roof, backlite header and right C-pillar; each increment on the measurement rod is 5 cm (2 in)

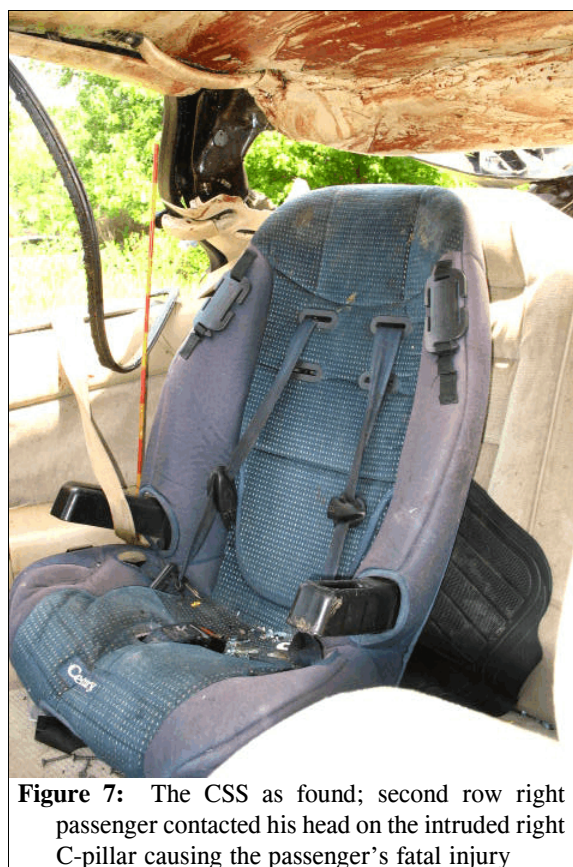
Vehicle Interior: The CSS was found in the second row right seat position and a large deposit of blood and brain matter were on the intruded right C-pillar (**Figure 7**) indicating the second row right passenger contacted his head on the C-pillar during the rollover. The deposit of blood and brain matter extended across the roof to the left C-pillar (**Figure 8**). The second row right passenger's seat belt retractor was jammed and a length of seat belt extended out of the retractor consistent with usage of the belt in the crash. Examination of the front row area revealed a bent right front door arm rest, displaced door handle frame, and that the door panel was bowed outward. The contact evidence indicated that the front right passenger had impacted the door during the rollover. Scuff marks were present on the left instrument panel due to contact by the driver's left knee, and there were scuff marks on the left front arm rest from contact by the driver's left hip. The front right passenger's shoulder belt was twisted and wedged tightly into the front corner of the D-ring, and the seat belt retractor was jammed with a length of the belt extended out of the retractor consistent with usage of the seat belt in the crash. Several passenger compartment intrusions were documented, all of which occurred in the second row. The most severe intrusions that occurred within the second row right passenger's occupant space involved the backlight header, roof and right C-pillar. The backlight header and roof intruded 16 centimeters (6.3 inches) vertically. The dominate intrusion of the C-pillar was 8 centimeters (3.1 inches) forward, but it was also displaced 5 centimeters (2 inches) laterally and 4 centimeters (1.6 inches) vertically.

Figure 7: The CSS as found; second row right passenger contacted his head on the intruded right C-pillar causing the passenger's fatal injury

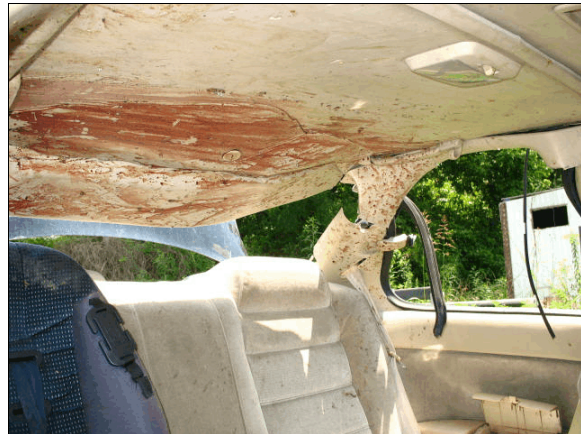
Figure 8: Blood and brain matter sprayed across roof from right "C"-pillar

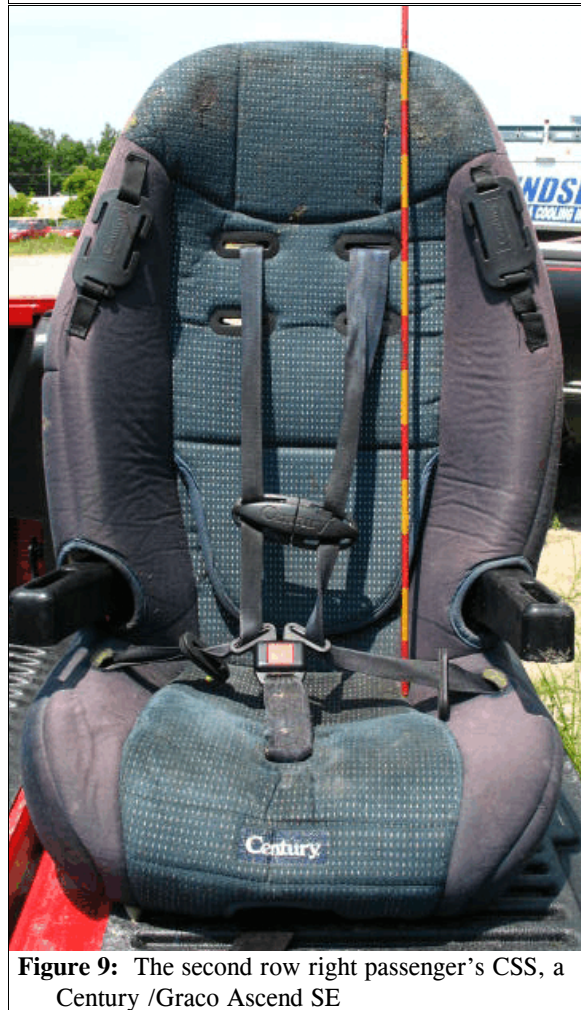
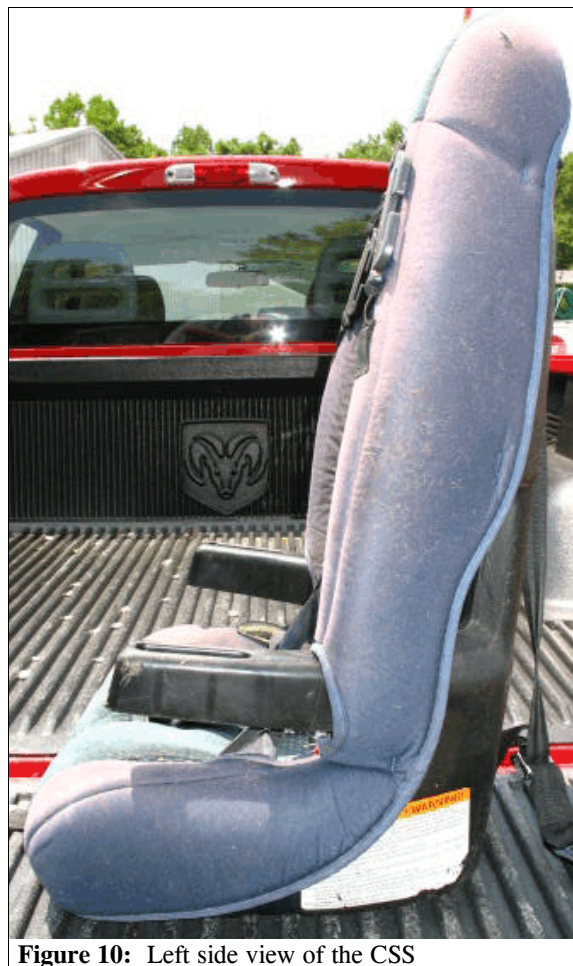
The Honda's second row right passenger was seated in a hi-back booster seat (**Figures 9 and 10** below) designed with a 5-point harness and rear tether strap. The CSS was manufactured by Century/Graco Products November 27, 2001 and the model name was Ascend SE. The model number had worn off the identification label and could not be read. The CSS was designed to be used either as a belt positioning booster seat or with the harness system. There were two sets of slots to thread the harness straps through and they were threaded through the top slots. There was also a belt guide on the back of the CSS and a shoulder belt clip on each side of the seat back. The CSS was used as a belt positioning booster in this crash. The manufacturer's information label indicated that usage of the CSS without the harness was intended for children who weigh between 13.6 to 36.3 kilograms (30 to 80 pounds) and are 89 to 127 centimeters (35 to 50 inches) in height. The second row right passenger was 97 centimeters (38 inches) tall and weighed 19 kilograms (42 pounds).

The CSS was constructed of a one piece plastic shell and was designed with arm rests. The shell was fitted with a single cloth covered foam pad. Inspection of the CSS revealed no crash induced damage.

Figure 9: The second row right passenger's CSS, a Century /Graco Ascend SE

Figure 10: Left side view of the CSS

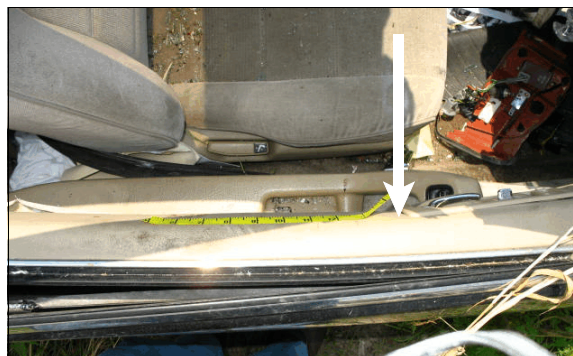
Figure 11: Right front door slightly bowed outward from contact by front right passenger

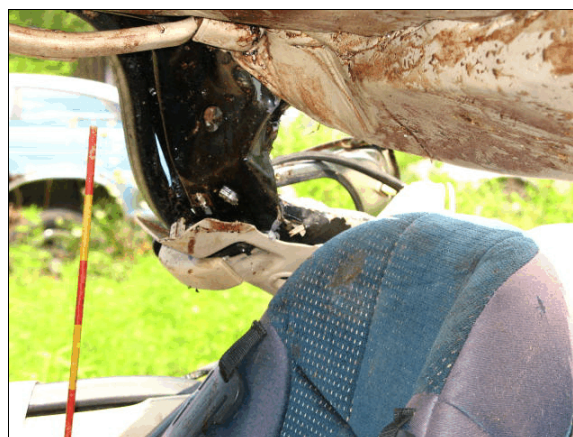
As the Honda rotated CCW across the roadway, the second row right passenger’s seat belt retractor probably locked and the passenger was displaced to the right within the CSS. As the Honda rolled over, the passenger was displaced toward the roof and loaded the seat belt. When the vehicle landed on the right C-pillar and roof area, the passenger contacted his head on the intruded right C-pillar (**Figure 12**). As a result of the contact, the passenger sustained a crushed skull and extrusion of brain matter. The sheriff department’s on-scene photographs showed the passenger in the CSS at final rest. Due to the crash forces, the lap belt had ridden up on his abdomen and the CSS was slightly off the seat cushion. The on-scene photographs also showed that the passenger’s right arm and right leg had been ejected out of the vehicle’s right rear window, and his left foot had been ejected out of the right front window. The glazing in both windows had disintegrated during the rollover.

Figure 12: The second row right passenger contacted his head on the intruded right C-pillar

Injury Number	Injury Description (including Aspect)	NASS Injury Code & AIS 90	Injury Source	Source Confidence	Source of Injury Data
1	Crushed skull including extrusion of brain matter with skull fractures and brain laceration	maximum 113000.6,0	“C”-pillar {intruded}	Certain	Post-mortem examination
